## CONDITION REPORT

Report No: 2016303384

MFC Auction House  
M57 Pretoria Rd, Glenmarais, KEMPTON PARK  
Gauteng

Vehicle Type	PASSENGER VEHICLE	Registered Owner	MFC AUCTION HOUSE
Manufacturer	HYUNDAI	Registration Number	KH57WLGP
Model	i20	Register Number	
VIN	MALBM51CLKM538344	Date Of First Licensing	
Engine Number		Last COR	
Doors	5	License Expiry Date	30/11/2023
Color	RED	Power / Displacement	
Year Model		Paint Finish	TWO COAT UNI
Km Reading	83,010 KM	Fuel	PETROL
Cab / Body Type	HATCHBACK	Transmission	MANUAL

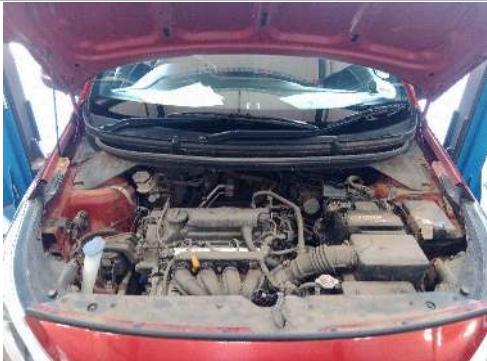
ENGINE 1

Damage	Repair Way
Engine	Engine bay dirty.
Engine	Signs of rodent in engine bay
Body and Exterior	Dents and scratches on some body panels
Body and Exterior	Stone chips and spray work on some body panels
Body and Exterior	Some body panels misaligned
Undercarriage	Vehicle undercarriage dirty.

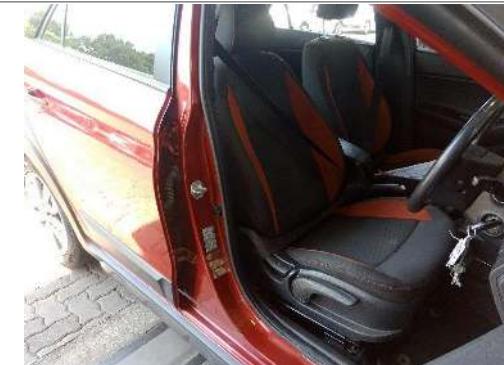
Damage	Repair Way
Battery box Damaged	Replace
Center Console / Cubbyhole + Lid Defective	Repair
Windscreen Wiper Damaged	Replace
Dim Light Left Damaged	Replace
Dim Light Right Damaged	Replace
Bright Light Right Damaged	Replace
Seat Front Left Dirty	Repair
Seat Front Right Damaged	Repair
Seat Rear Dirty	Repair
Boot Carpet Defective	Repair
Front Bumper Paintwork • Scratched	Repair
Bonnet Paintwork • Scratched	Repair
Front Fender Right Paintwork • Scratched	Repair
Door Front Left Dented	Repair
Door Front Right Paintwork • Scratched	Repair
Door Rear Right Paintwork • Scratched	Repair
Rear bumper Paintwork • Scratched	Repair
Inner Boot Floor Pan and Spare Wheel Well Dented	Repair
Sill Panel Right Paintwork • Scratched	Repair
Rocker Panel Left Paintwork • Scratched	Repair
Spare Tyre Damaged	Replace
Rim Front Left Scratched	Repair
Rim Front Right Scratched	Repair
Rim Rear Left Scratched	Repair
Chassis Dented	Repair
Sub Frame Scratched	Replace

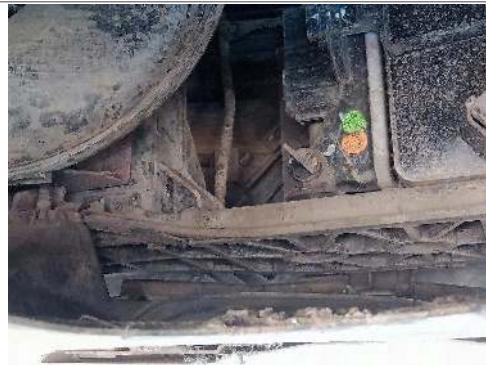
Belly plates Defective	Repair
Radiator Cradle Cracked	Repair
Interior	Vehicle interior dirty and some panels scratched
