## CONDITION REPORT

Report No:  
2017295103  
DATE  
07/09/2026

| Manufacturer | SUZUKI | Registration Number | FVW994L |
| Model | DZIRE 1.2 GL MC [2020-2025] | Register Number | |

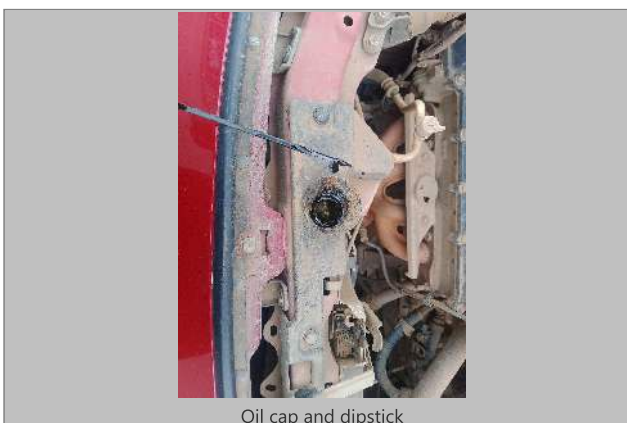
Oil cap and dipstick

| Foreign substance on oil cap | Repair |

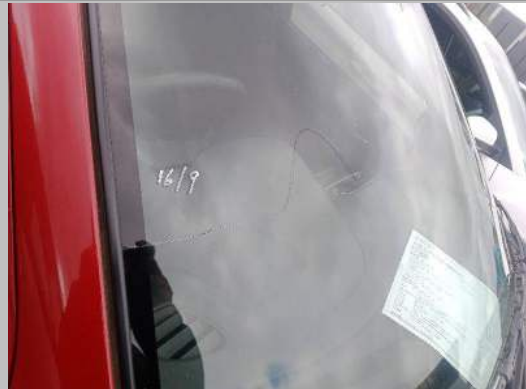
| Windscreen Cracked | Replace |

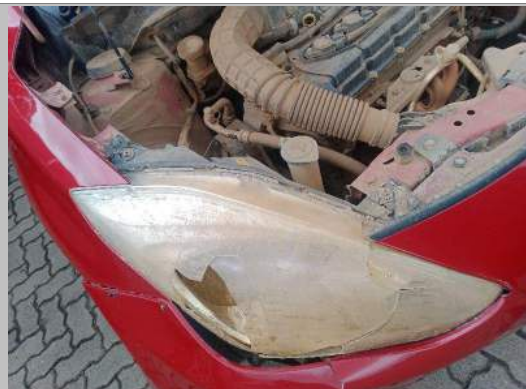
| Headlight Right Damaged | Replace |

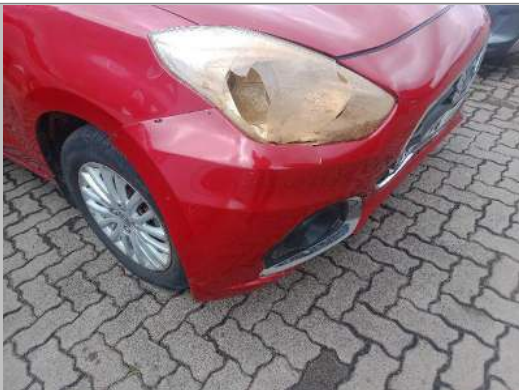
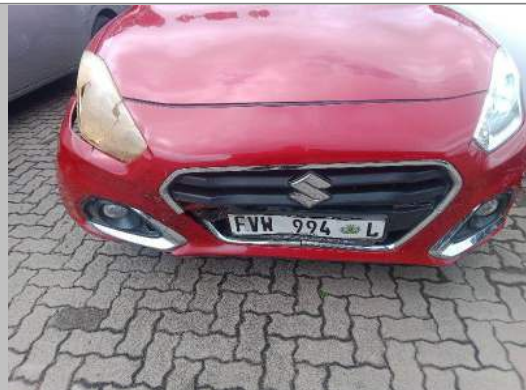
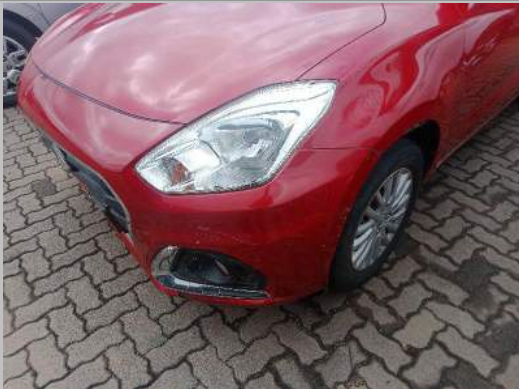
| Front Bumper Damaged | Repair |
| Body exterior | Impact damage at front of vehicle |

Front Bumper

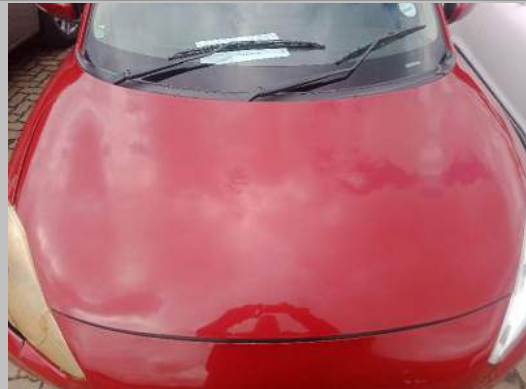
| Bonnet Paintwork • Scratched | Repair |

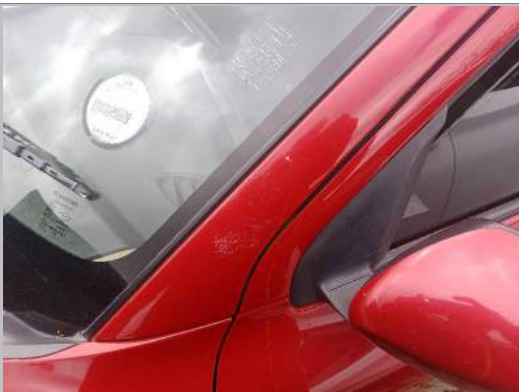
| A • Pillar Left Paintwork • Scratched | Repair |

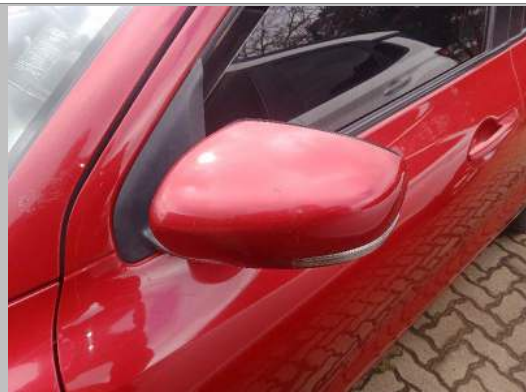
| Side Mirror Left Paintwork • Scratched | Repair |

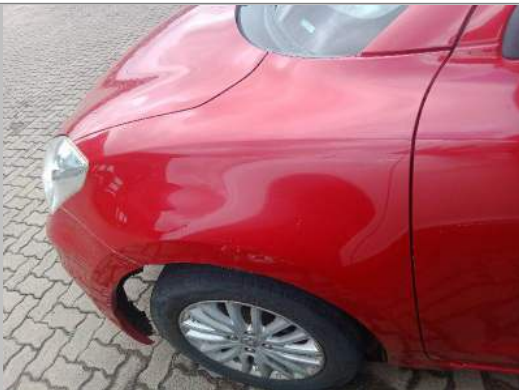
| Front Fender Left Paintwork • Scratched | Repair |

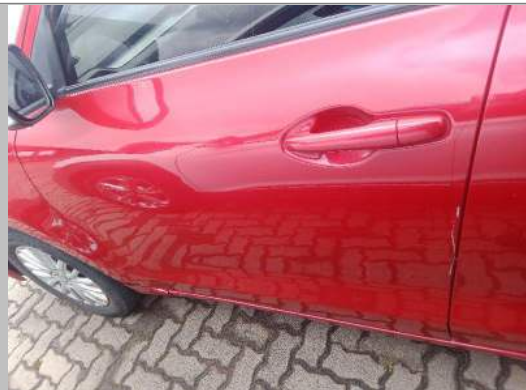
| Door Front Left Paintwork • Scratched | Repair |

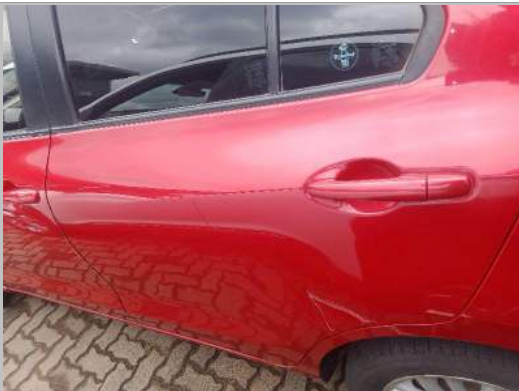
| Door Rear Left Paintwork • Scratched | Repair |

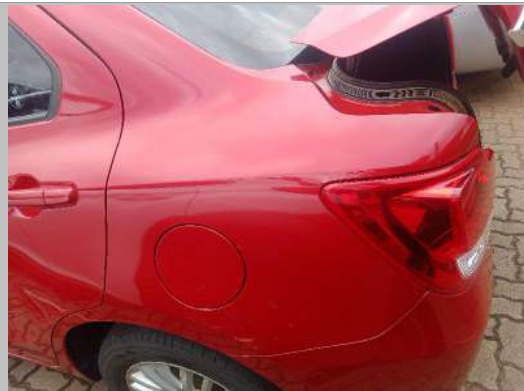
| Rear Fender Left Paintwork • Scratched | Repair |

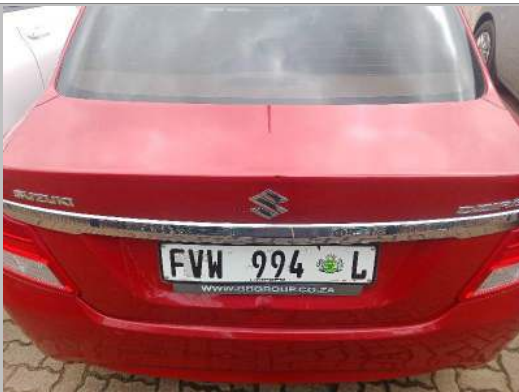
| Boot Lid / Hatch door Dented | Repair |

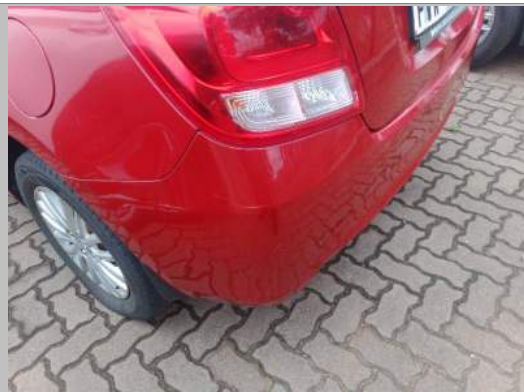
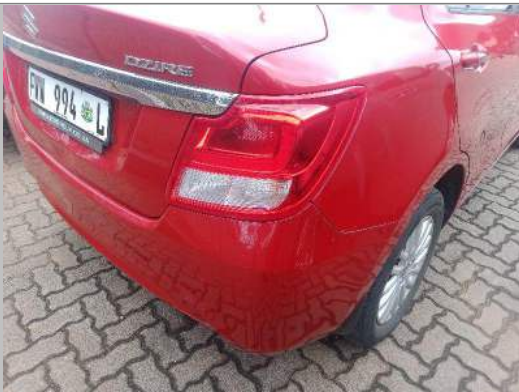
| Rear bumper Paintwork • Scratched | Repair |

Rear bumper

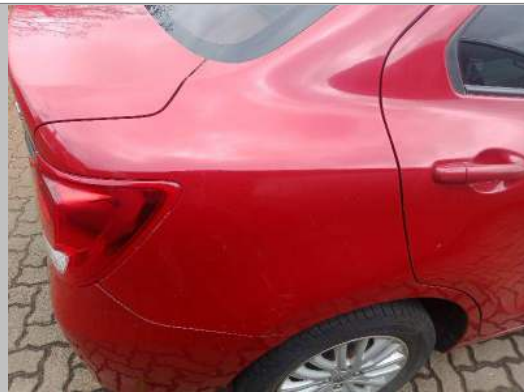
| Rear Fender Right Paintwork • Scratched | Repair |

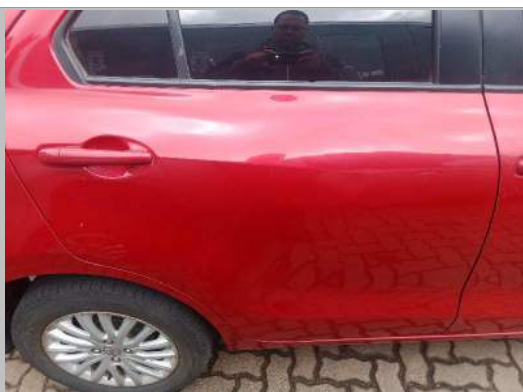
| Door Rear Right Paintwork • Scratched | Repair |

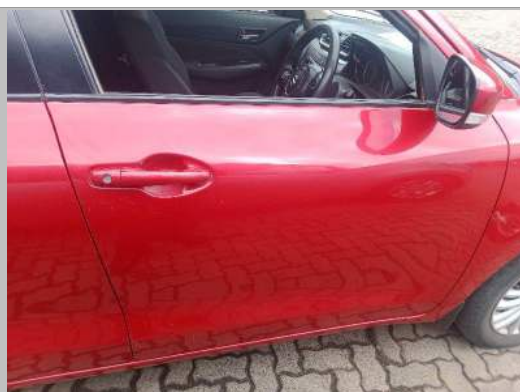
| Door Front Right Paintwork • Scratched | Repair |

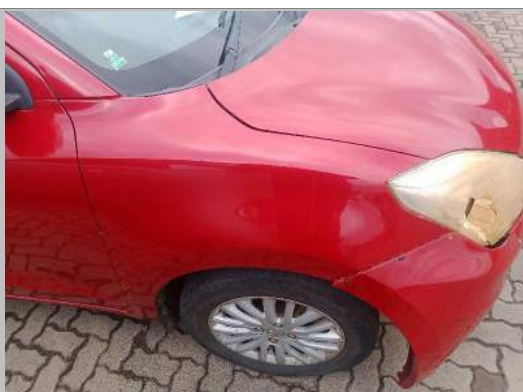
| Front Fender Right Paintwork • Scratched | Repair |

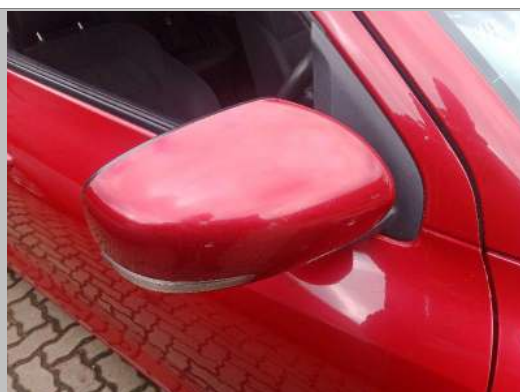
| Side Mirror Right Paintwork • Scratched | Repair |

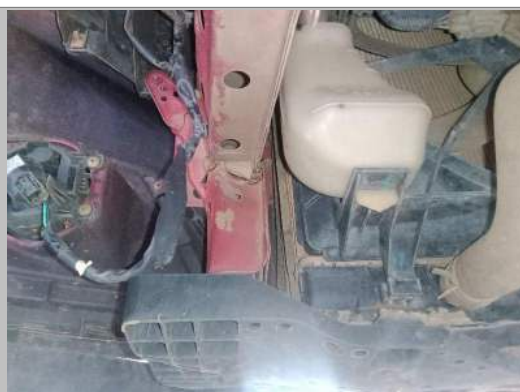
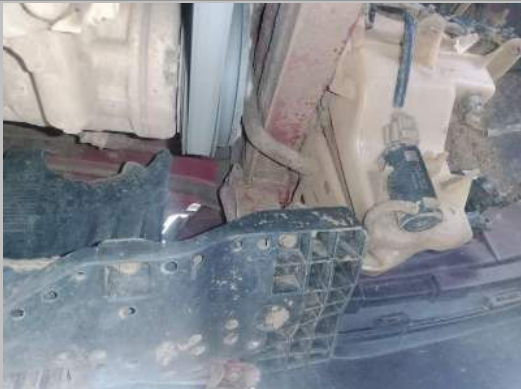
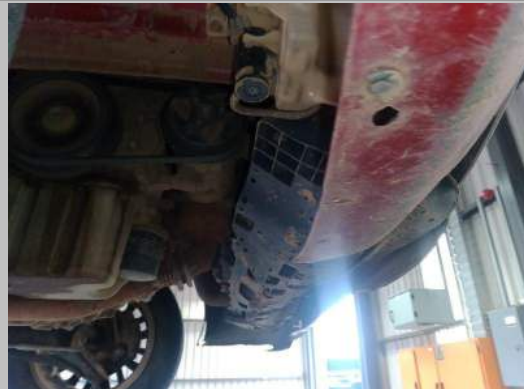
| Radiator Cradle Dented | Repair |

Radiator Cradle
