## CONDITION REPORT

Report No:  
2017297321  
DATE  
10/09/2026

| Manufacturer | RENAULT | Registration Number | HC39ZLGP |
| Model | KWID | Register Number | |

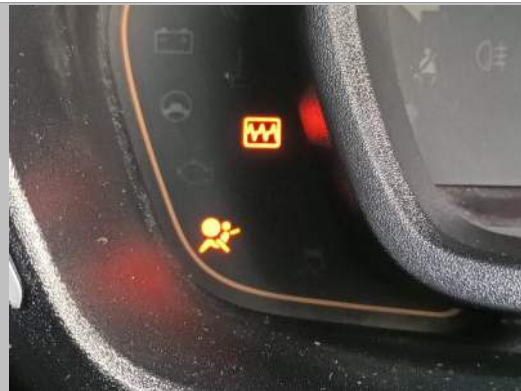
| Damage | Repair Way |
|---|---|
| Warning lights illuminated | Repair |

Warning lights illuminated

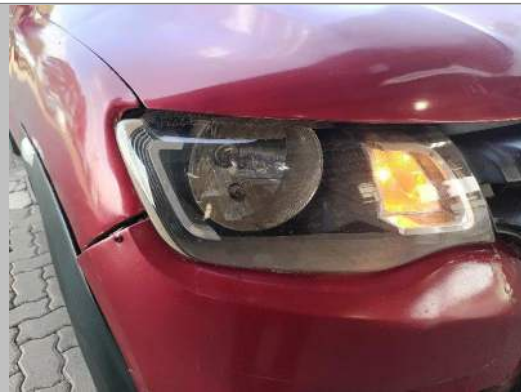
| Damage | Repair Way |
|---|---|
| Dim Light Right Defective | Replace |

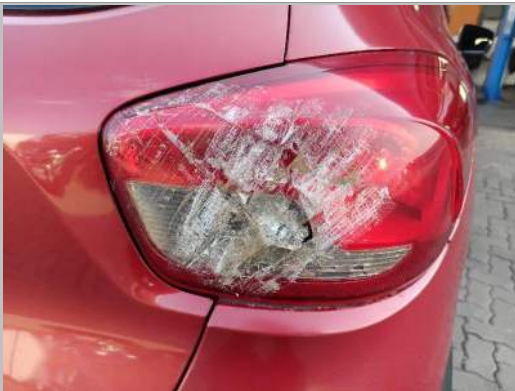
| Damage | Repair Way |
|---|---|
| Tail Light Right Damaged | Replace |

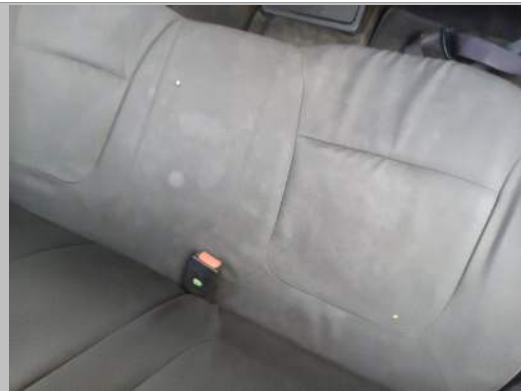
| Damage | Repair Way |
|---|---|
| Seat Rear Torn / Cut | Repair |

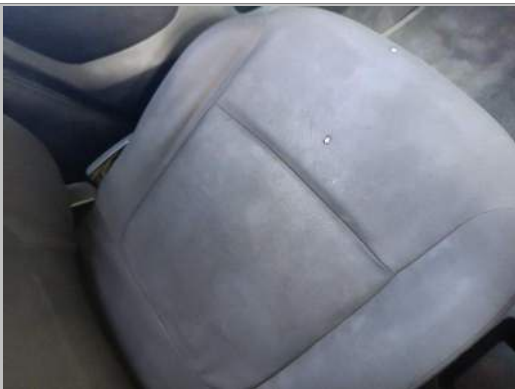
| Damage | Repair Way |
|---|---|
| Seat Front Left Torn / Cut | Repair |

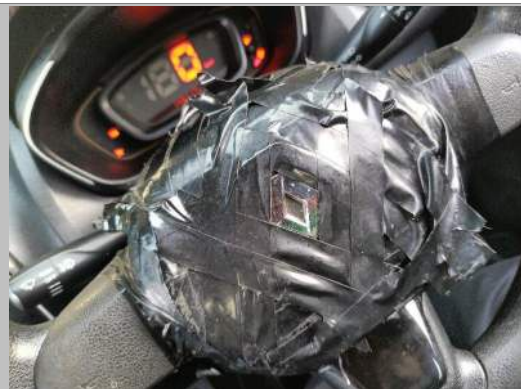
| Damage | Repair Way |
|---|---|
| Steering Wheel Trim Damaged | Repair |

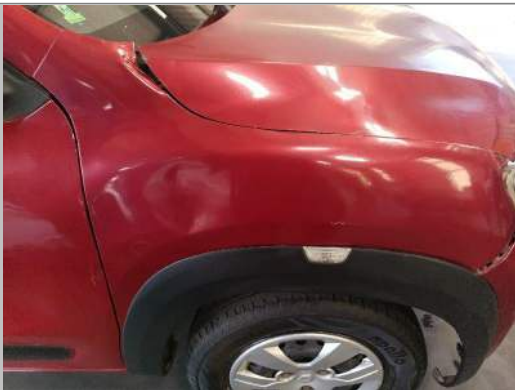
| Damage | Repair Way |
|---|---|
| Front Fender Right Residual Traces of Repair | Repair |

General Comments: Body • Exterior: Residual traces of poor repair on body panels. Signs of spray work done on body panels.

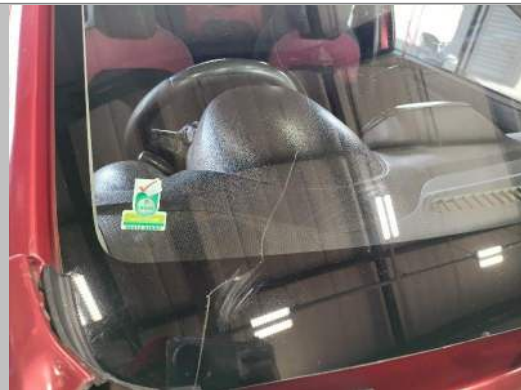
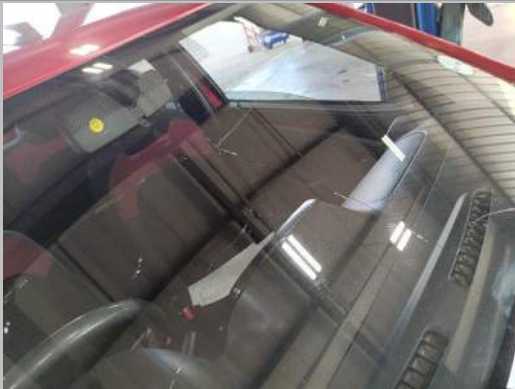
| Damage | Repair Way |
|---|---|
| Windscreen Cracked | Replace |

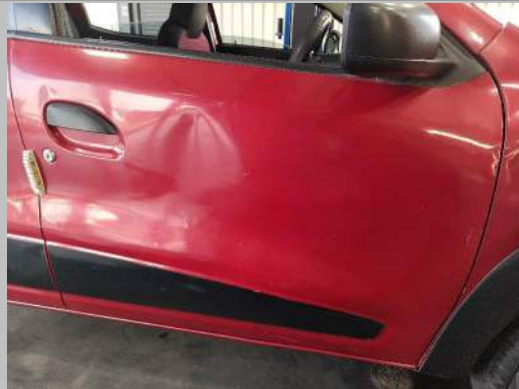
| Damage | Repair Way |
|---|---|
| Door Front Right Residual Traces of Repair | Repair |

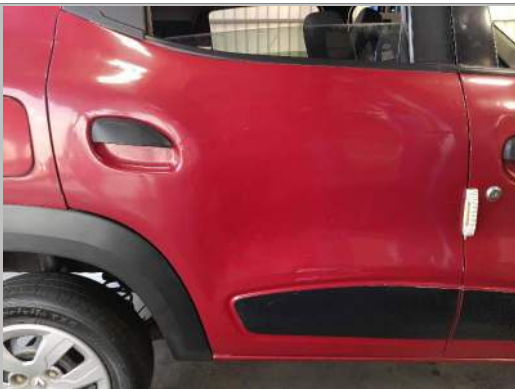
| Damage | Repair Way |
|---|---|
| Door Rear Right Residual Traces of Repair | Repair |

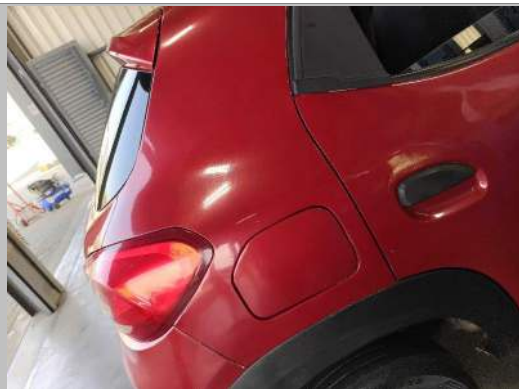
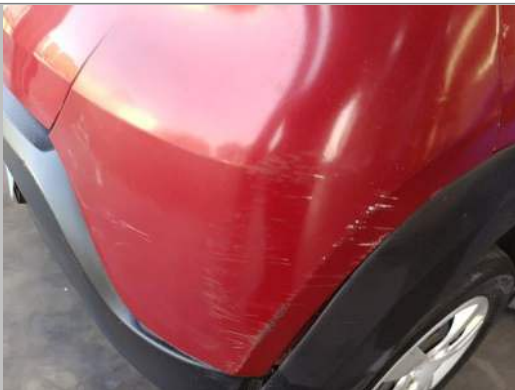
| Damage | Repair Way |
|---|---|
| Rear Fender Right Residual Traces of Repair | Repair |

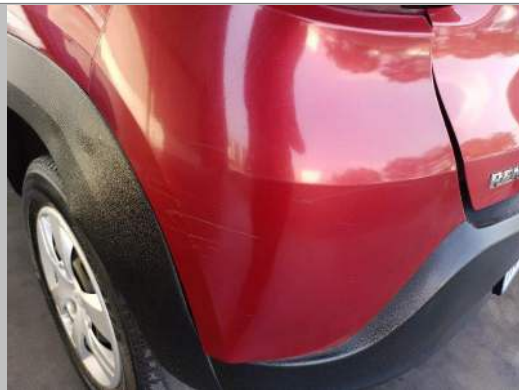
| Damage | Repair Way |
|---|---|
| Rear Fender Left Paintwork • Scratched | Repair |

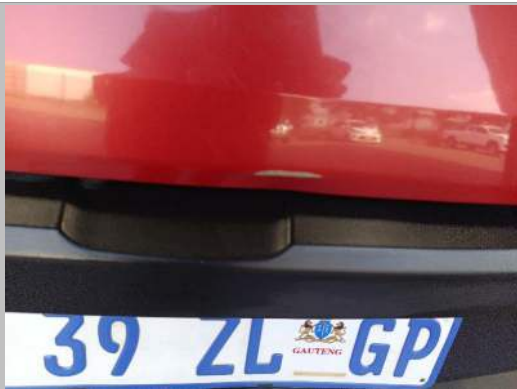
| Damage | Repair Way |
|---|---|
| Boot Lid / Hatch door Dented | Repair |

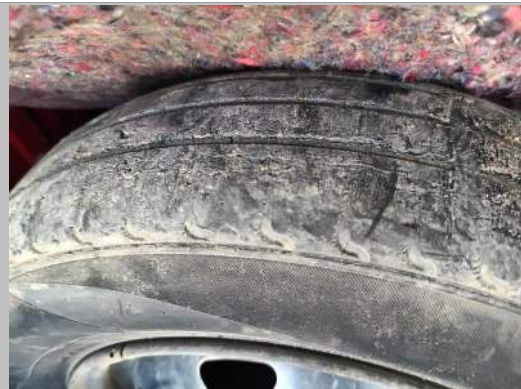
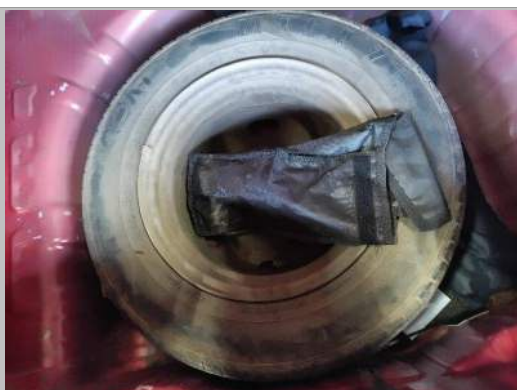
| Damage | Repair Way |
|---|---|
| Spare Tyre Smooth | Replace |

| | Size | Load/Speed Index | Manufacture | Model | Type* | Production Date | Tread Depth (mm) |
|---|---|---|---|---|---|---|---|
| Spare | 155/80R13 | 79T | Ceat | Milaze | V | 0000 | 0 mm |

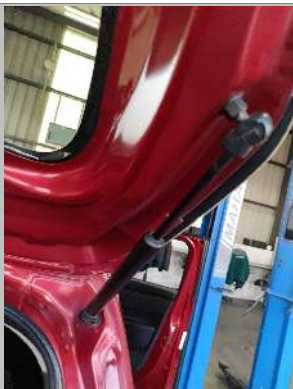
| Damage | Repair Way |
|---|---|
| Boot Lid / Hatch Door Shock Right Defective | Repair |

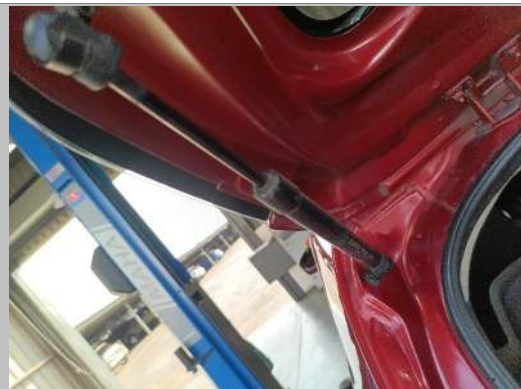
| Damage | Repair Way |
|---|---|
| Boot Lid / Hatch Door Shock Left Defective | Repair |

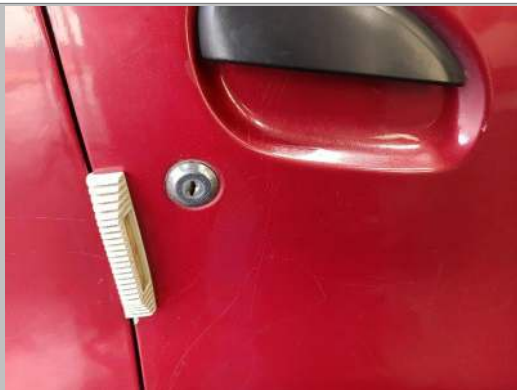
| Damage | Repair Way |
|---|---|
| Door Lock Front Right Damaged | Repair |

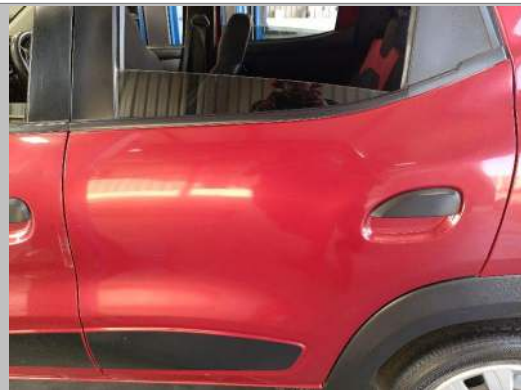
| Damage | Repair Way |
|---|---|
| Door Rear Left Dented | Repair |

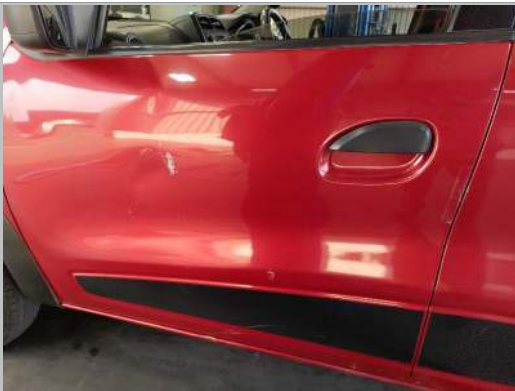
| Damage | Repair Way |
|---|---|
| Door Front Left Paintwork • Scratched | Repair |

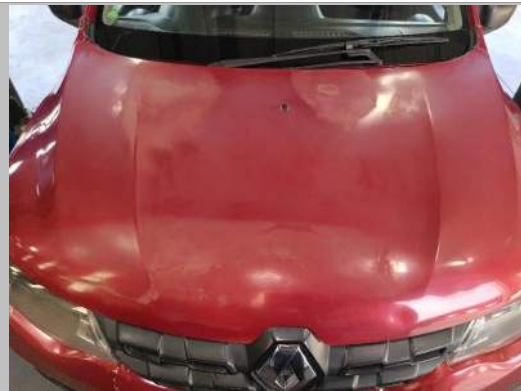
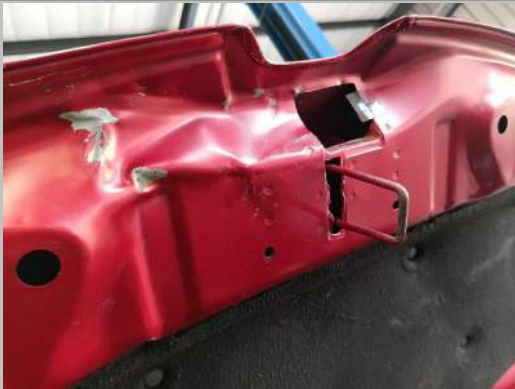
| Damage | Repair Way |
|---|---|
| Bonnet Paintwork • Flaking | Repair |

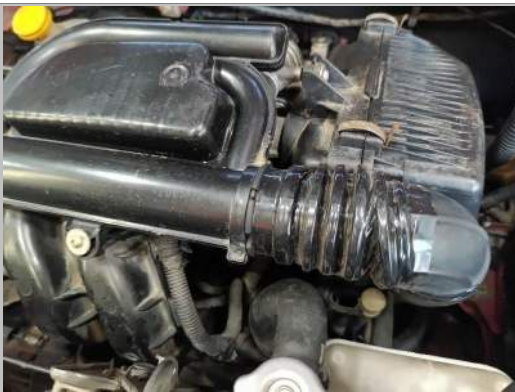
| Damage | Repair Way |
|---|---|
| Air cleaner Damaged | Repair |

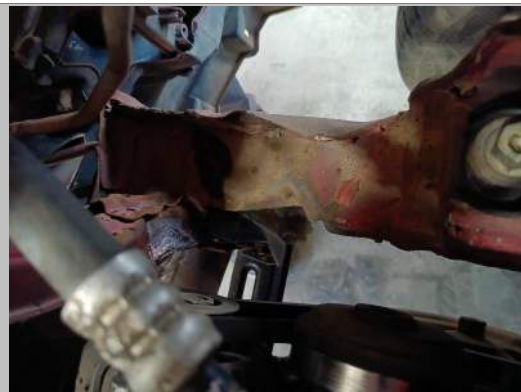
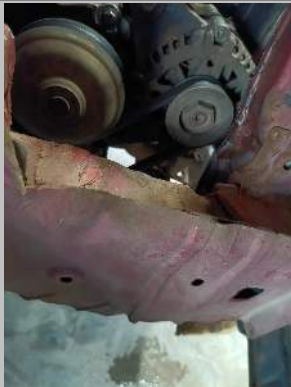
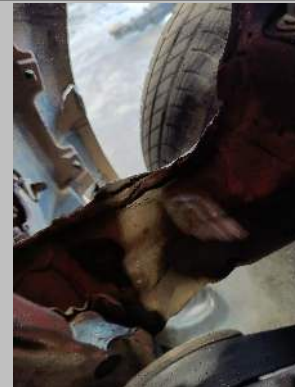
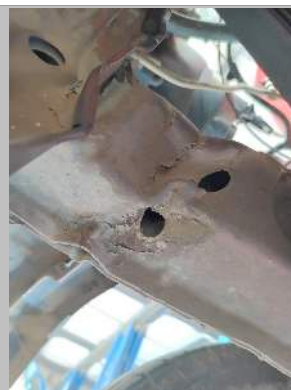
| Damage | Repair Way |
|---|---|
| Main Beam Right Damaged | Repair |

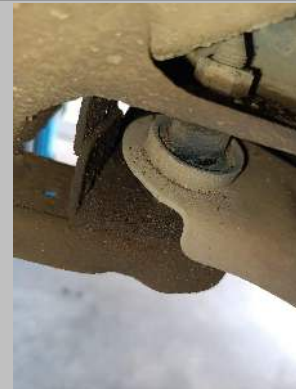
| Damage | Repair Way |
|---|---|
| Control Arm Bush(es) Front Axle Right Cracked | Replace |

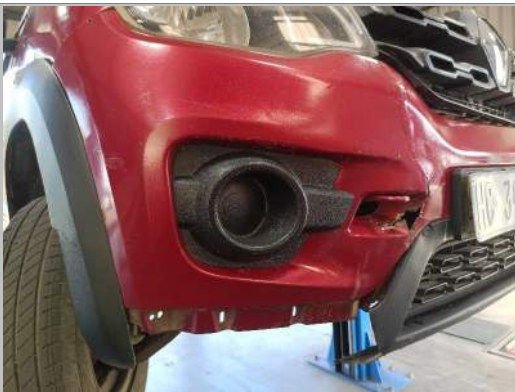
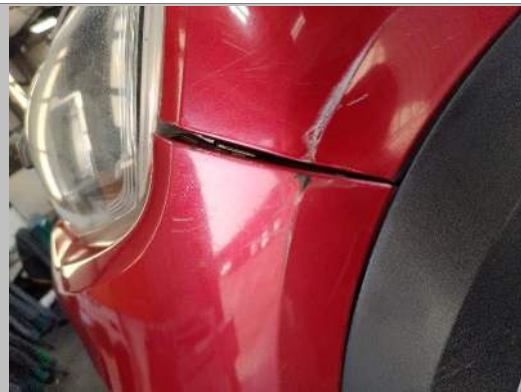
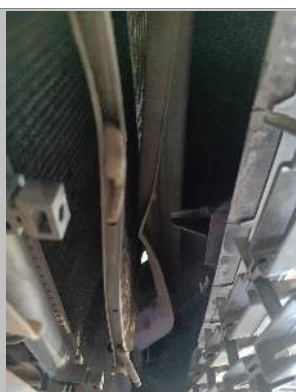
| Damage | Repair Way |
|---|---|
| Front Bumper Damaged | Replace |

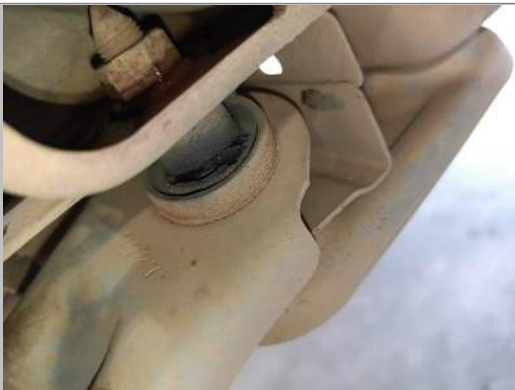
| Damage | Repair Way |
|---|---|
| Control Arm Bush(es) Front Axle Left Cracked | Replace |

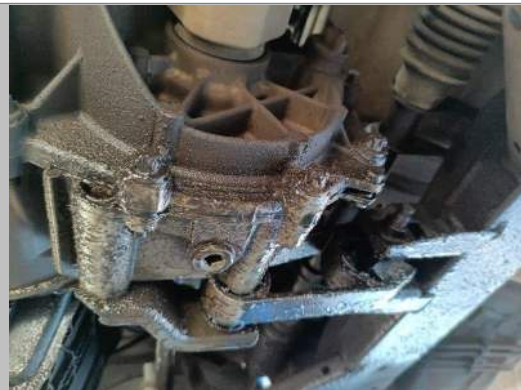
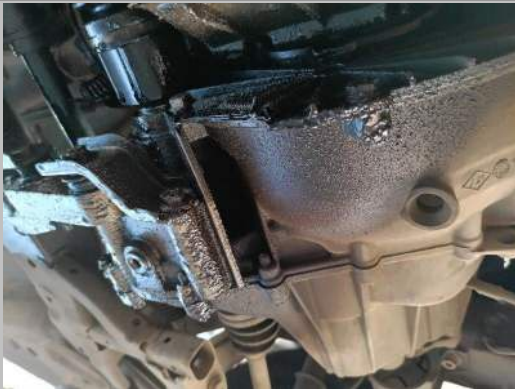
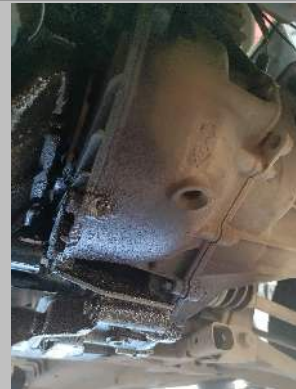
| Damage | Repair Way |
|---|---|
| Gearbox Oil Leak | Replace |

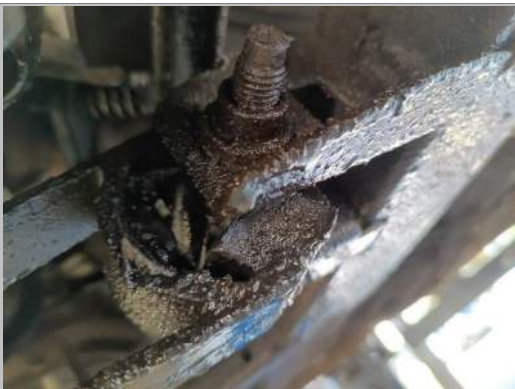
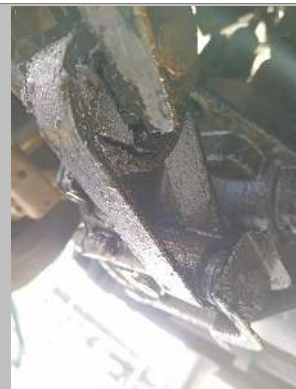
| Damage | Repair Way |
|---|---|
| Gearbox Mountings Damaged | Replace |

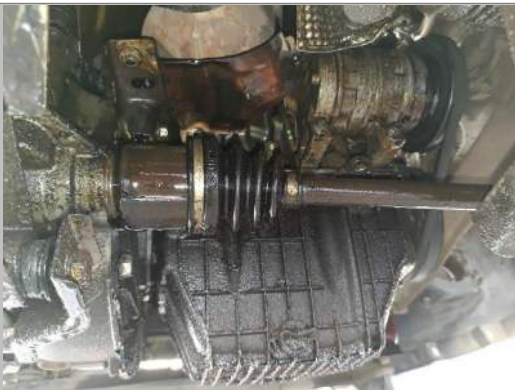
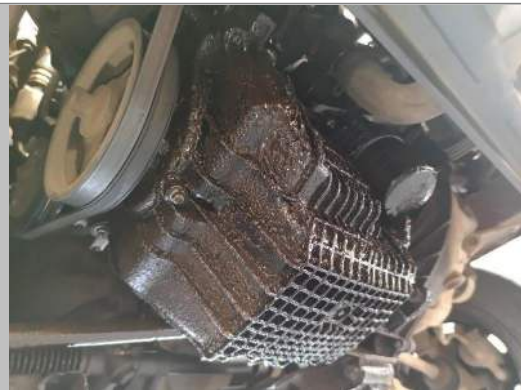
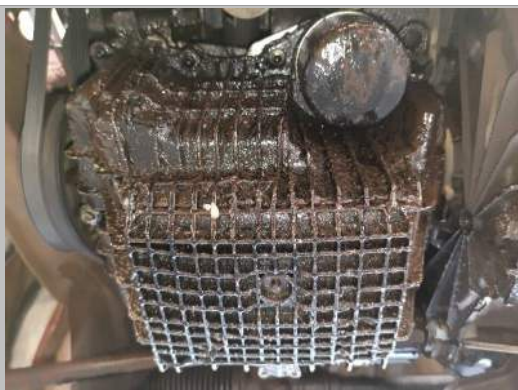
| Damage | Repair Way |
|---|---|
| Engine Oil Leak | Replace |

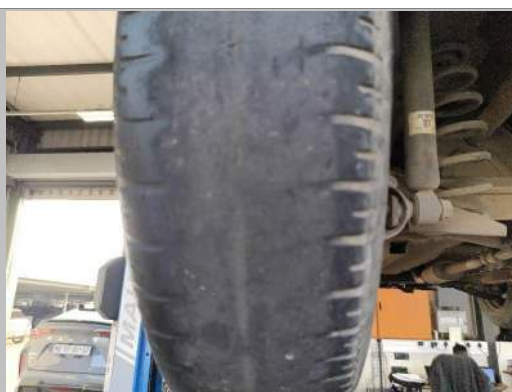
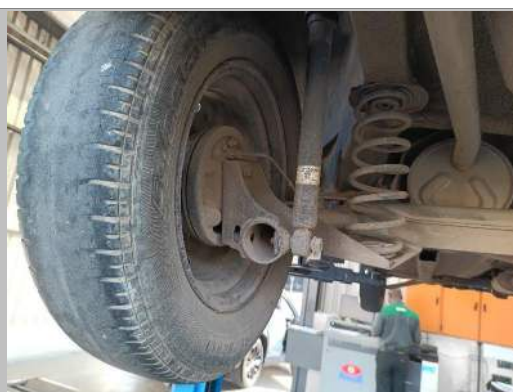
| Damage | Repair Way |
|---|---|
| Tyre Rear Left Smooth | Replace |

| | Size | Load/Speed Index | Manufacture | Model | Type* | Production Date | Tread Depth (mm) |
|---|---|---|---|---|---|---|---|
| Rear Left | 155/80R13 | 79T | Sava | Effecta | V | 2919 | 0 mm |

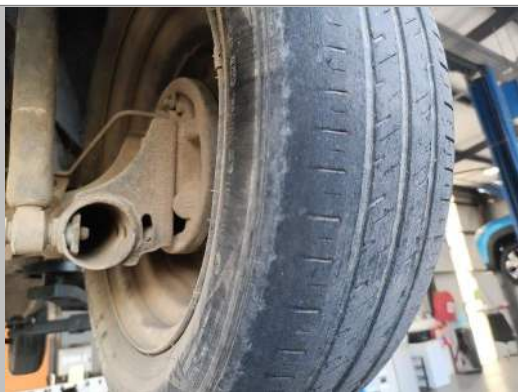
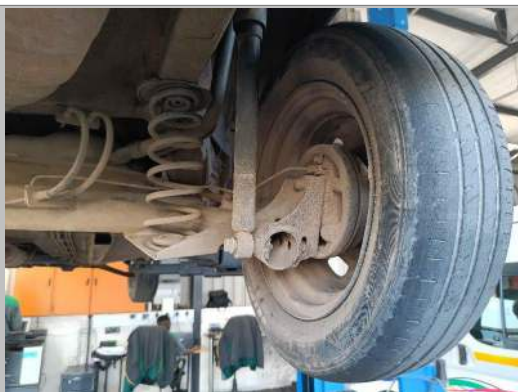
| Damage | Repair Way |
|---|---|
| Tyre Rear Right Smooth | Replace |
| Rear tyre size differs | Replace |

| | Size | Load/Speed Index | Manufacture | Model | Type* | Production Date | Tread Depth (mm) |
|---|---|---|---|---|---|---|---|
| Rear Right | 165/65R13 | 77T | Tracmak | Privilo | V | 0000 | 0 mm |
