## CONDITION REPORT

Report No: 2016250636

MFC Auction House  
M57 Pretoria Rd, Glenmarais, KEMPTON PARK  
Gauteng

Vehicle Type	PASSENGER VEHICLE	Registered Owner	MFC AUCTION HOUSE
Manufacturer	RENAULT	Registration Number	JF15GCGP
Model	KWID	Register Number	
VIN	MEEBBA00400660941	Date Of First Licensing	
Engine Number		Last COR	
Doors	5	License Expiry Date	31/08/2023
Color	WHITE	Power / Displacement	
Year Model		Paint Finish	TWO COAT UNI
Km Reading	47,075 KM	Fuel	PETROL
Cab / Body Type	HATCHBACK	Transmission	MANUAL

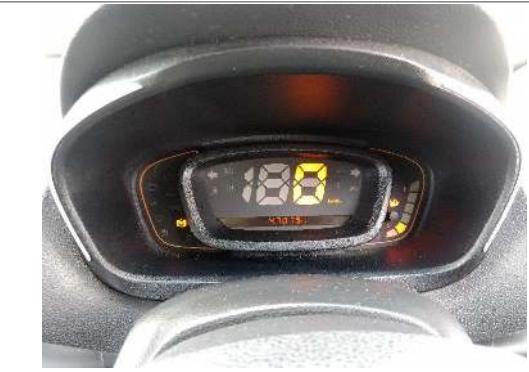
DASHBOARD (W/ ENGINE RUNNING)

Damage	Repair Way
Triangle Missing ABS warning light illuminated on dashboard.	Replace Repair

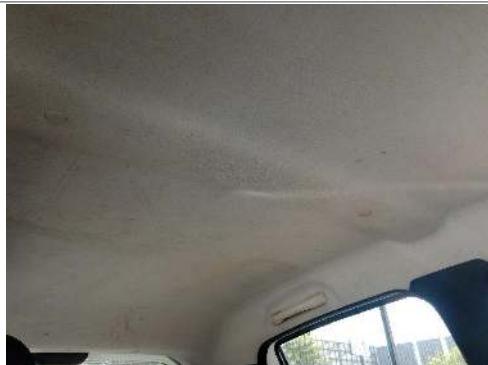
Damage	Repair Way
Engine Oil Leak	Repair
Headlight Left Damaged	Replace
Seat Front Left Damaged	Repair
Seat Front Right Damaged	Repair
Hood Lining Dirty	Repair
Door Sealing Rubber Front Right Damaged	Replace
Door Lock Boot Lid Damaged	Replace
Parcel Tray Damaged	Repair
Steering Wheel Trim Defective	Repair
Front Bumper Damaged	Repair
Bonnet Dented	Repair
Front Fender Left Damaged	Repair
Rear Fender Right Paintwork • Scratched	Repair
Front Fender Left / Inner Tray Damaged	Repair
Door Front Left Dented	Repair
Door Front Right Paintwork • Scratched	Repair
Door Rear Left Paintwork • Scratched	Repair
Door Rear Right Dented	Repair
Boot Lid / Hatch door Dented	Repair
Rear bumper Paintwork • Scratched	Repair
Windscreen Chipped	Repair
Service Brake Performance Rear Axle Left / Right Difference out of legal range	Repair
Control Arm Bush(es) Front Axle Left Cracked	Replace
Control Arm Bush(es) Front Axle Right Cracked	Replace

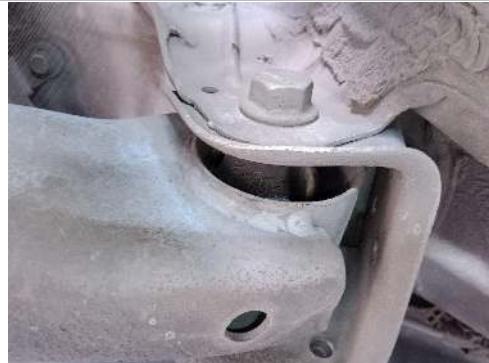
Mounting Rubber(s) Rear Axle Left Cracked	Replace
Mounting Rubber(s) Rear Axle Right Cracked	Replace
Jack Missing	Replace
Wheel Spanner Missing	Replace
