## CONDITION REPORT

Report No:  
2017298575  
DATE  
14/09/2026

| Manufacturer | RENAULT | Registration Number | KNG155MP |
| Model | KWID | Register Number | |

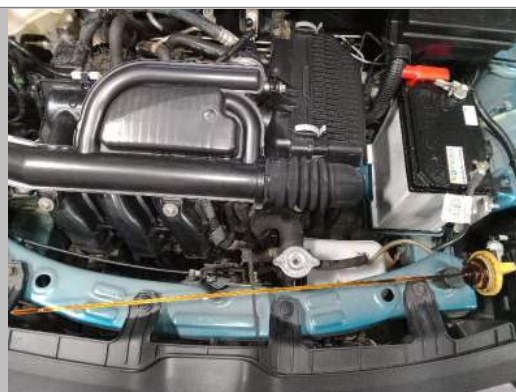
Oil cap and dipstick

| Damage | Repair Way |
|---|---|
| Foreign substance on oil cap | Repair |

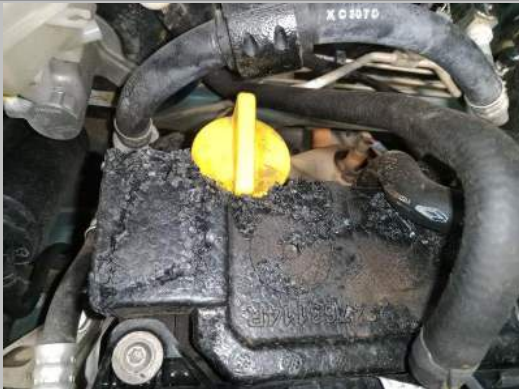
| Damage | Repair Way |
|---|---|
| Engine cover damaged | Replace |

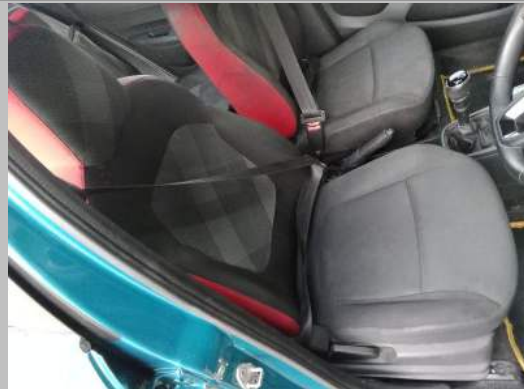
| Damage | Repair Way |
|---|---|
| Seat Front Right Dirty | Repair |

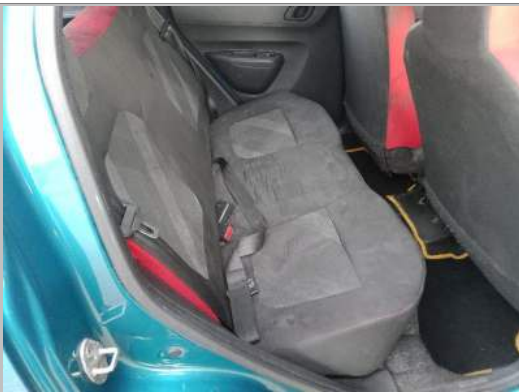
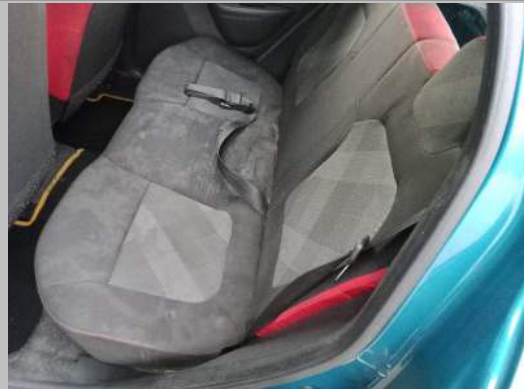
| Damage | Repair Way |
|---|---|
| Seat Rear Dirty | Repair |

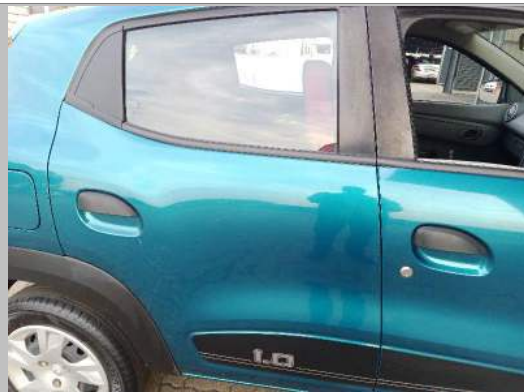
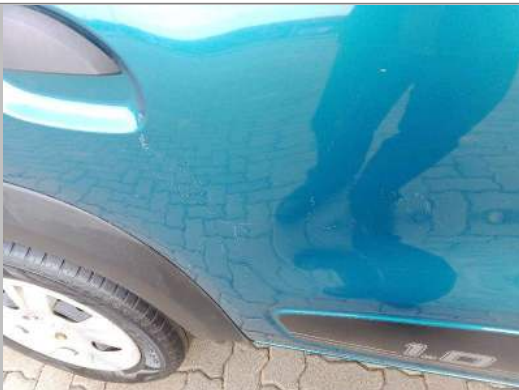
| Damage | Repair Way |
|---|---|
| Door Rear Right Paintwork • Scratched | Repair |

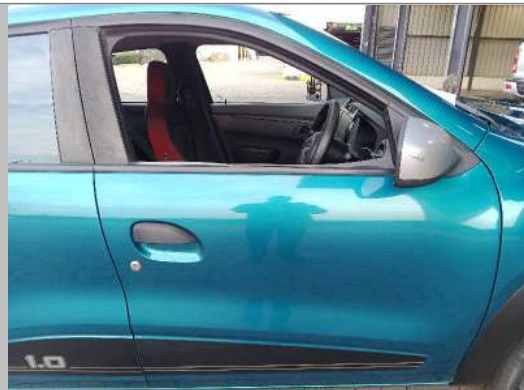
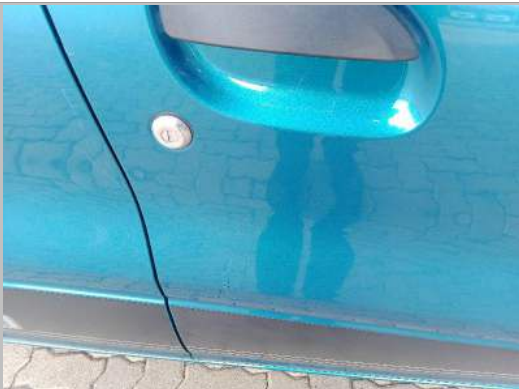
| Damage | Repair Way |
|---|---|
| Door Front Right Paintwork • Scratched | Repair |

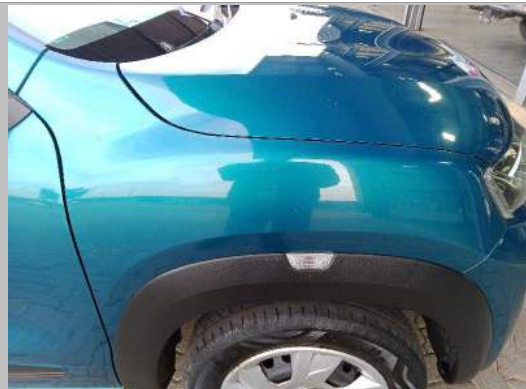
| Damage | Repair Way |
|---|---|
| Front Fender Right Paintwork • Scratched | Repair |

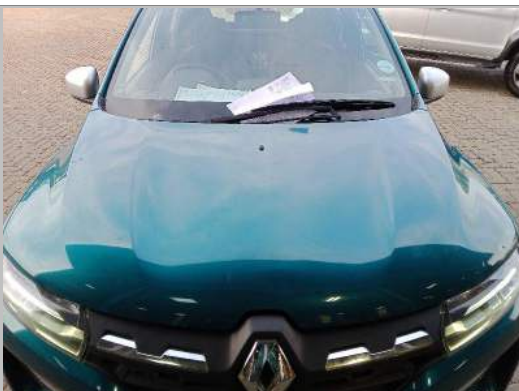
| Damage | Repair Way |
|---|---|
| Bonnet Damaged | Repair |

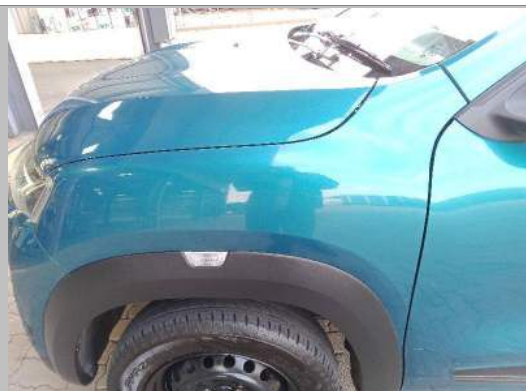
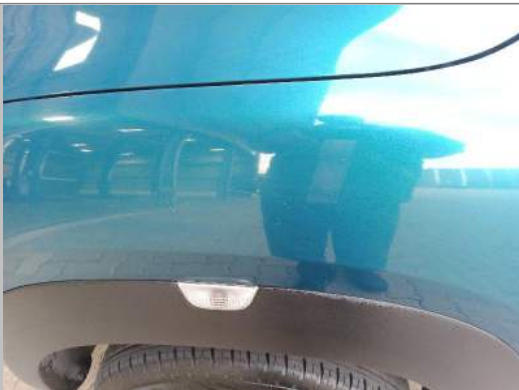
| Damage | Repair Way |
|---|---|
| Front Fender Left Paintwork • Scratched | Repair |

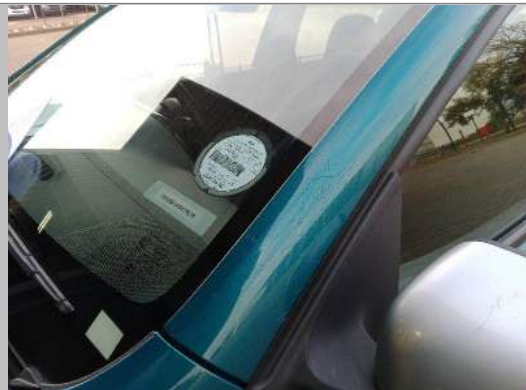
| Damage | Repair Way |
|---|---|
| A • Pillar Left Paintwork • Scratched | Repair |

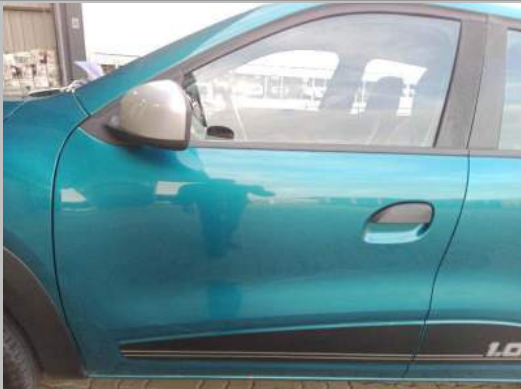
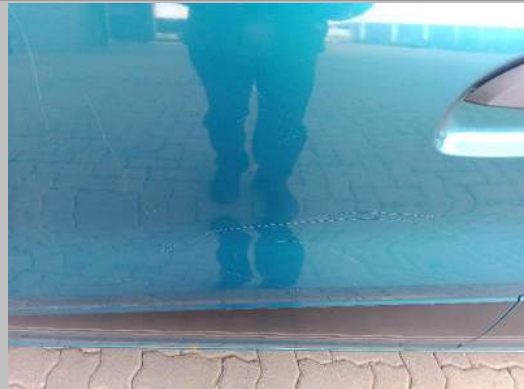
| Damage | Repair Way |
|---|---|
| Door Front Left Paintwork • Scratched | Repair |

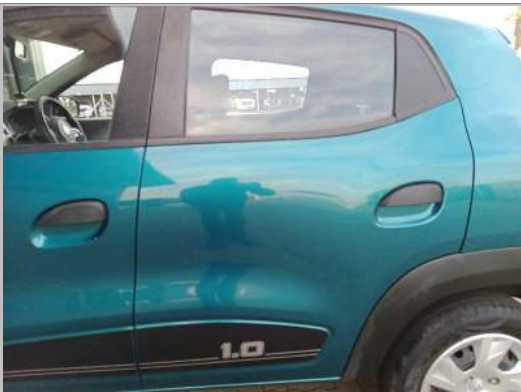
| Damage | Repair Way |
|---|---|
| Door Rear Left Paintwork • Scratched | Repair |

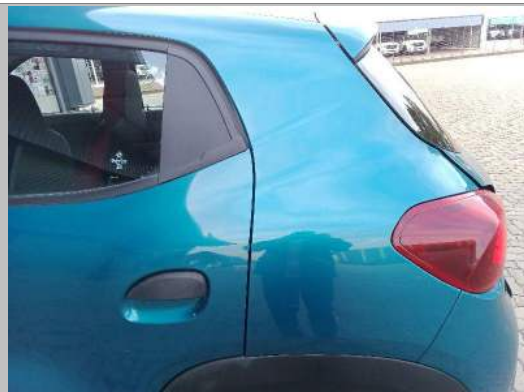
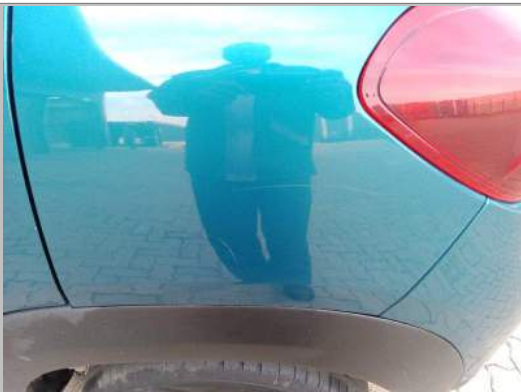
| Damage | Repair Way |
|---|---|
| Rear Fender Left Paintwork • Scratched | Repair |

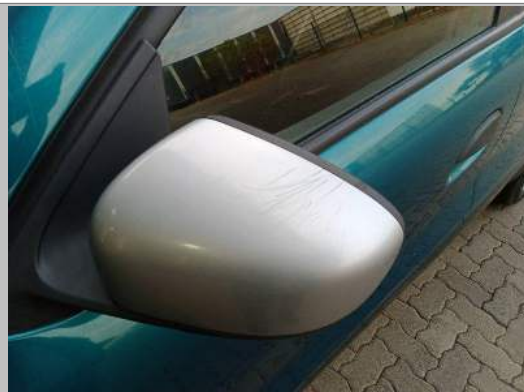
| Damage | Repair Way |
|---|---|
| Side Mirror Left Paintwork • Scratched | Repair |

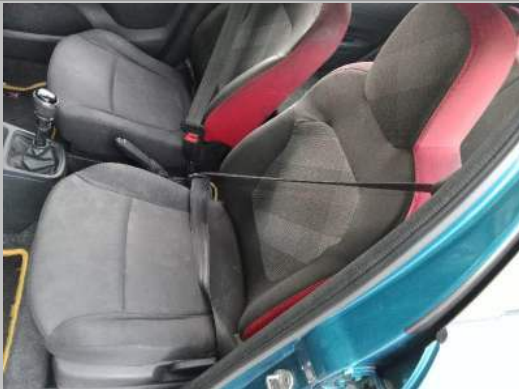
| Damage | Repair Way |
|---|---|
| Seat Front Left Dirty | Repair |

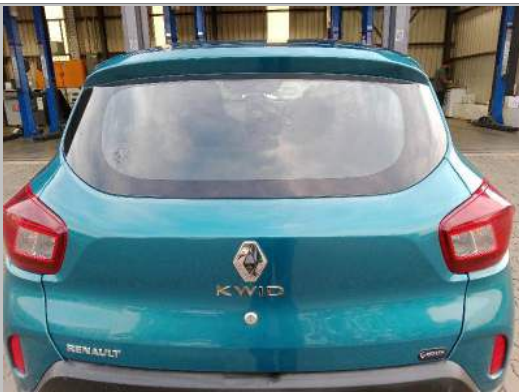
| Damage | Repair Way |
|---|---|
| Boot Lid / Hatch door Dented | Repair |

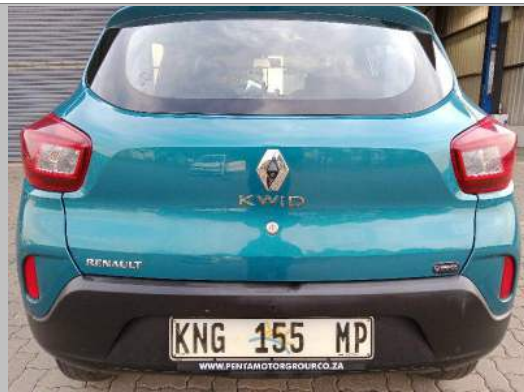
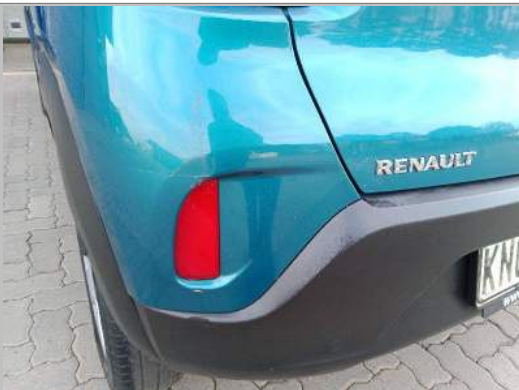
| Damage | Repair Way |
|---|---|
| Rear bumper Paintwork • Scratched | Repair |

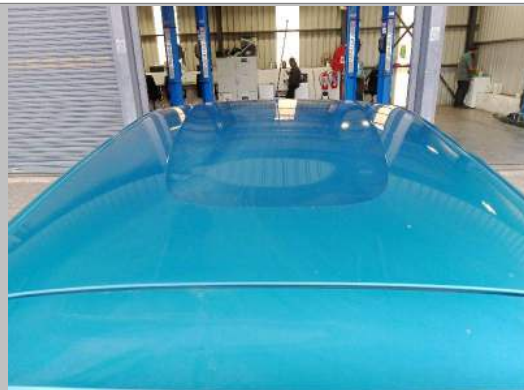
| Damage | Repair Way |
|---|---|
| Roof Dented | Repair |

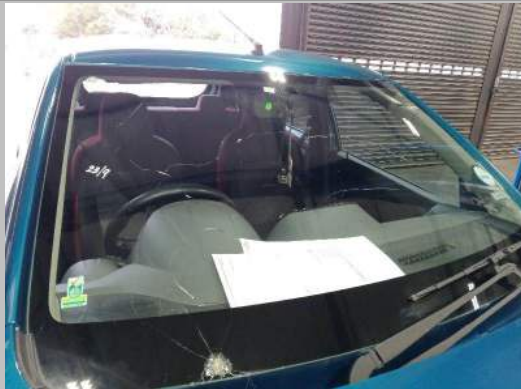
| Damage | Repair Way |
|---|---|
| Windscreen Damaged | Replace |

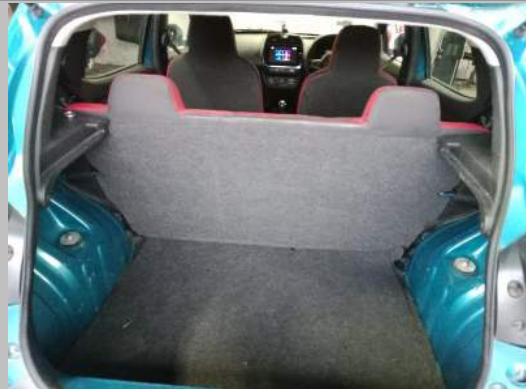
| Damage | Repair Way |
|---|---|
| Parcel Tray Missing | Replace |

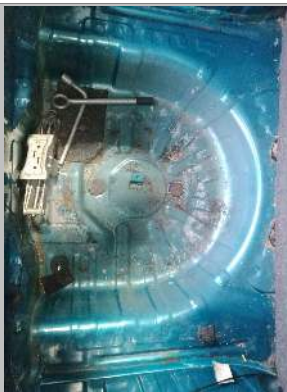
| Damage | Repair Way |
|---|---|
| Inner Boot Floor Pan and Spare Wheel Well Paintwork • Scratched | Repair |

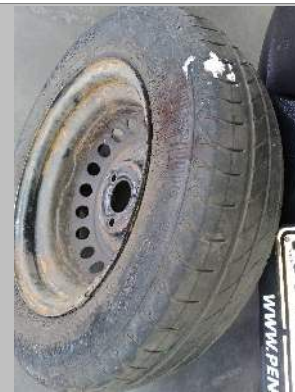
| Damage | Repair Way |
|---|---|
| Spare Tyre Worn | Replace |

| | Size | Load/Speed Index | Manufacture | Model | Type* | Production Date | Tread Depth (mm) |
|---|---|---|---|---|---|---|---|
| Spare | 165/70 R14 | 81T | Apollo | Amazer | V | 4521 | 0 mm |

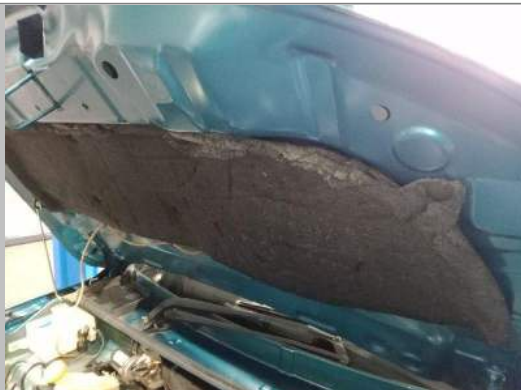
| Damage | Repair Way |
|---|---|
| Under bonnet insulation cover Damaged | Repair |

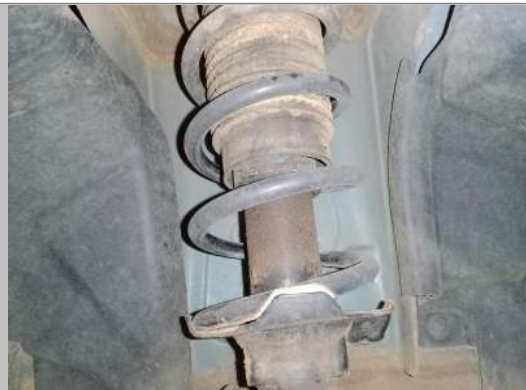
| Damage | Repair Way |
|---|---|
| Shock Absorber Front Right Sweat | Replace |
| Front right shock absorber weak | Replace |

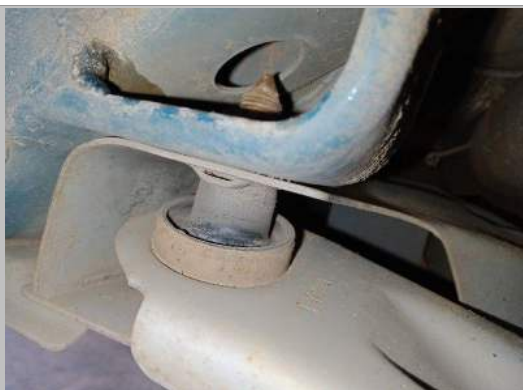
| Damage | Repair Way |
|---|---|
| Control Arm Bush(es) Front Axle Right Cracked | Replace |

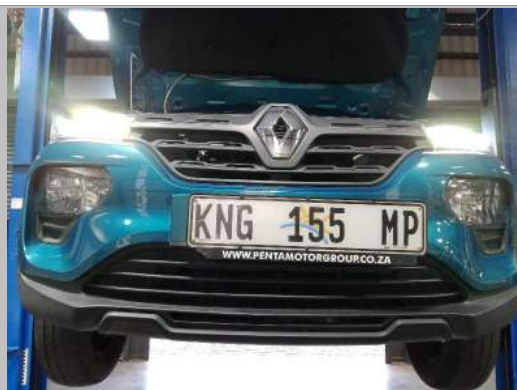
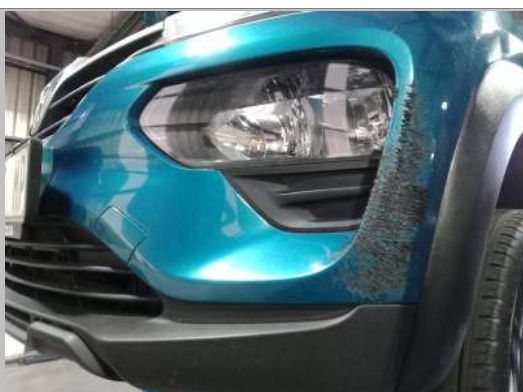
| Damage | Repair Way |
|---|---|
| Front Bumper Damaged | Repair |

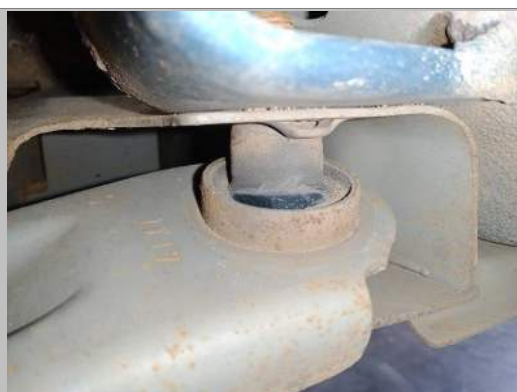
| Damage | Repair Way |
|---|---|
| Control Arm Bush(es) Front Axle Left Cracked | Replace |

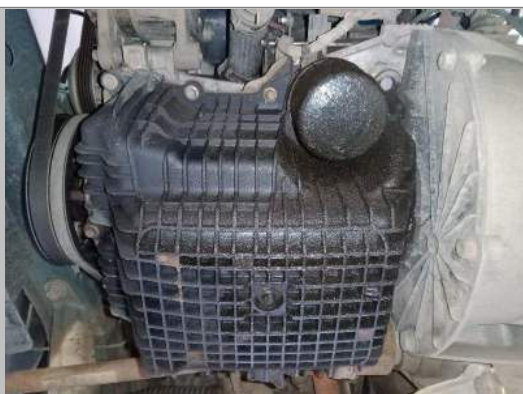
| Damage | Repair Way |
|---|---|
| Engine Oil Leak | Repair |

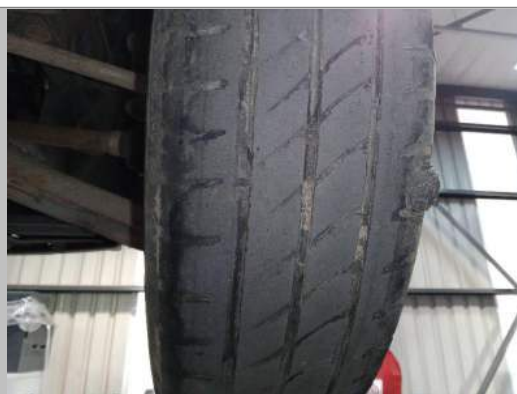
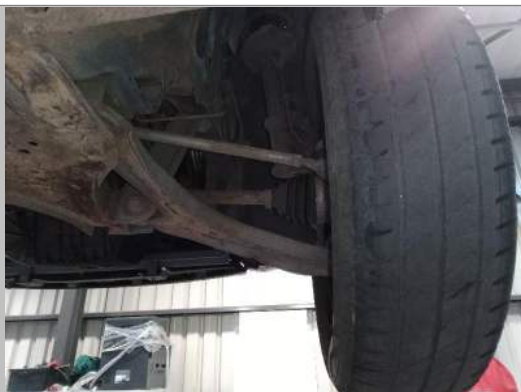
| Damage | Repair Way |
|---|---|
| Tyre Front Right Damaged | Replace |

| | Size | Load/Speed Index | Manufacture | Model | Type* | Production Date | Tread Depth (mm) |
|---|---|---|---|---|---|---|---|
| Front Right | 165/70 R14 | 81T | Apollo | Amazer | V | 4621 | 0 mm |

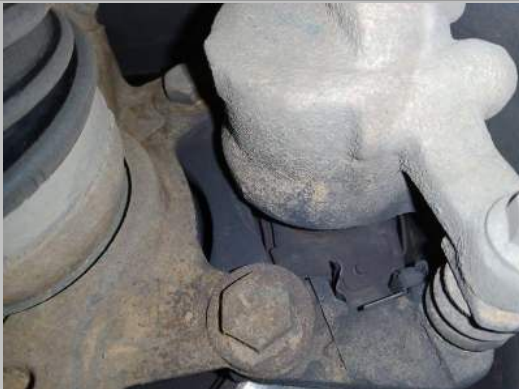
| Damage | Repair Way |
|---|---|
| Brake Pad 1. Axle left Excessive Wear & Tear | Replace |

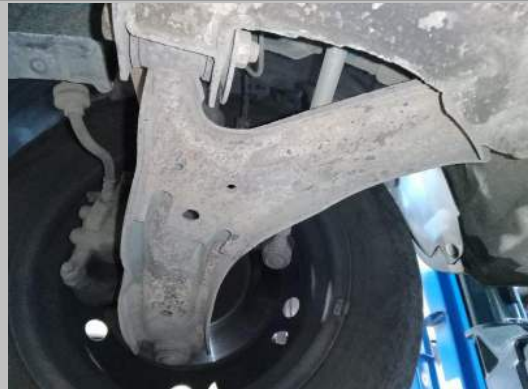
| Damage | Repair Way |
|---|---|
| Control Arm(s) Front Axle Right Damaged | Replace |

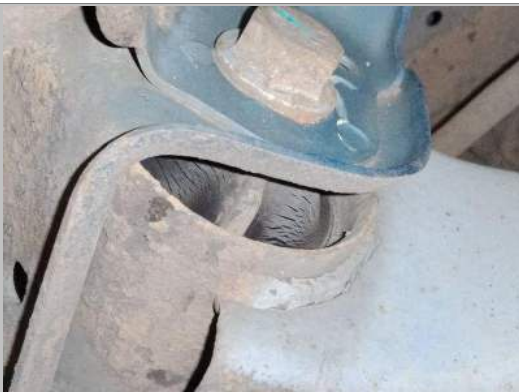
| Damage | Repair Way |
|---|---|
| Mounting Rubber(s) Rear Axle Left Cracked | Replace |

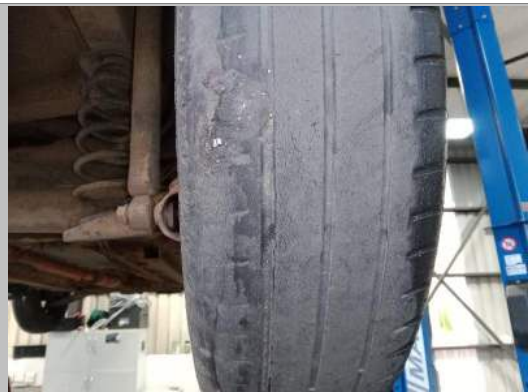
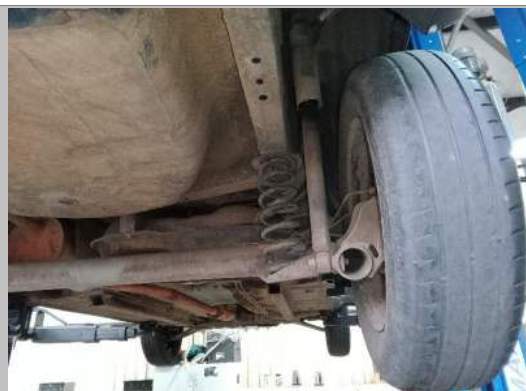
| Damage | Repair Way |
|---|---|
| Tyre Rear Right Damaged | Replace |

| | Size | Load/Speed Index | Manufacture | Model | Type* | Production Date | Tread Depth (mm) |
|---|---|---|---|---|---|---|---|
| Rear Right | 165/70 R14 | 81T | Apollo | Amazer | V | 4621 | 0 mm |

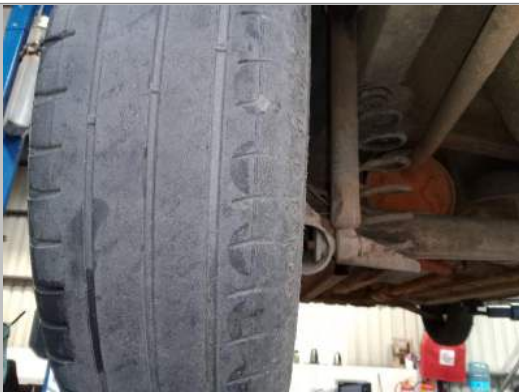
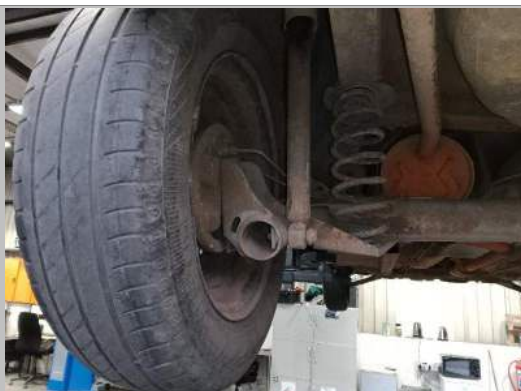
| Damage | Repair Way |
|---|---|
| Tyre Rear Left Damaged | Replace |

| | Size | Load/Speed Index | Manufacture | Model | Type* | Production Date | Tread Depth (mm) |
|---|---|---|---|---|---|---|---|
| Rear Left | 165/70 R14 | 81T | Apollo | Amazer | V | 4521 | 0 mm |

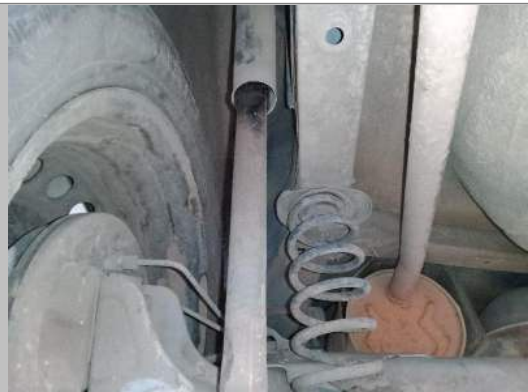
| Damage | Repair Way |
|---|---|
| Shock Absorber Rear Left Sweat | Replace |

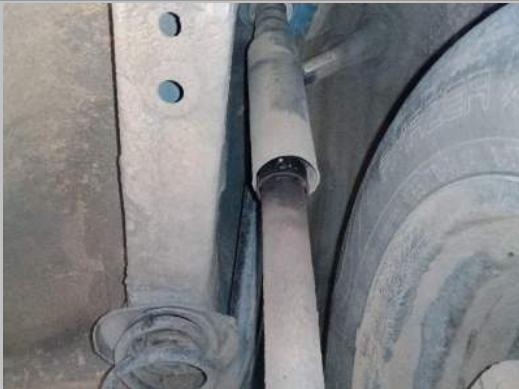
| Damage | Repair Way |
|---|---|
| Shock Absorber Rear Right Sweat | Replace |

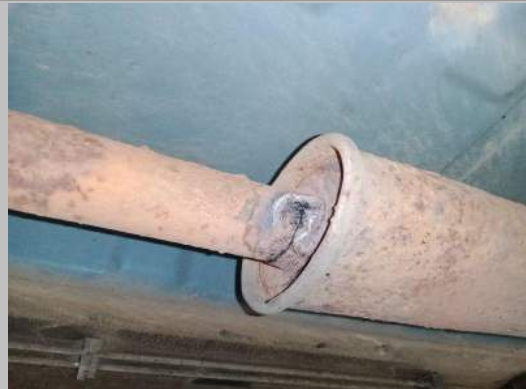
| Damage | Repair Way |
|---|---|
| Engine to silencer pipe Leak | Repair |

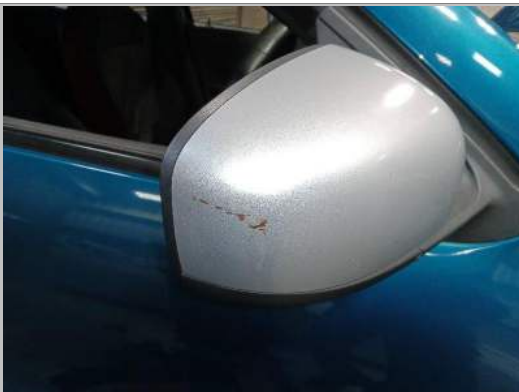
| Damage | Repair Way |
|---|---|
| Side Mirror Right Paintwork • Scratched | Repair |
