CONDITION REPORT

Report No:  
2017295665  
DATE  
08/09/2026

| Manufacturer | RENAULT | Registration Number | KD84XHGP |
| Model | KWID | Register Number | |

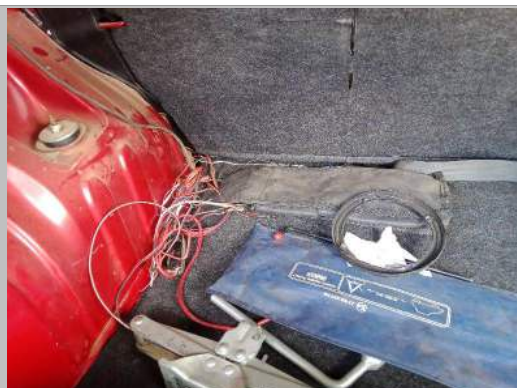
| Damage | Repair Way |
|---|---|
| Loose sound wiring inside of vehicle | Replace |

Loose sound wiring

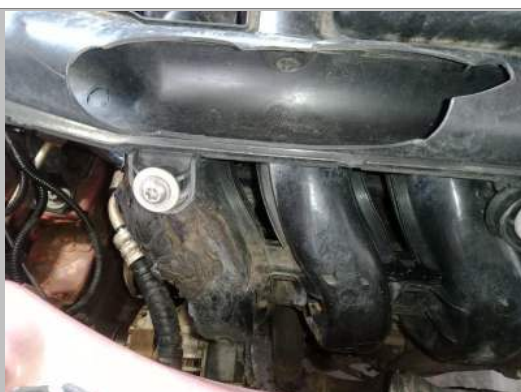
| Damage | Repair Way |
|---|---|
| Intake manifold damaged | Replace |

Intake manifold

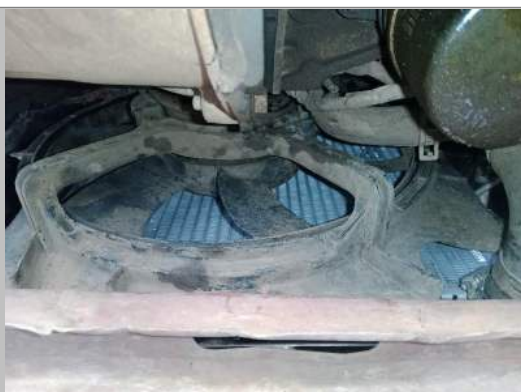
| Damage | Repair Way |
|---|---|
| Fan Cowley damaged | Replace |

Fan Cowley

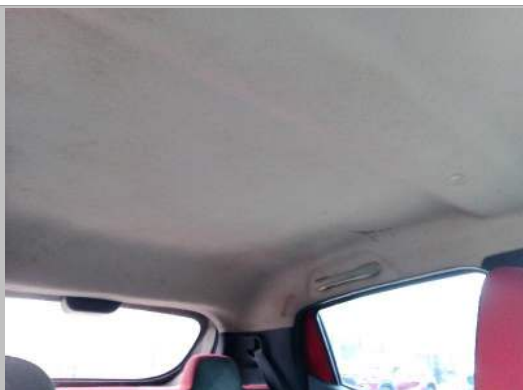
| Hood Lining Dirty | Repair |

Hood Lining

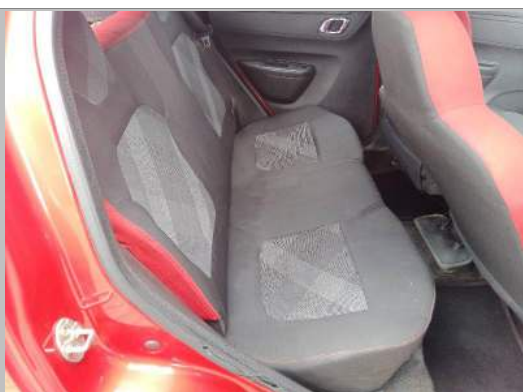
| Seat Rear Dirty | Repair |

Seat Rear

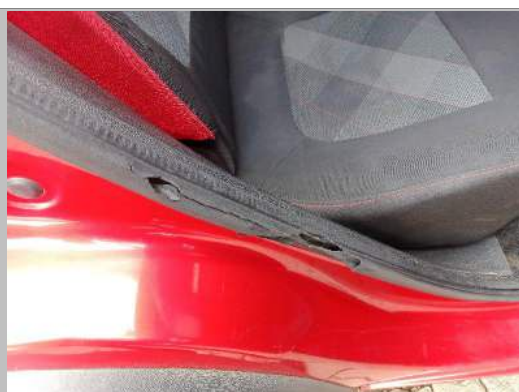
| Door Sealing Rubber Rear Right Damaged | Replace |

Door Sealing Rubber Rear Right

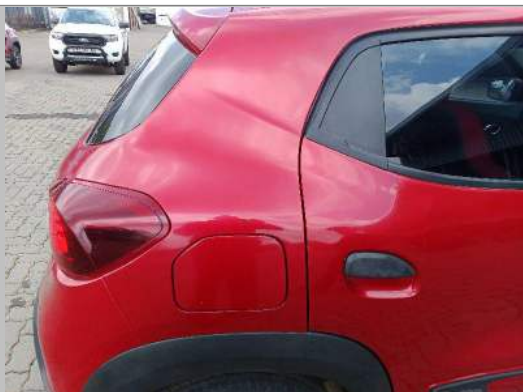
| Rear Fender Right Residual Traces of Repair | Repair |

Rear Fender Right

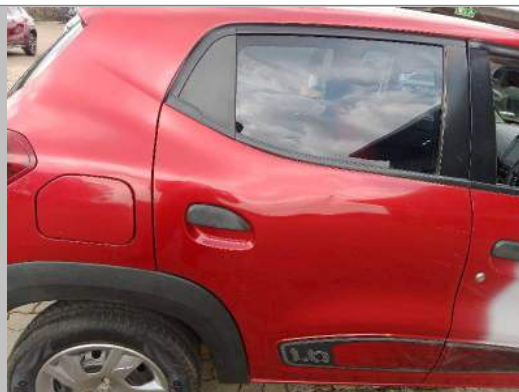
| Door Rear Right Damaged | Repair |

Door Rear Right

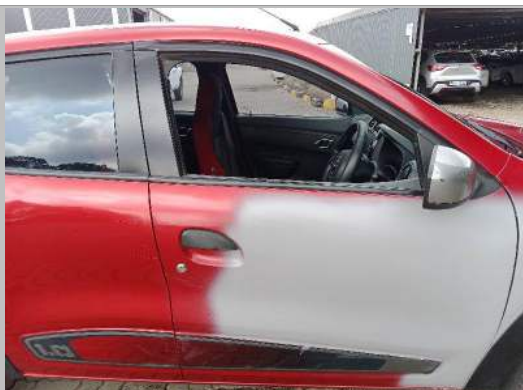
| Door Front Right Residual Traces of Repair | Repair |

Door Front Right

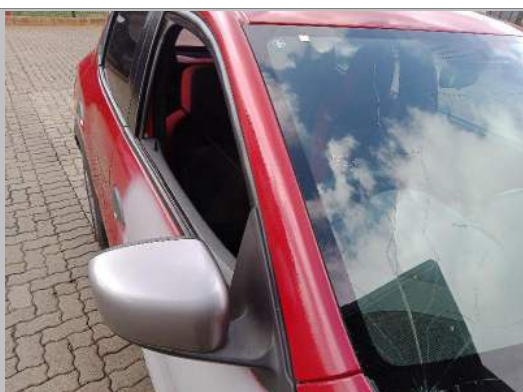
| A • Pillar Right Residual Traces of Repair | Repair |

A • Pillar Right

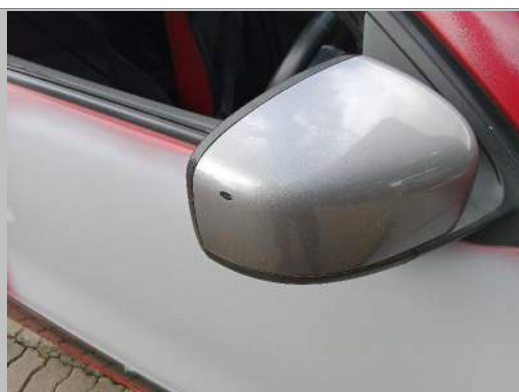
| Side Mirror Right Paintwork • Scratched | Repair |

Side Mirror Right

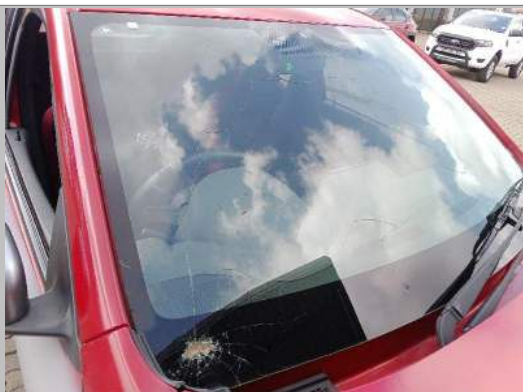
| Windscreen Damaged | Replace |

Windscreen

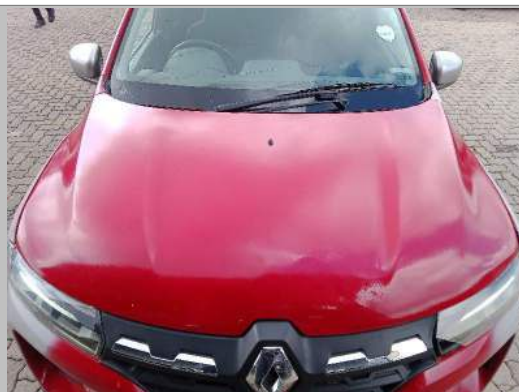
| Bonnet Damaged | Replace |

Bonnet

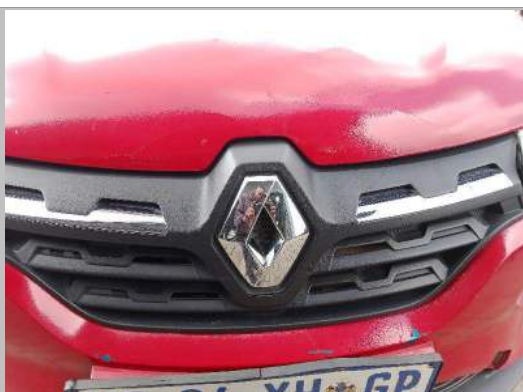
| Grill Damaged | Replace |

Grill

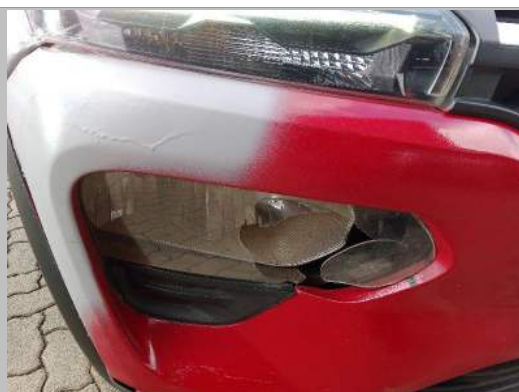
| Headlight Right Damaged | Replace |

Headlight Right

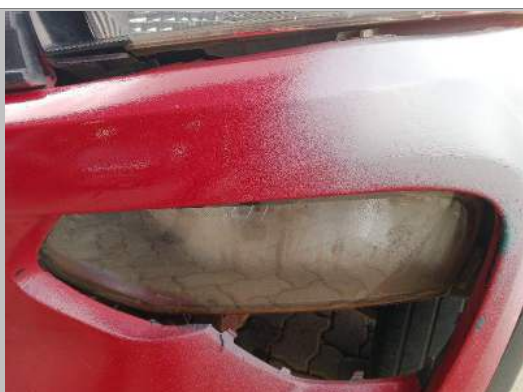
| Headlight Left Damaged | Replace |

Headlight Left

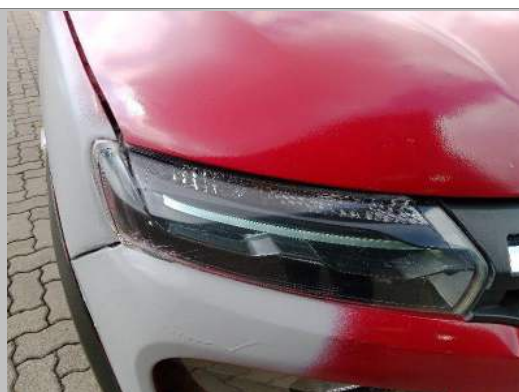
| Indicator Light Front Right Damaged | Replace |

Indicator Light Front Right

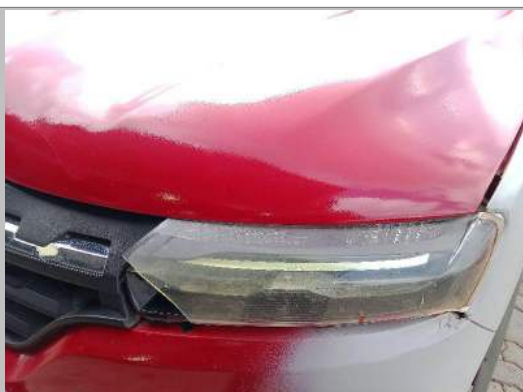
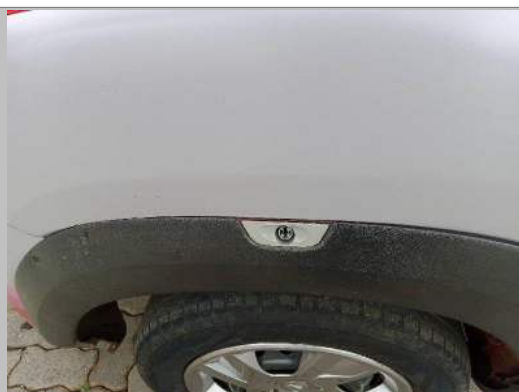
| Indicator Light Front Left Damaged | Replace |

Indicator Light Front Left

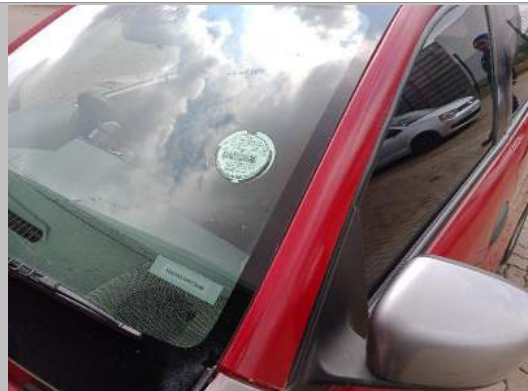
| A • Pillar Left Residual Traces of Repair | Repair |

A • Pillar Left

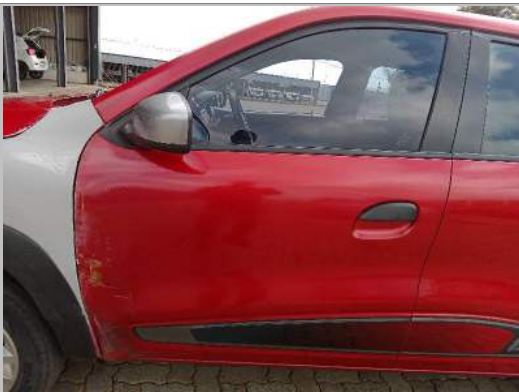
| Door Front Left Damaged | Repair |

Door Front Left

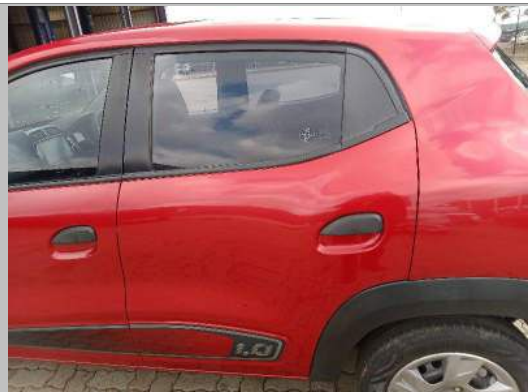
| Door Rear Left Dented | Repair |

Door Rear Left

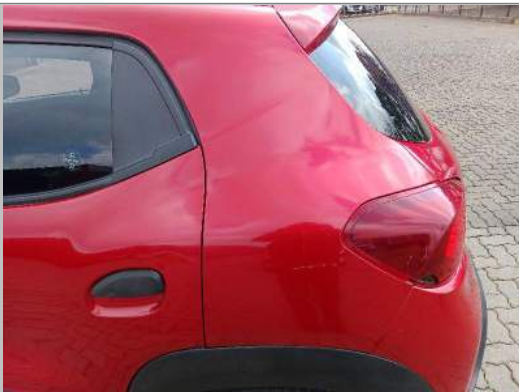
| Rear Fender Left Damaged | Repair |

Rear Fender Left

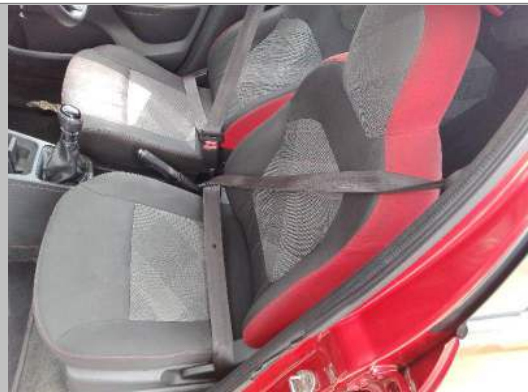
| Seat Front Left Dirty | Repair |

Seat Front Left

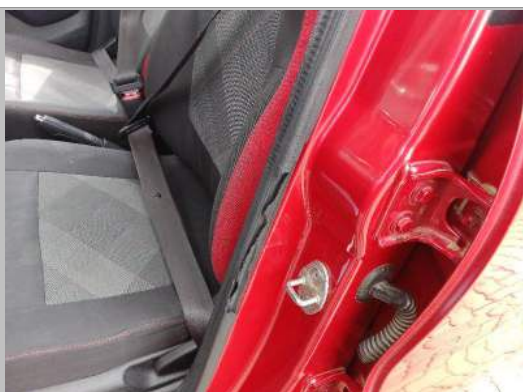
| Door Sealing Rubber Front Left Damaged | Replace |

Door Sealing Rubber Front Left

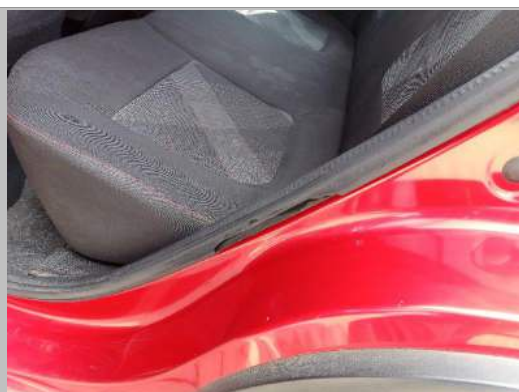
| Door Sealing Rubber Rear Left Damaged | Replace |

Door Sealing Rubber Rear Left

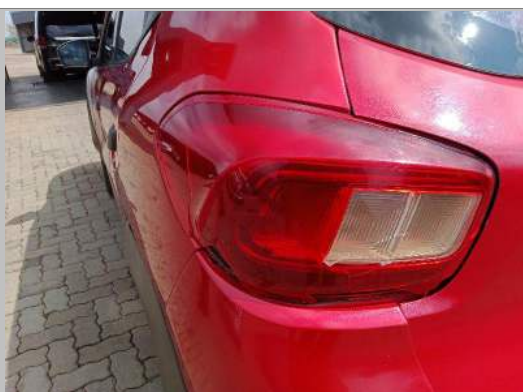
| Tail Light Left Damaged | Replace |

Tail Light Left

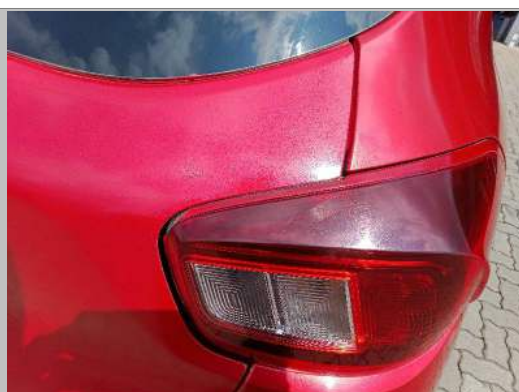
| Tail Light Right Damaged | Replace |

Tail Light Right

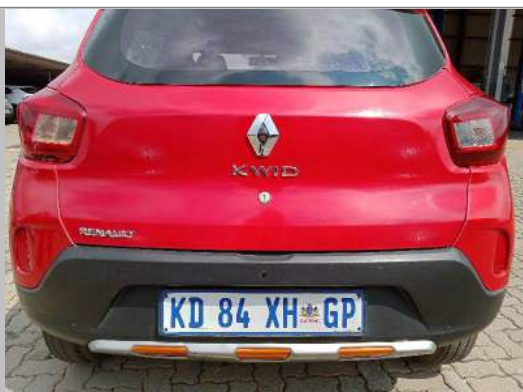
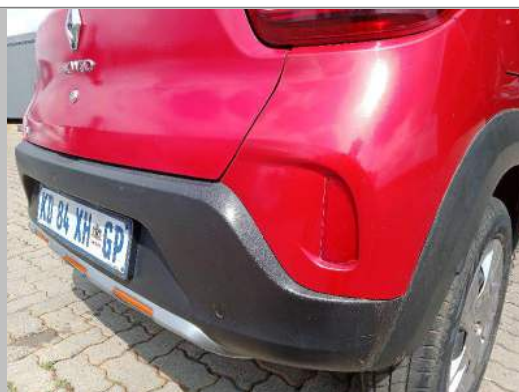
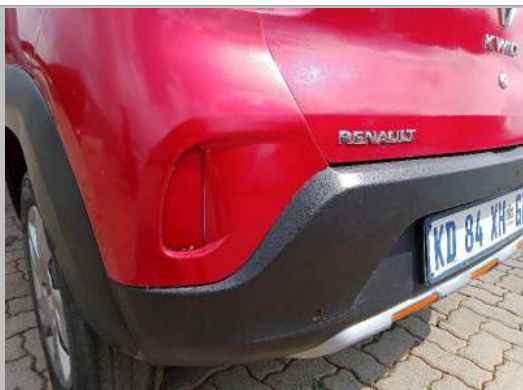
| Rear bumper Damaged | Repair |

Rear bumper

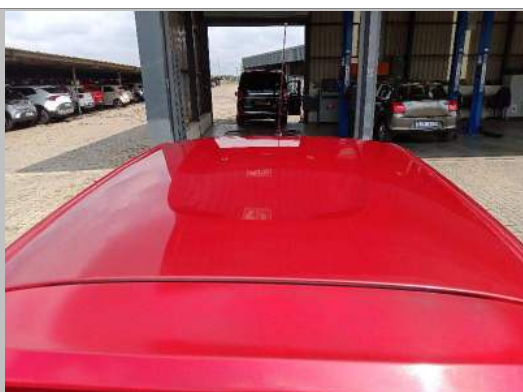
| Roof Dented | Repair |

Roof

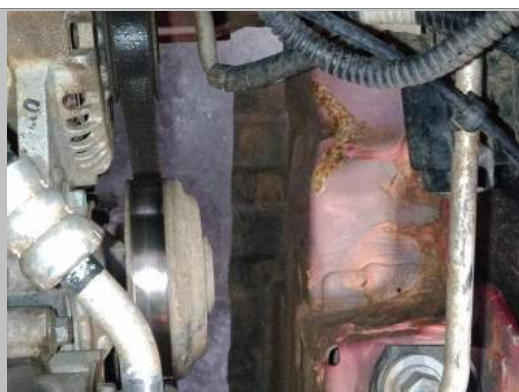
| Main Beam Right Damaged | Repair |

Main Beam Right

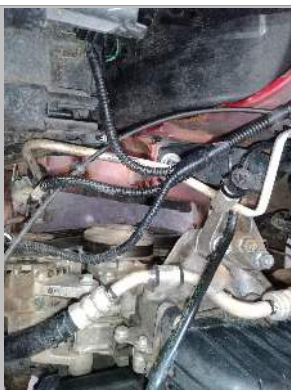
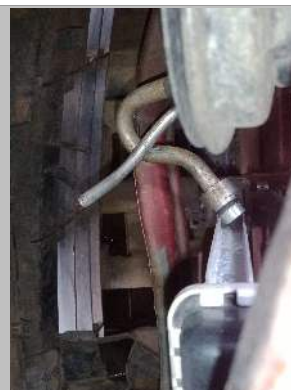
| Air conditioner pipes Damaged | Replace |

Air conditioner pipes

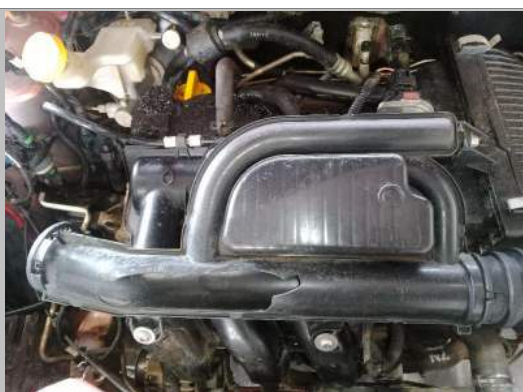
| Air cleaner Damaged | Replace |

Air cleaner

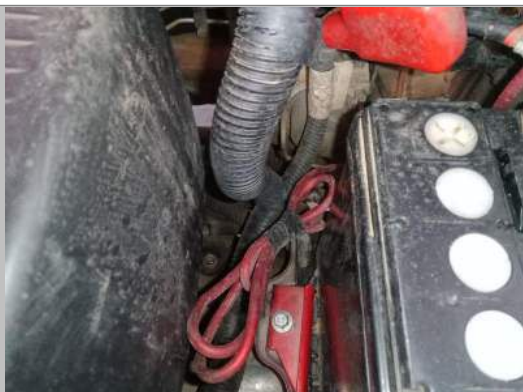
| Engine Wiring Defective | Replace |

Engine Wiring

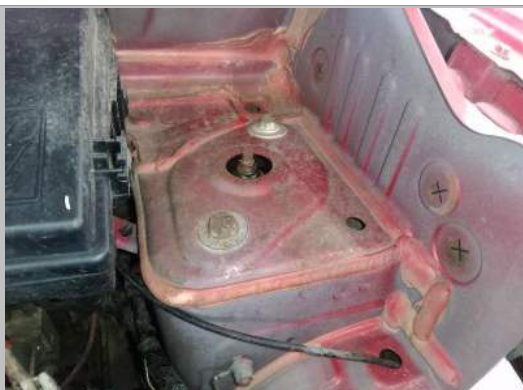
| Bonnet slam plate (Shock tower/ Inner tray) Damaged | Repair |

Bonnet slam plate (Shock tower/ Inner tray)

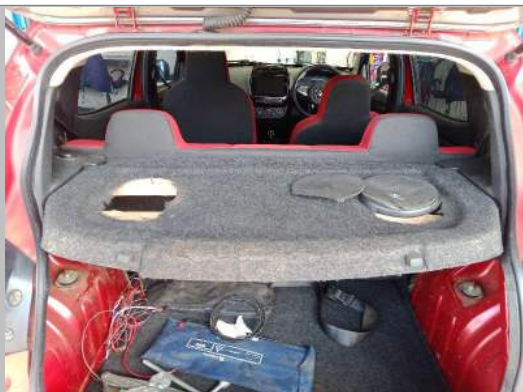
| Parcel Tray Damaged | Replace |

Parcel Tray

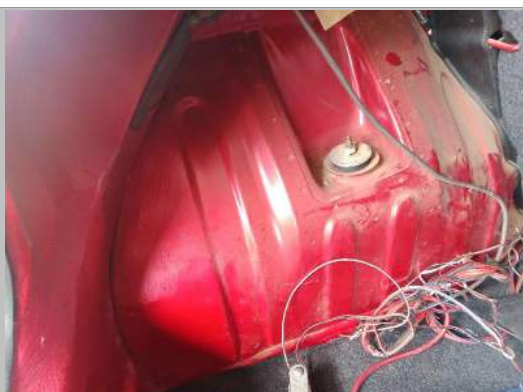
| Rear Fender Left / Inner Tray Damaged | Repair |

Rear Fender Left / Inner Tray

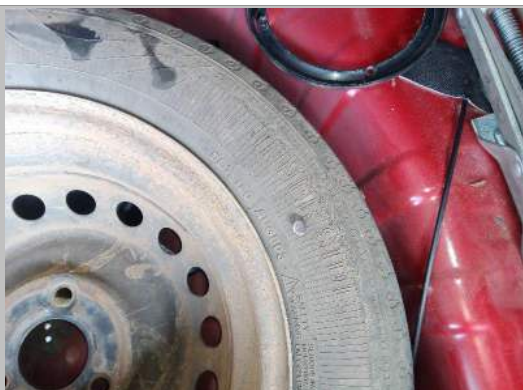
| Spare Tyre Damaged | Replace |

Spare Tyre

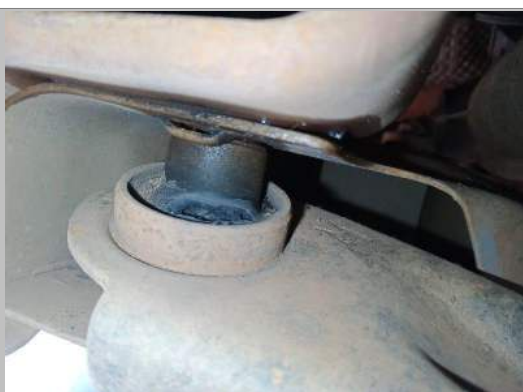
| Control Arm Bush(es) Front Axle Right Cracked | Replace |

Control Arm Bush(es) Front Axle Right

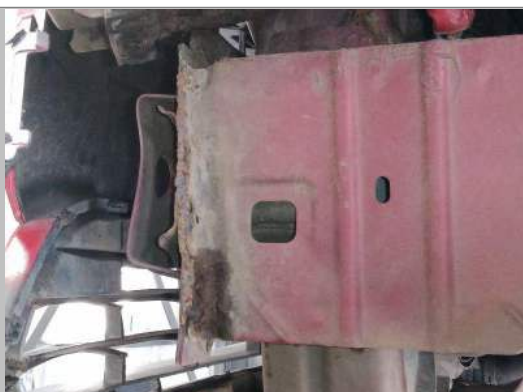
| Main Beam Left Damaged | Repair |

Main Beam Left

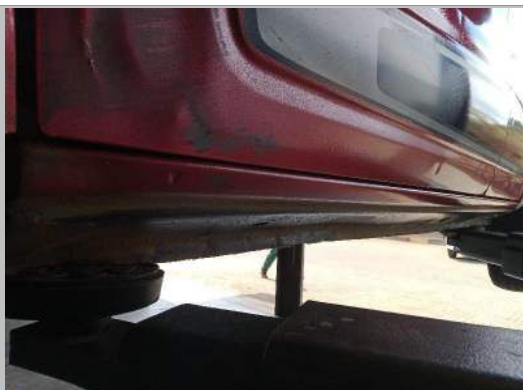
| Sill Panel Left Damaged | Repair |

Sill Panel Left

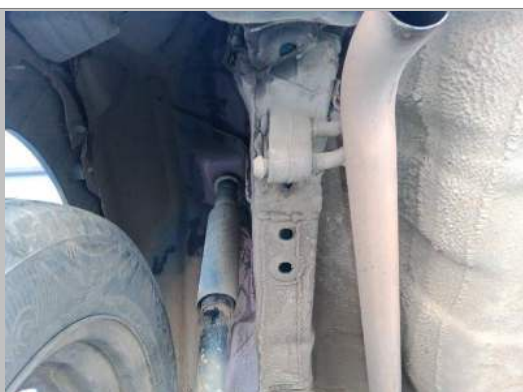
Main Beam Left

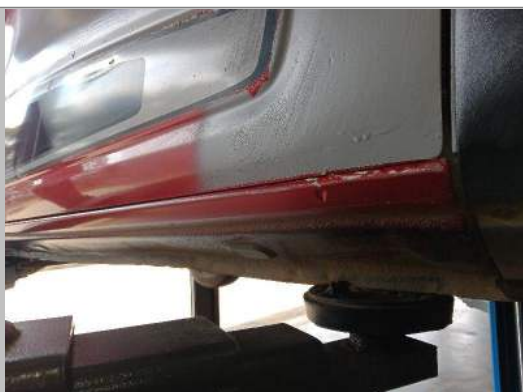
| Sill Panel Right Damaged | Repair |

Sill Panel Right

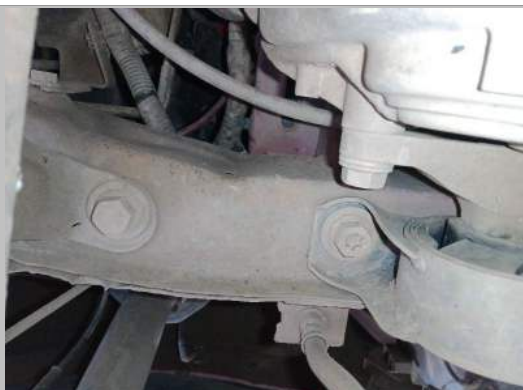
Main Beam Left

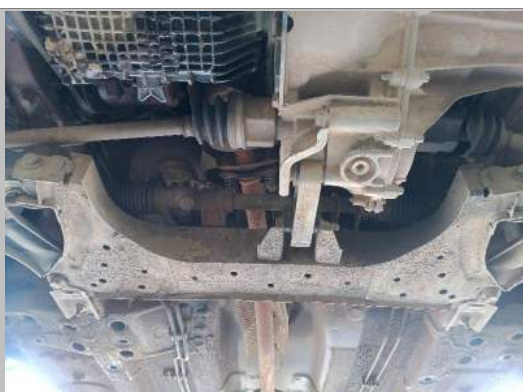
| Sub Frame Dented | Repair |

Sub Frame

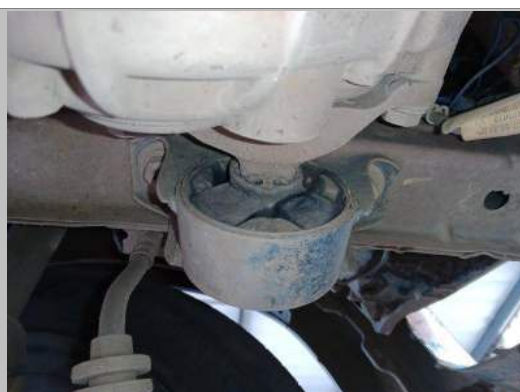
| Damage | Repair Way |
|---|---|
| Gearbox Mountings Cracked | Replace |

Gearbox Mountings

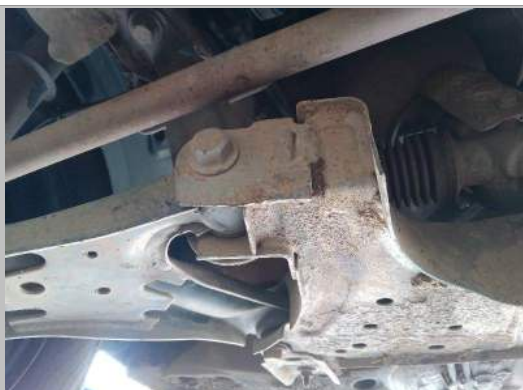
Sub Frame

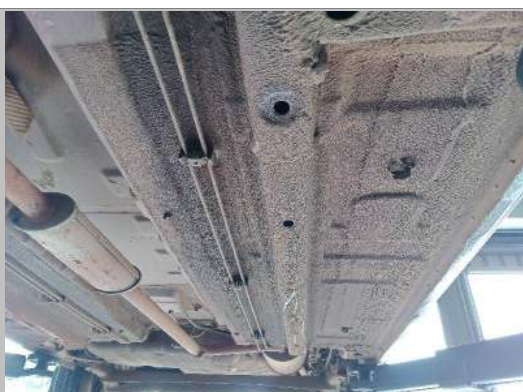
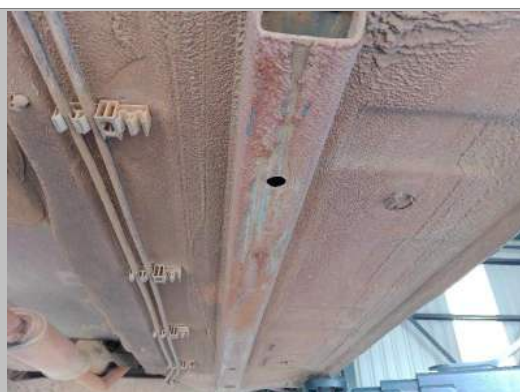
| Chassis Scratched | Repair |

Chassis

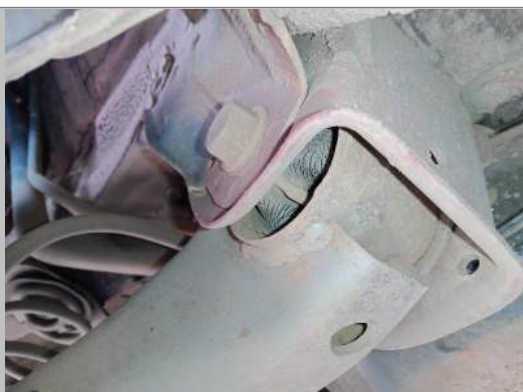
| Mounting Rubber(s) Rear Axle Right Cracked | Replace |

Mounting Rubber(s) Rear Axle Right

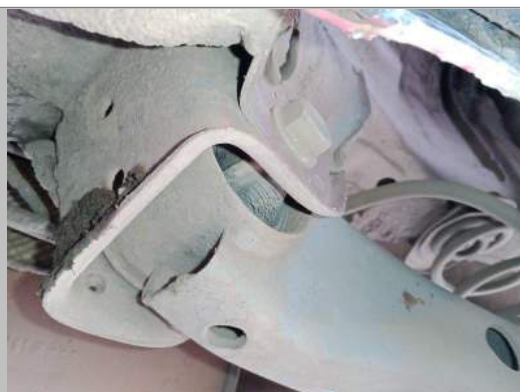
| Mounting Rubber(s) Rear Axle Left Cracked | Replace |

Mounting Rubber(s) Rear Axle Left

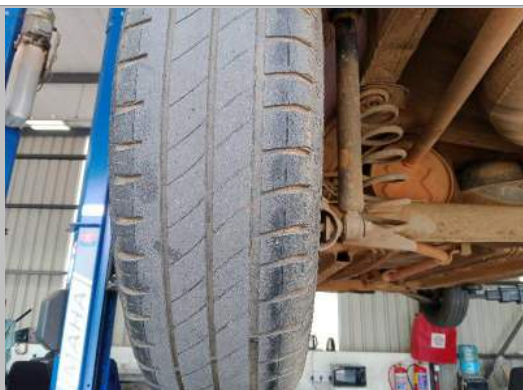
| Tyre Rear Left Damaged | Replace |

| Damage | Repair Way |
|---|---|
| Rear left tyre regrooved | Replace |

| | Size | Load/Speed Index | Manufacture | Model | Type* | Production Date | Tread Depth (mm) |
|---|---|---|---|---|---|---|---|
| Rear Left | 165/70 R14 | 81T | Apollo | Amazer | V | 0221 | 0 mm |

Tyre Rear Left

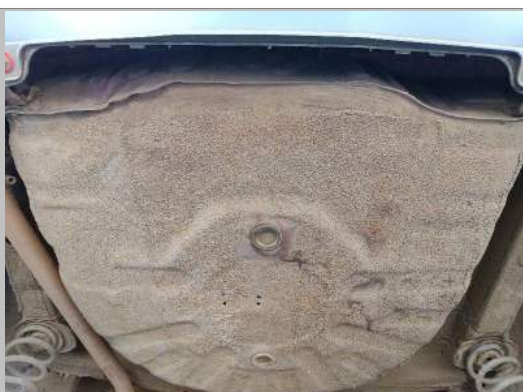
| Inner Boot Floor Pan and Spare Wheel Well Damaged | Repair |

Inner Boot Floor Pan and Spare Wheel Well

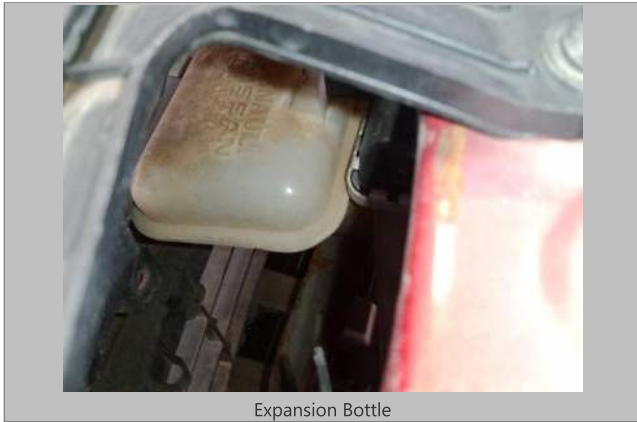
| Expansion Bottle Damaged | Replace |

Expansion Bottle
