## CONDITION REPORT

2017293640

| Manufacturer | RENAULT | Registration Number | LG18WRGP |
| Model | TRIBES | Register Number | |

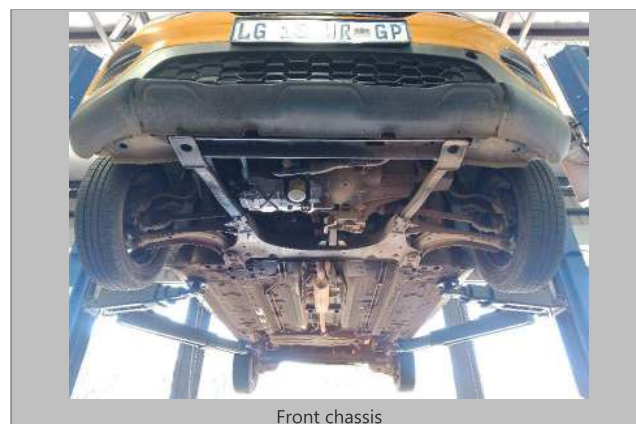
Front chassis

| Damage | Repair Way |
|---|---|
| Chassis Dented | Repair |

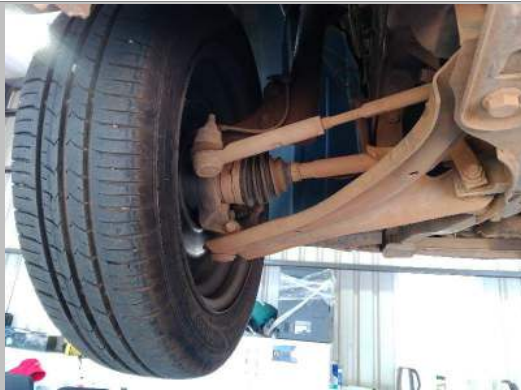
LF TYRE TREAD

| | Size | Load/Speed Index | Manufacture | Model | Type* | Production Date | Tread Depth (mm) |
|---|---|---|---|---|---|---|---|
| Front Left | 155/65 R14 | 75S | Goodyear | Efficient | V | 3823 | 2 mm |

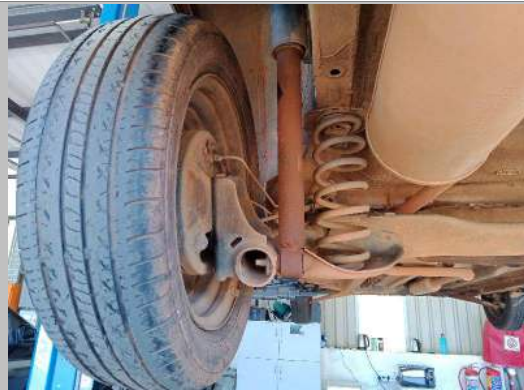
LR TYRE TREAD

| Damage | Repair Way |
|---|---|
| Rear left and right tyre sizes different | Repair |

| | Size | Load/Speed Index | Manufacture | Model | Type* | Production Date | Tread Depth (mm) |
|---|---|---|---|---|---|---|---|
| Rear Left | 165/60 R14 | 75H | Annaite | AN600 | V | 1924 | 1 mm |

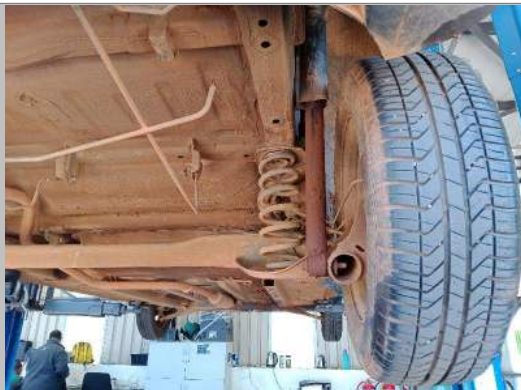
RR TYRE TREAD

| | Size | Load/Speed Index | Manufacture | Model | Type* | Production Date | Tread Depth (mm) |
|---|---|---|---|---|---|---|---|
| Rear Right | 185/65 R14 | 86H | Sumitomo | HTR | V | 2723 | 3 mm |

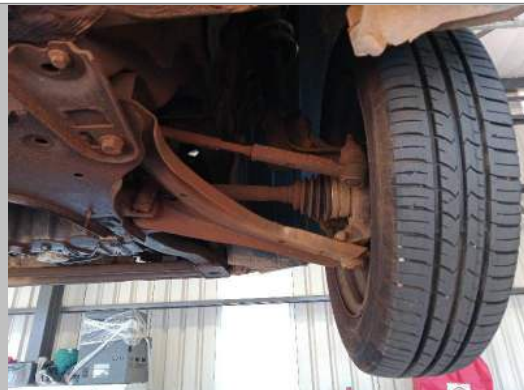
RF TYRE TREAD

| | Size | Load/Speed Index | Manufacture | Model | Type* | Production Date | Tread Depth (mm) |
|---|---|---|---|---|---|---|---|
| Front Right | 155/65 R14 | 75S | Goodyear | Efficient | V | 3223 | 4 mm |

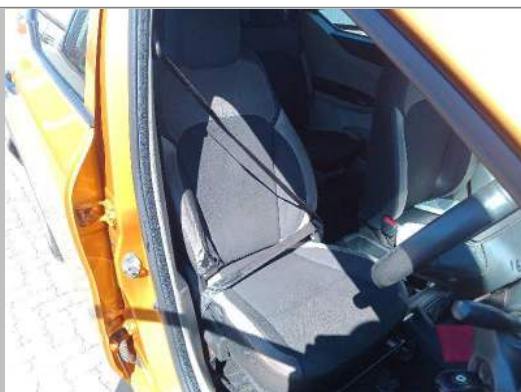
| Damage | Repair Way |
|---|---|
| Seat Front Right Damaged | Repair |

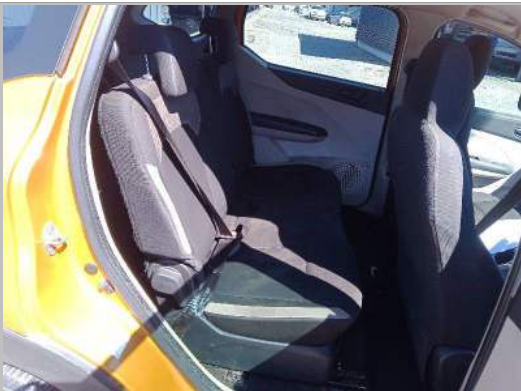
| Damage | Repair Way |
|---|---|
| Seat Rear Dirty | Repair |

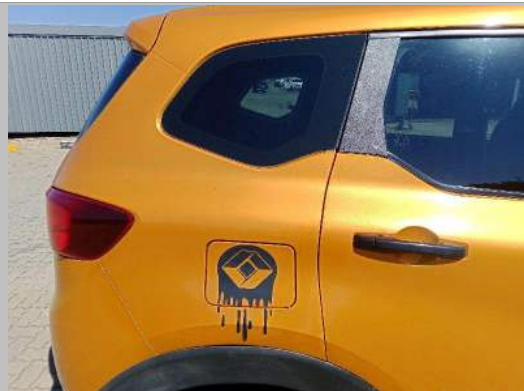
| Damage | Repair Way |
|---|---|
| Rear Fender Right Damaged | Repair |

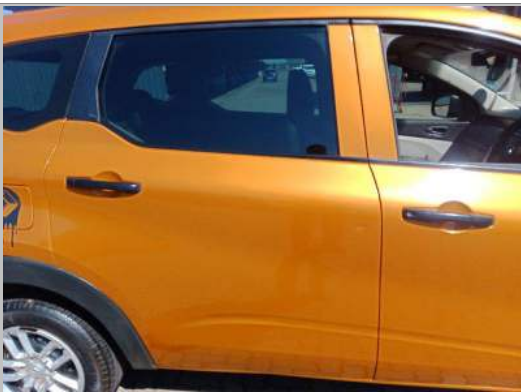
| Damage | Repair Way |
|---|---|
| Door Rear Right Dented | Repair |

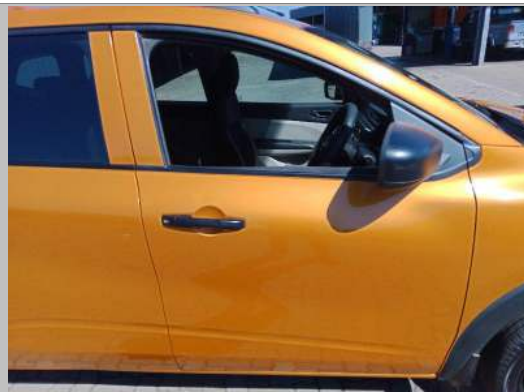
| Damage | Repair Way |
|---|---|
| Door Front Right Dented | Repair |

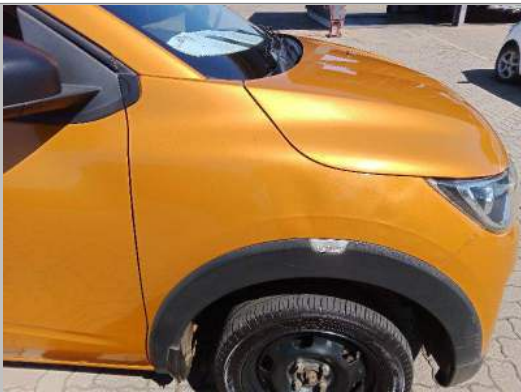
| Damage | Repair Way |
|---|---|
| Front Fender Right Damaged | Repair |

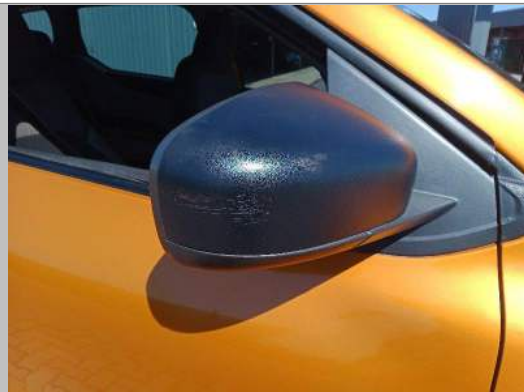
| Damage | Repair Way |
|---|---|
| Side Mirror Right Paintwork • Scratched | Repair |

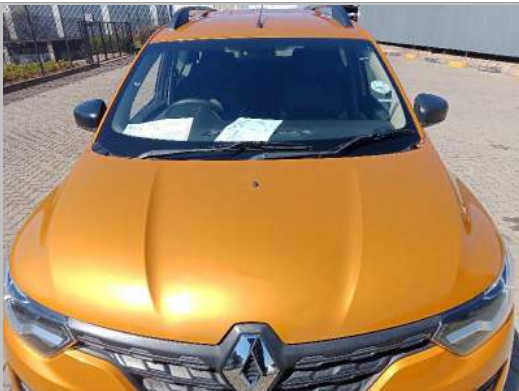
| Damage | Repair Way |
|---|---|
| Bonnet Damaged | Repair |

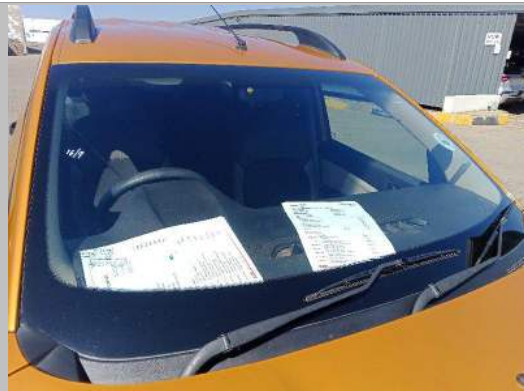
| Damage | Repair Way |
|---|---|
| Windscreen Chipped | Repair |

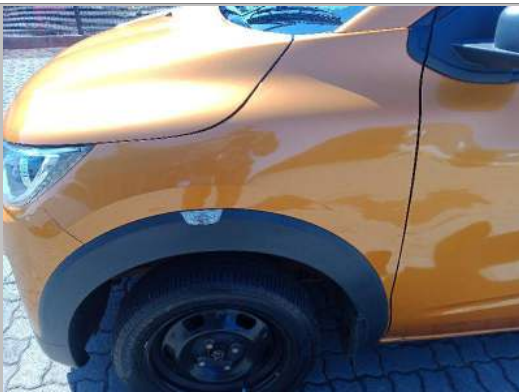
| Damage | Repair Way |
|---|---|
| Front Fender Left Damaged | Repair |

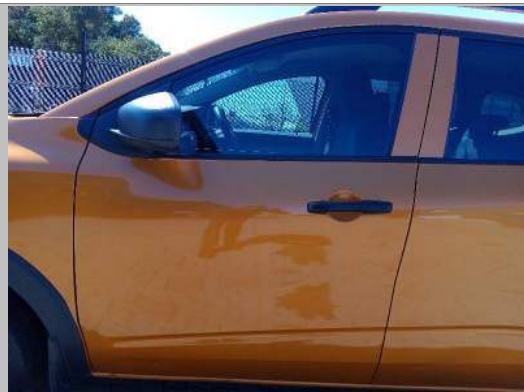
| Damage | Repair Way |
|---|---|
| Door Front Left Damaged | Repair |

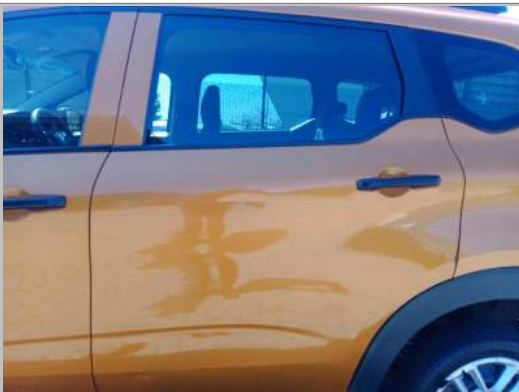
| Damage | Repair Way |
|---|---|
| Door Rear Left Damaged | Repair |

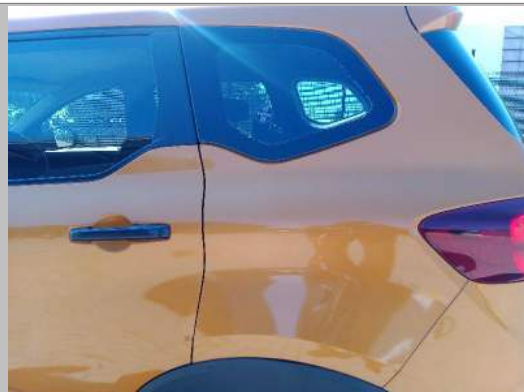
| Damage | Repair Way |
|---|---|
| Rear Fender Left Residual Traces of Repair | Repair |

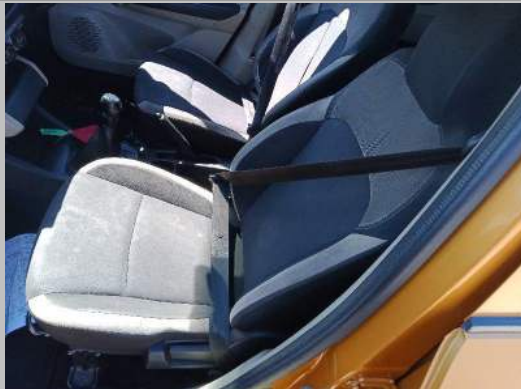
| Damage | Repair Way |
|---|---|
| Seat Front Left Dirty | Repair |

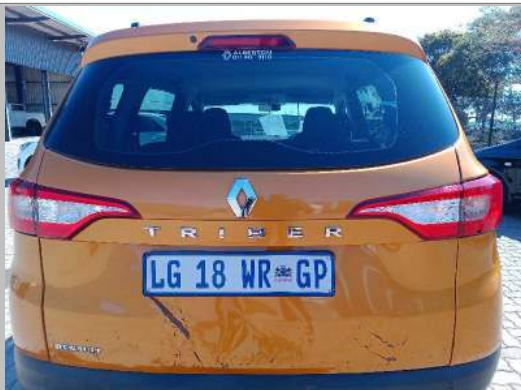
| Damage | Repair Way |
|---|---|
| Boot Lid / Hatch door Damaged | Repair |

Body • Exterior: Boot does not open.Signs of impact damage to front and rear of vehicle.Body panels misaligned.Dents and scratches on body panels

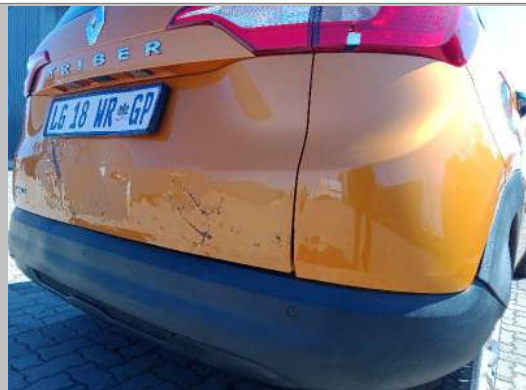
| Damage | Repair Way |
|---|---|
| Rear bumper Damaged | Repair |

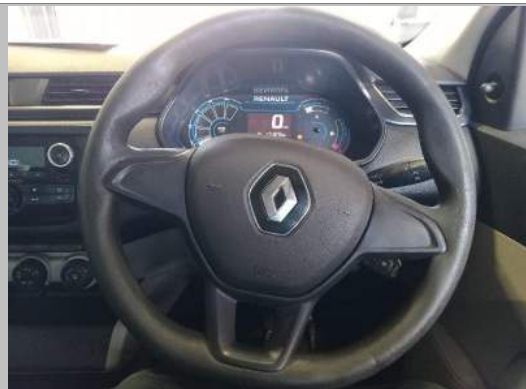
| Damage | Repair Way |
|---|---|
| Steering Wheel Trim Excessive Wear & Tear | Repair |

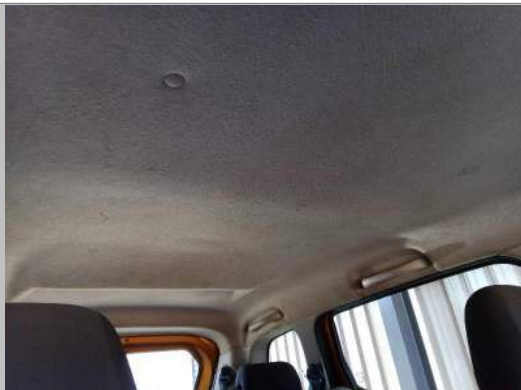
| Damage | Repair Way |
|---|---|
| Hood Lining Dirty | Repair |

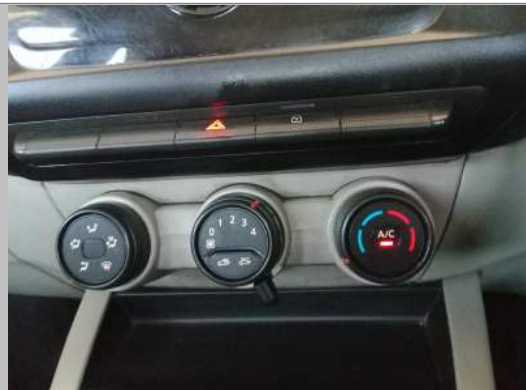
| Damage | Repair Way |
|---|---|
| Air Conditioner Insufficient | Replace |

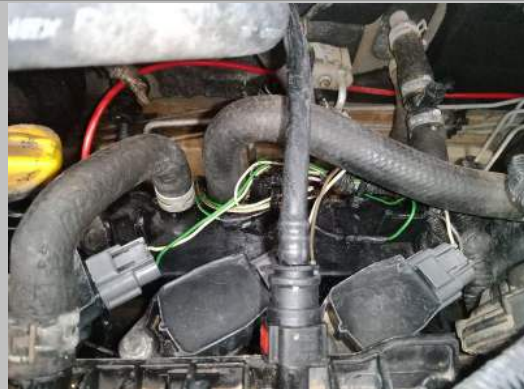
| Damage | Repair Way |
|---|---|
| Engine Wiring Defective | Repair |

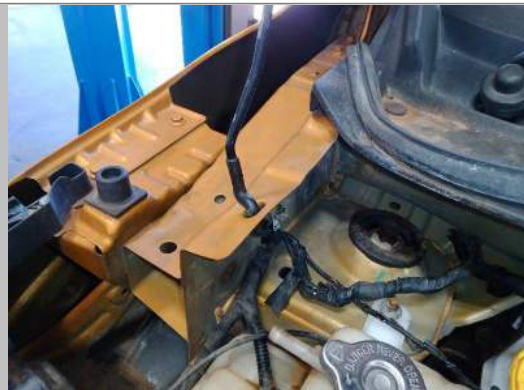
| Damage | Repair Way |
|---|---|
| Front Fender Right / Inner Tray Dented | Repair |

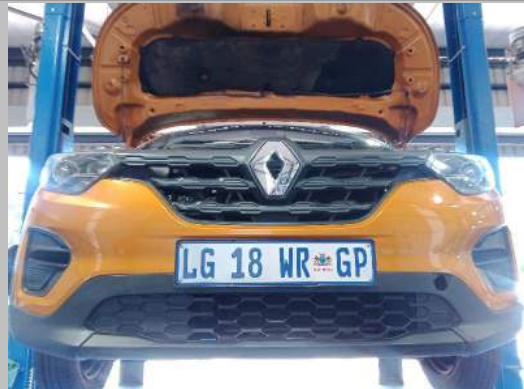
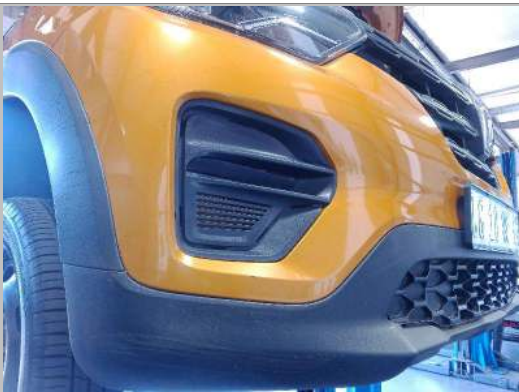
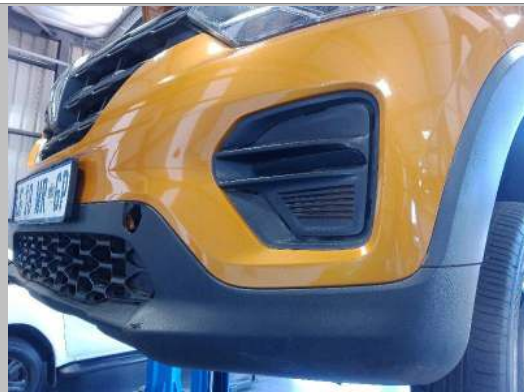
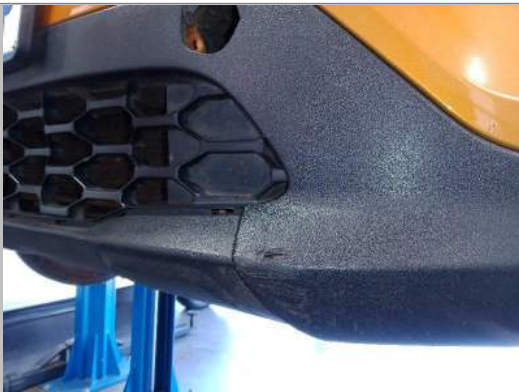
| Damage | Repair Way |
|---|---|
| Front Bumper Damaged | Repair |

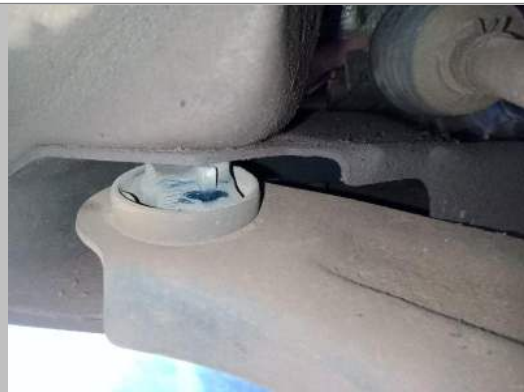
| Damage | Repair Way |
|---|---|
| Control Arm Bush(es) Front Axle Right Cracked | Replace |

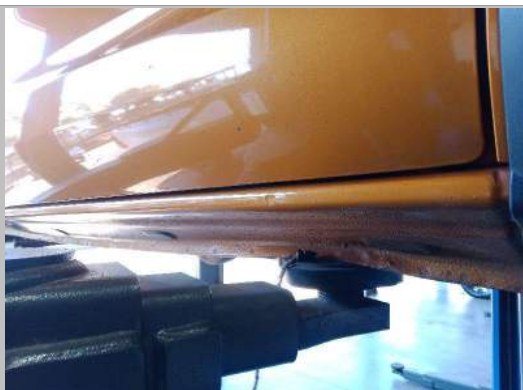
| Damage | Repair Way |
|---|---|
| Sill Panel Right Dented | Repair |

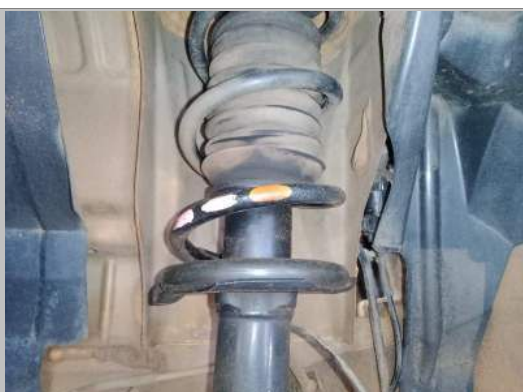
| Damage | Repair Way |
|---|---|
| Shock Absorber Front Left Sweat | Replace |

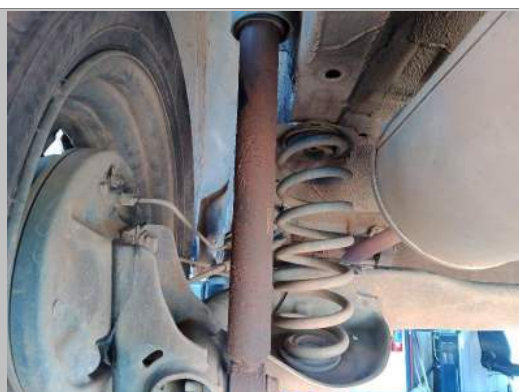
| Damage | Repair Way |
|---|---|
| Shock Absorber Rear Left Damaged | Replace |

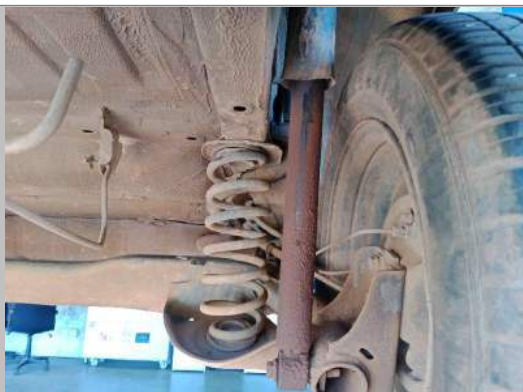
| Damage | Repair Way |
|---|---|
| Shock Absorber Rear Right Sweat | Replace |

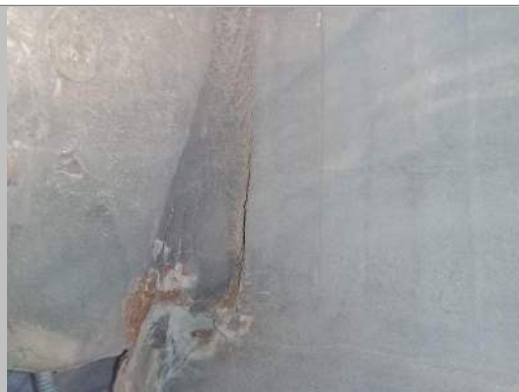
| Damage | Repair Way |
|---|---|
| Rear Fender Right / Inner Tray Damaged | Repair |

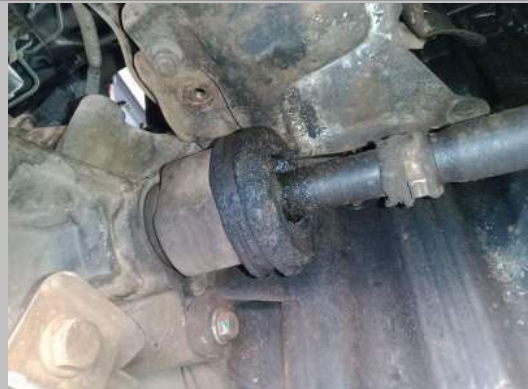
| Damage | Repair Way |
|---|---|
| CV Joint(s) Boot(s) Front Right (inner/outer) Damaged | Replace |

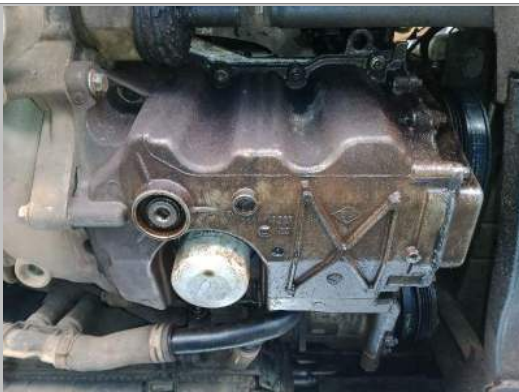
| Damage | Repair Way |
|---|---|
| Engine Oil Leak | Repair |
| Engine Smoke Excessive | Repair |

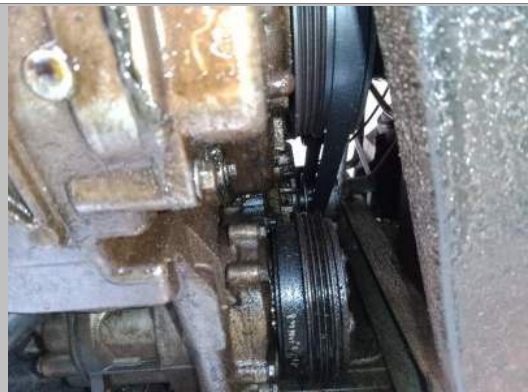
| Damage | Repair Way |
|---|---|
| Fan Belt Missing | Replace |

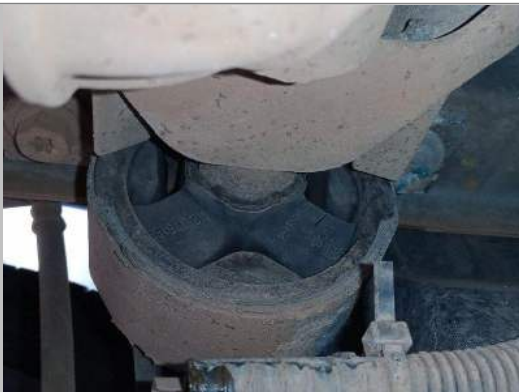
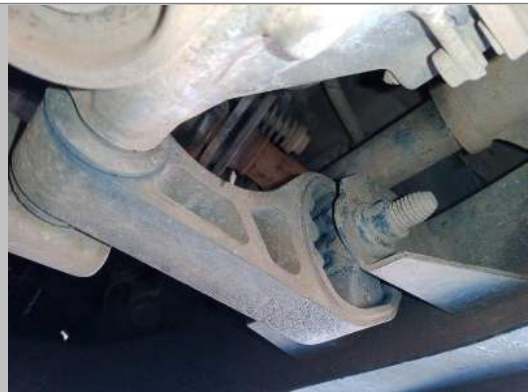
| Damage | Repair Way |
|---|---|
| Gearbox Mountings Cracked | Replace |

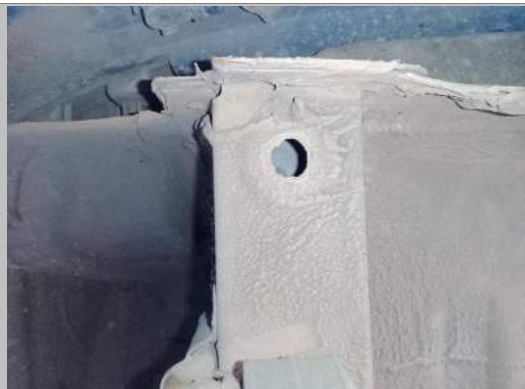
| Damage | Repair Way |
|---|---|
| Main Beam Left Dented | Repair |

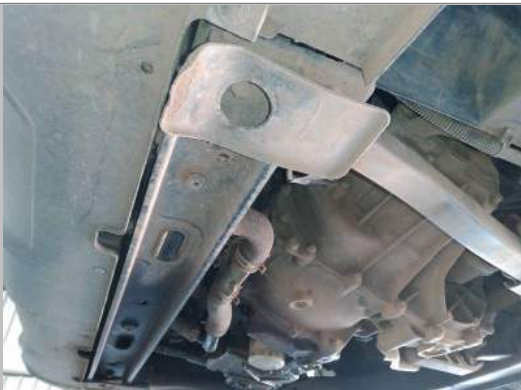
| Damage | Repair Way |
|---|---|
| Radiator Cradle Dented | Repair |

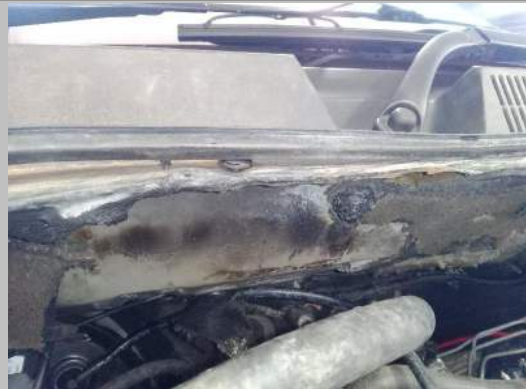
| Damage | Repair Way |
|---|---|
| Firewall Damaged | Repair |

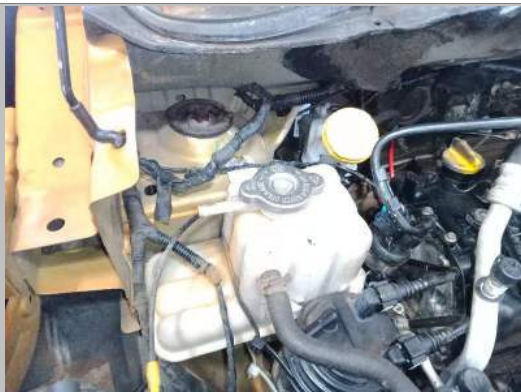
| Damage | Repair Way |
|---|---|
| Expansion Bottle Water Leak | Replace |

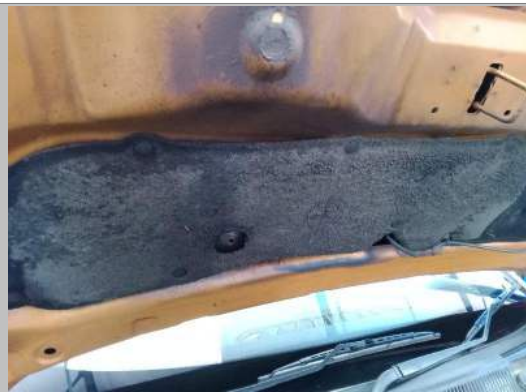
| Damage | Repair Way |
|---|---|
| Under bonnet insulation cover Damaged | Replace |

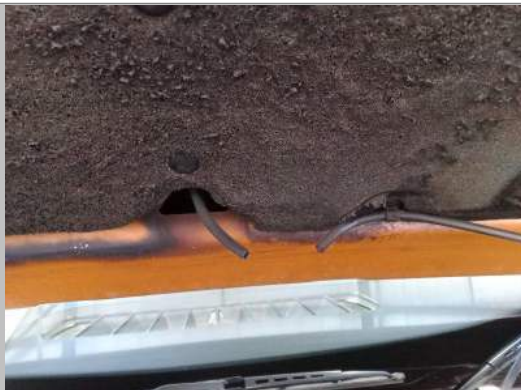
| Damage | Repair Way |
|---|---|
| Windscreen Washer Damaged | Repair |

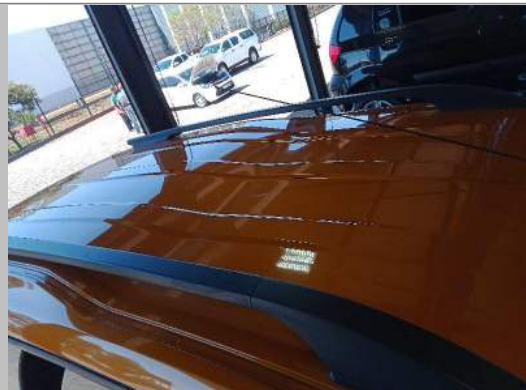
| Damage | Repair Way |
|---|---|
| Roof Damaged | Repair |
