## CONDITION REPORT

Report No:  
2017290034  
DATE  
27/08/2026

MFC Auction House  
M57 Pretoria Rd, Glenmarais, KEMPTON PARK  
Gauteng

| Manufacturer | RENAULT | Registration Number | MC90PDGP |

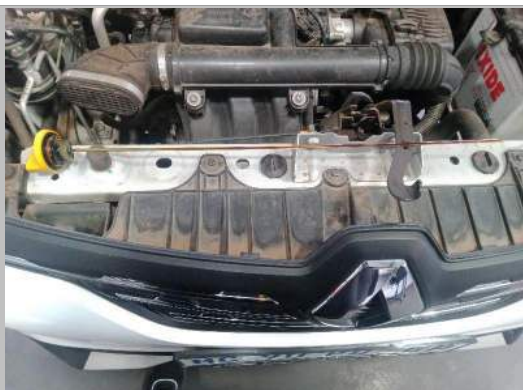
Oil cap and dipstick

| Foreign substance on oil cap | Repair |

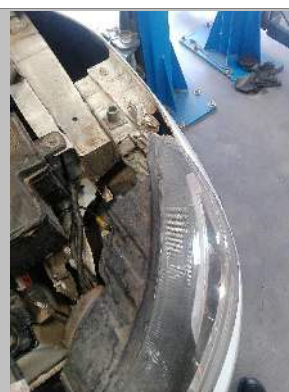
| Headlight Left Damaged | Repair |

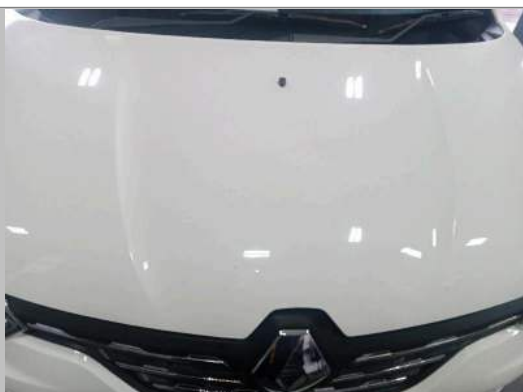
| Bonnet Paintwork • Chipmarks | Repair |

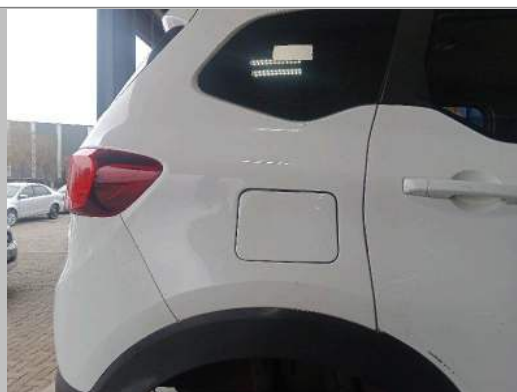
| Rear Fender Right Residual Traces of Repair | Repair |

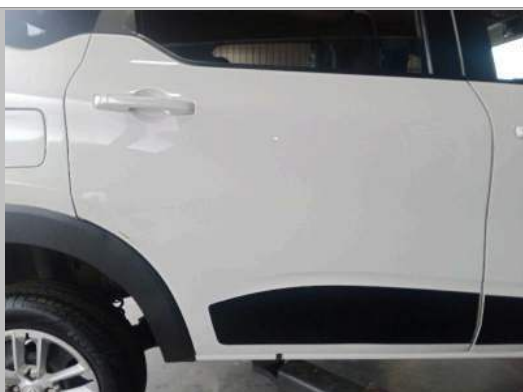
| Door Rear Right Dented | Repair |

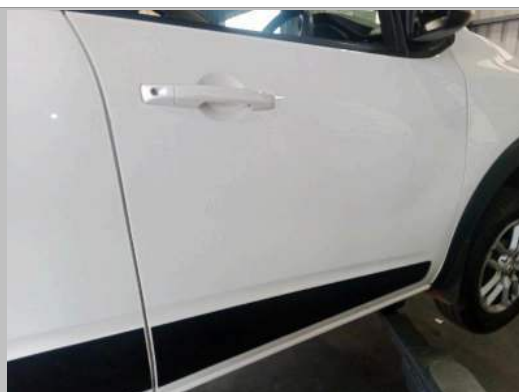
| Door Front Right Dented | Repair |

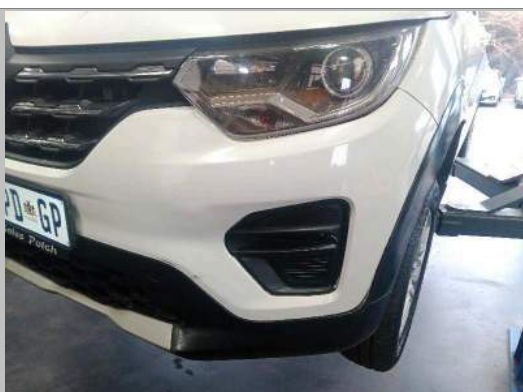
| Front Bumper Paintwork • Scratched | Repair |

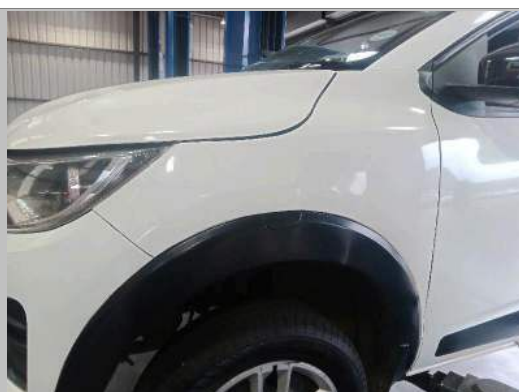
| Front Fender Left Residual Traces of Repair | Repair |

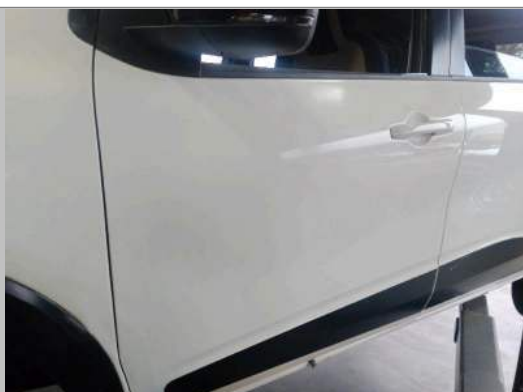
| Door Front Left Residual Traces of Repair | Repair |

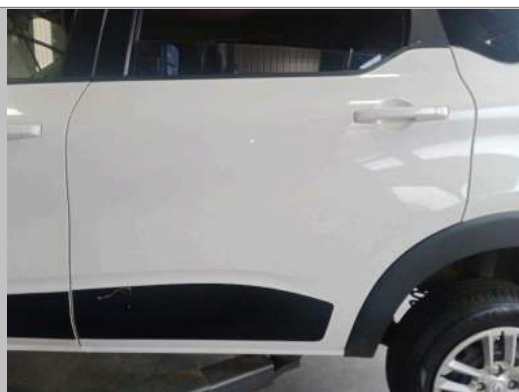
| Door Rear Left Paintwork • Scratched | Repair |

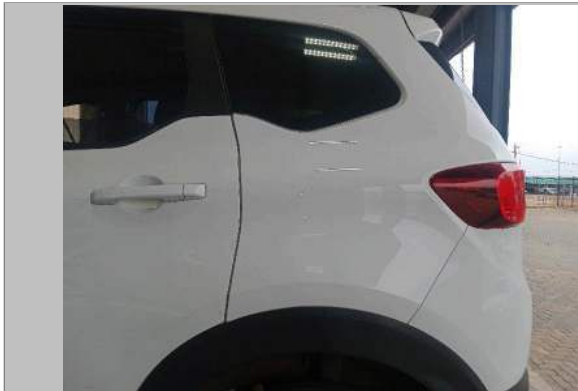
| Rear Fender Left Dented | Repair |

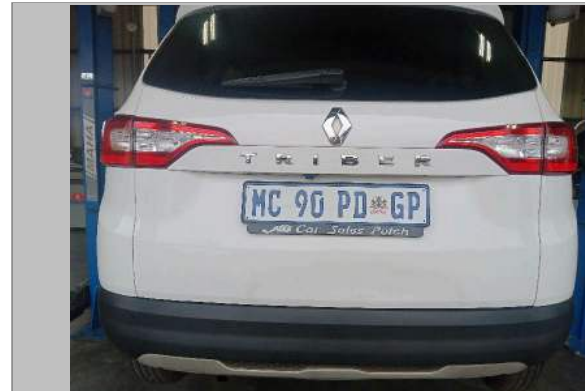
| Boot Lid / Hatch door Dented | Repair |
