CONDITION REPORT

Report No:  
2017298532  
DATE  
14/09/2026

| Manufacturer | TOYOTA | Registration Number | LW80HMGP |
| Model | AGYA 1.0 AUDIO 5-DR [2020-2023] | Register Number | |

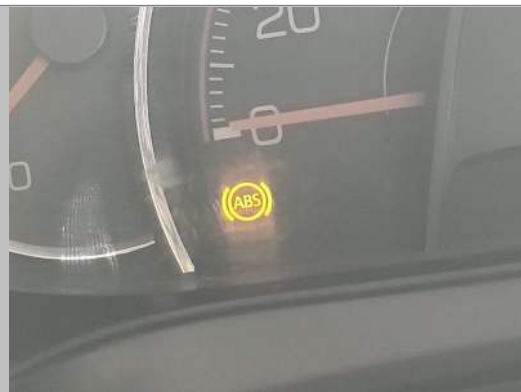
ABS warning lights illuminated

| Warning lights illuminated | Repair |

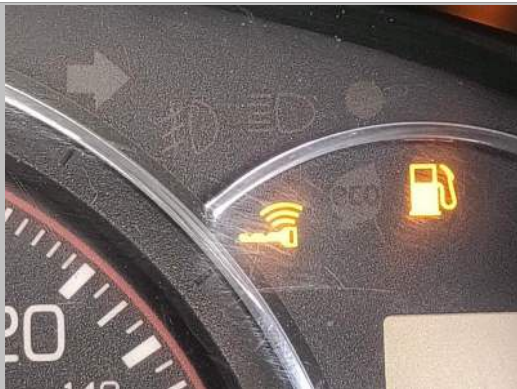
Warning lights illuminated

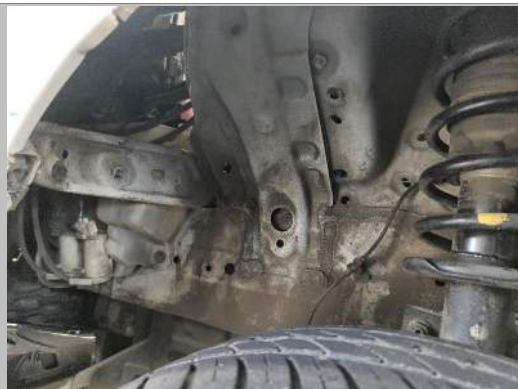
L/F fender liner missing

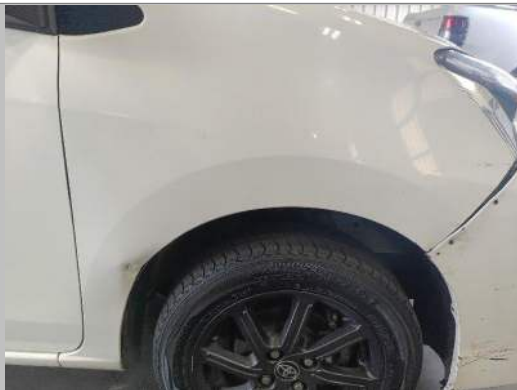
| Front Fender Right Dented | Repair |

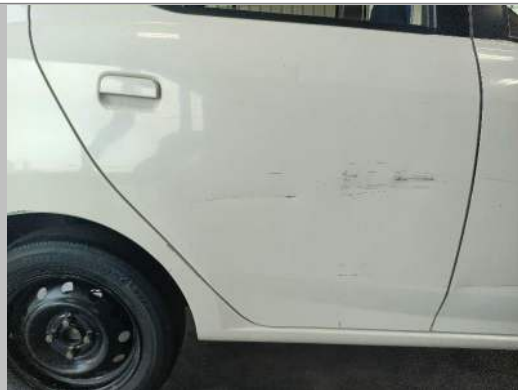
| Door Rear Right Paintwork • Scratched | Repair |

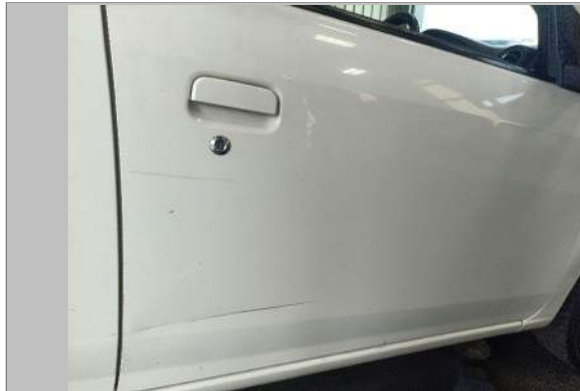
| Door Front Right Paintwork • Scratched | Repair |

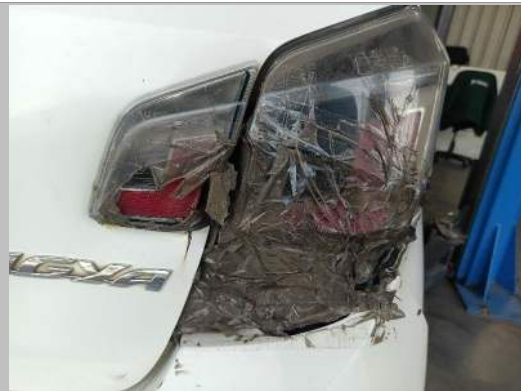
| Tail Light Right Damaged | Replace |

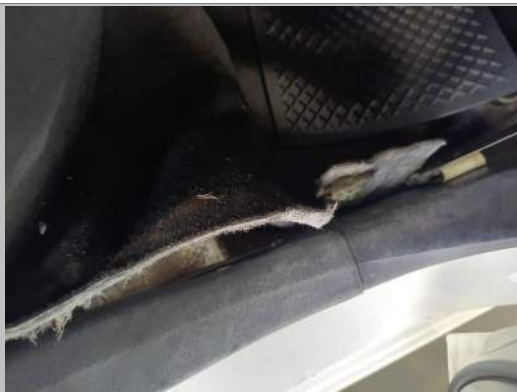
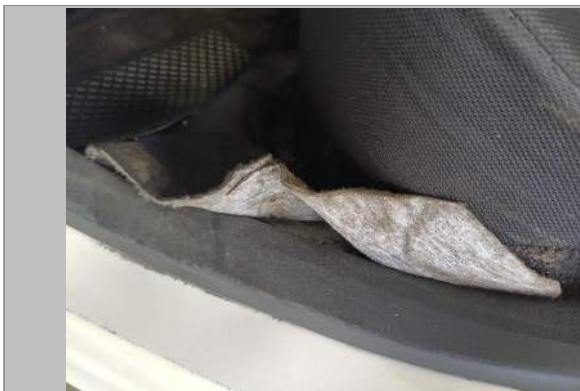
| Carpet Rear Torn / Cut | Repair |

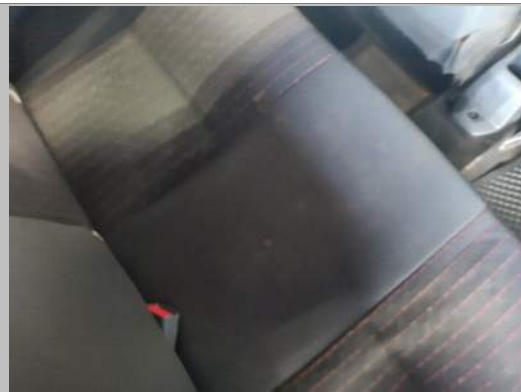
| Seat Rear Torn / Cut | Repair |

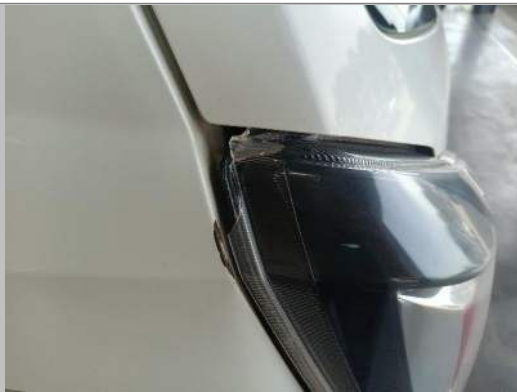
| Tail Light Left Chipped | Replace |

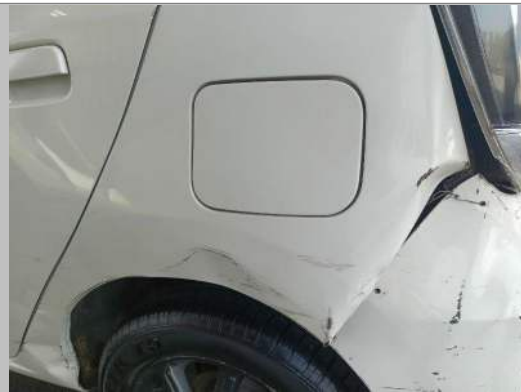
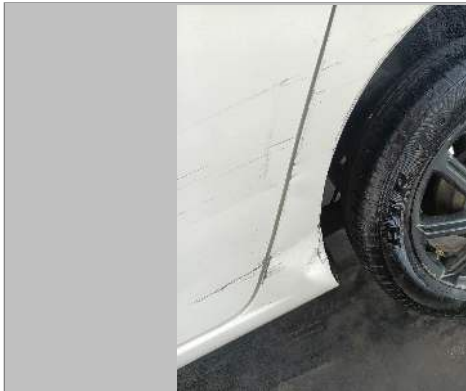
| Rear Fender Left Damaged | Repair |

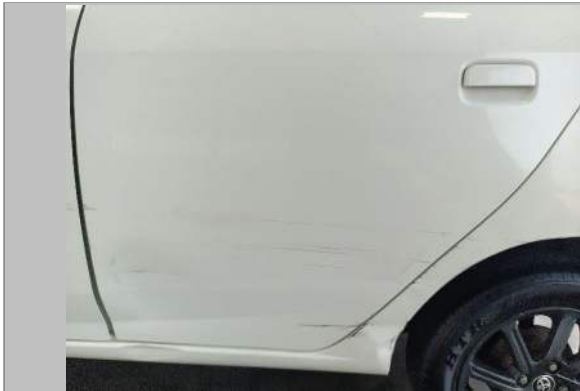
| Door Rear Left Paintwork • Scratched | Repair |

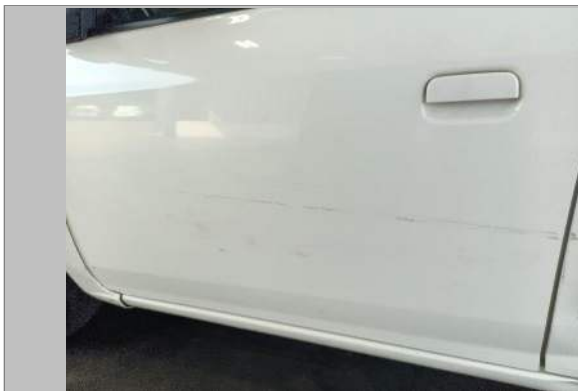
| Door Front Left Paintwork • Scratched | Repair |

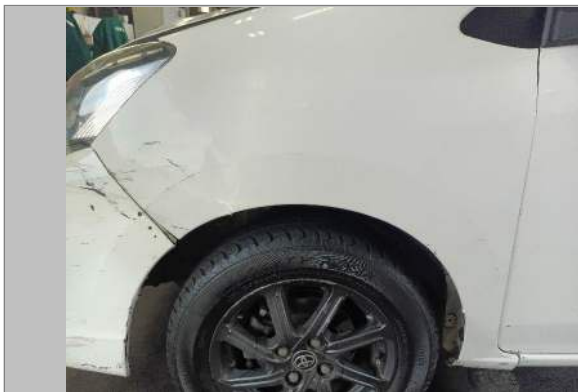
| Front Fender Left Paintwork • Scratched | Repair |

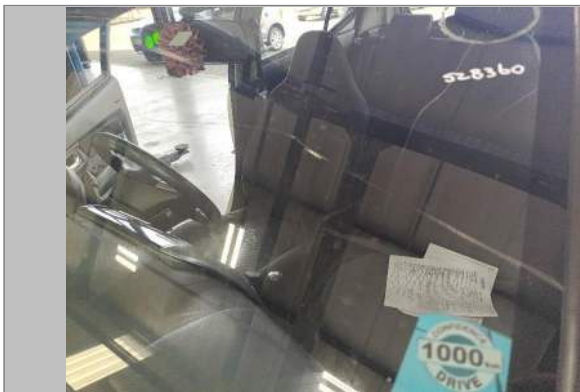
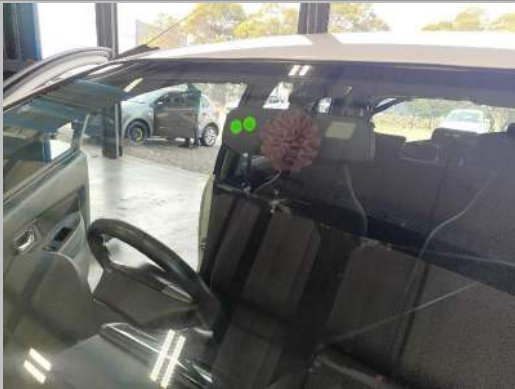
| Windscreen Cracked | Replace |

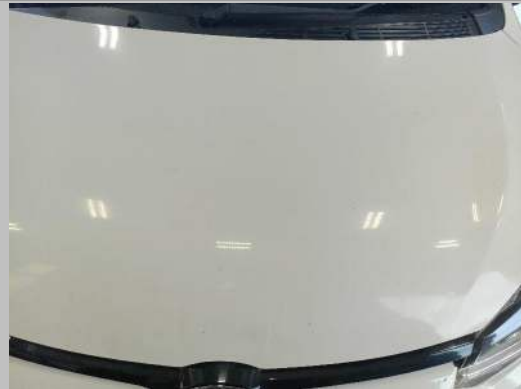
| Bonnet Paintwork • Chipmarks | Repair |

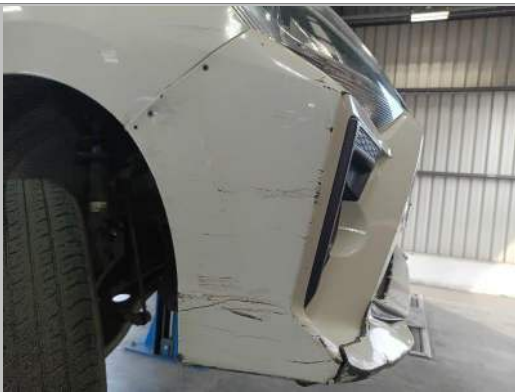
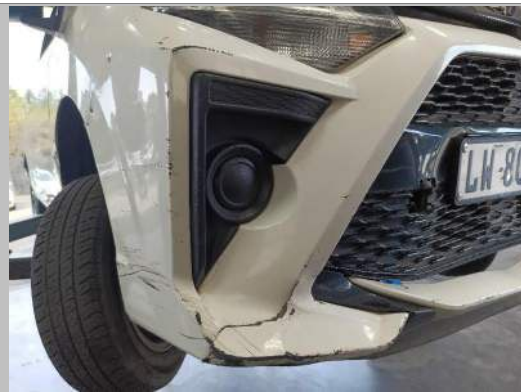
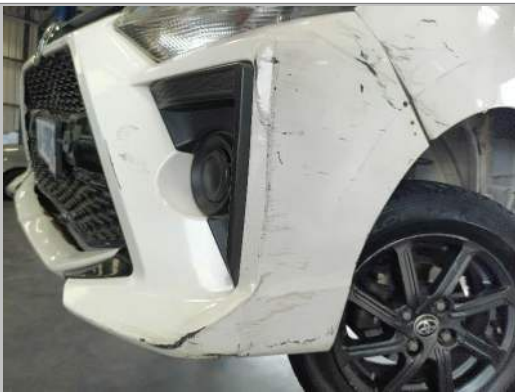
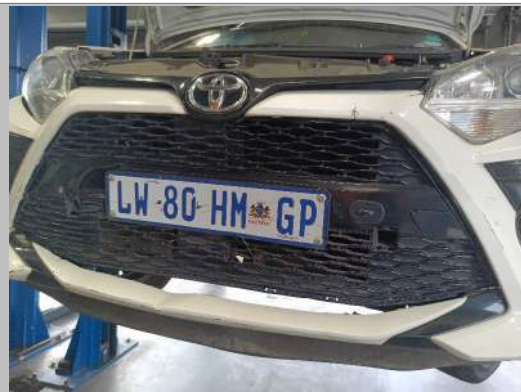
| Front Bumper Paintwork • Scratched | Repair |

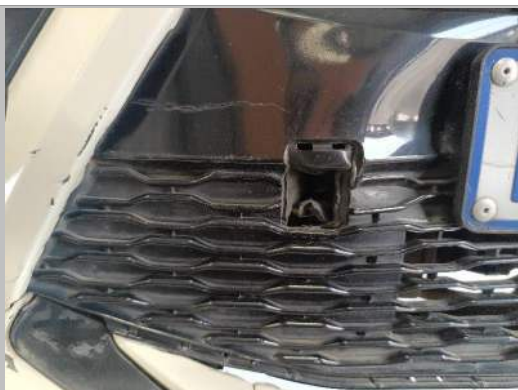
| Grill Damaged | Repair |

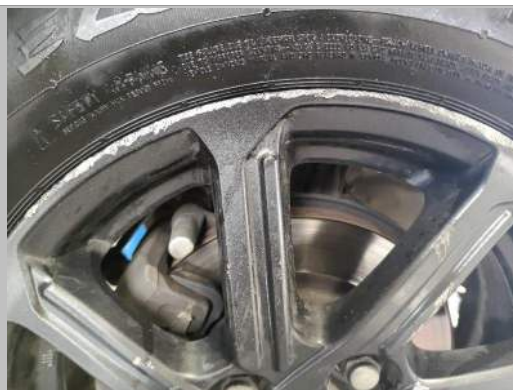
| Rim Front Left Scratched | Repair |

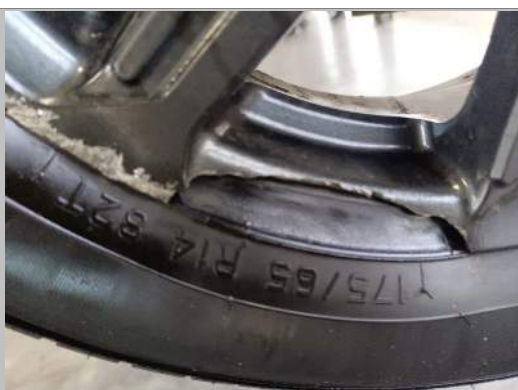
| Rim Rear Left Damaged | Repair |

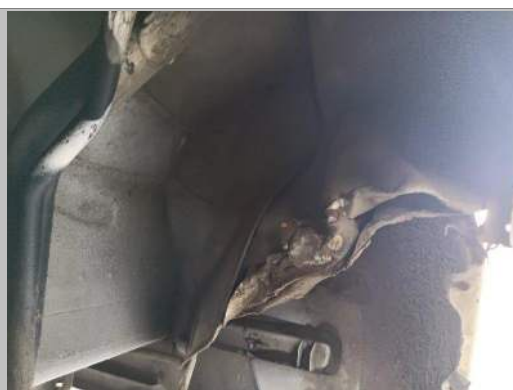
| Rear Fender Left / Inner Tray Damaged | Repair |

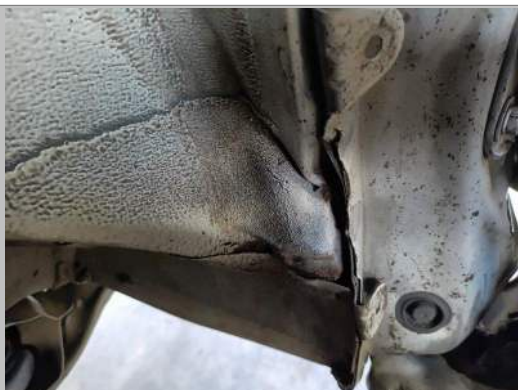
| Front Fender Left / Inner Tray Damaged | Repair |

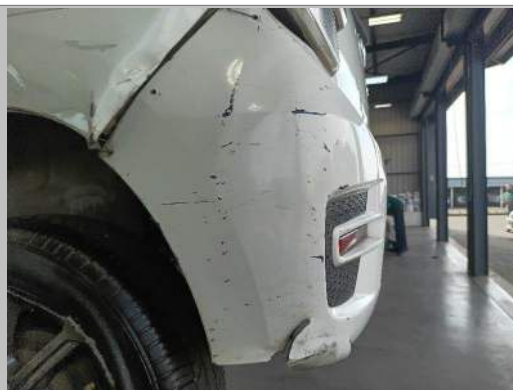
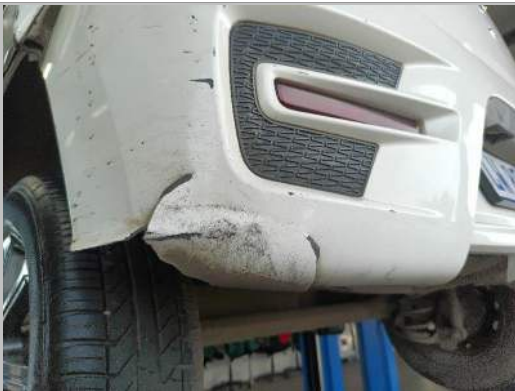
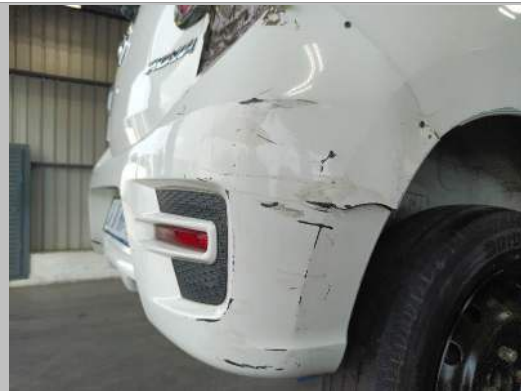
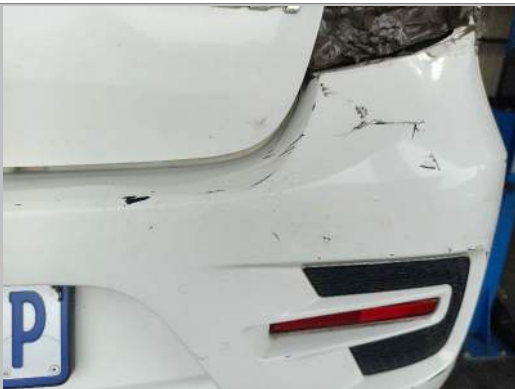
| Rear bumper Damaged | Repair |

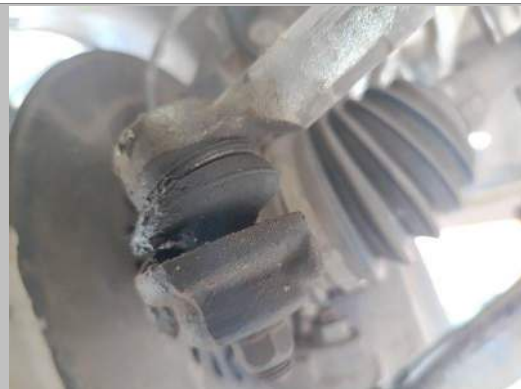
| Tie Rod End left Damaged | Replace |

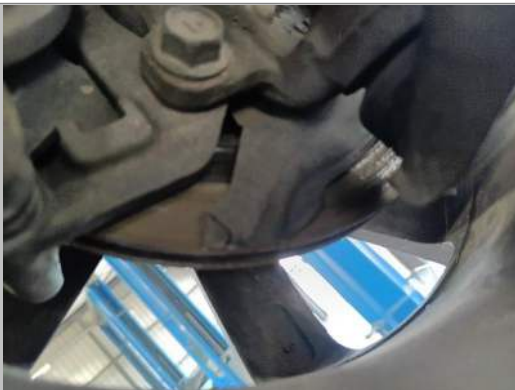
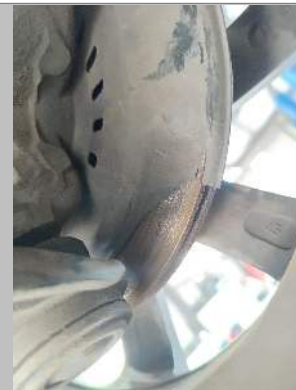
| Brake disc 1. Axle right Excessive Wear & Tear | Replace |

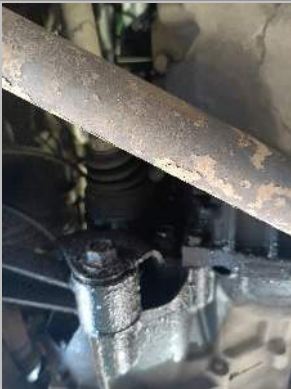
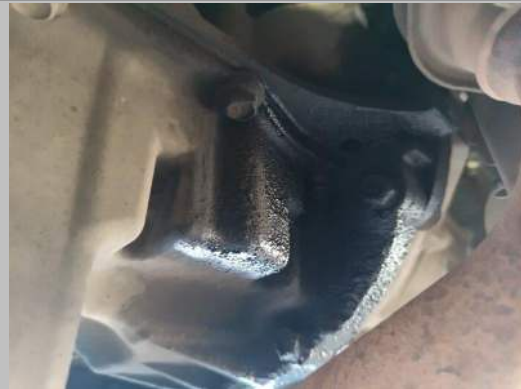
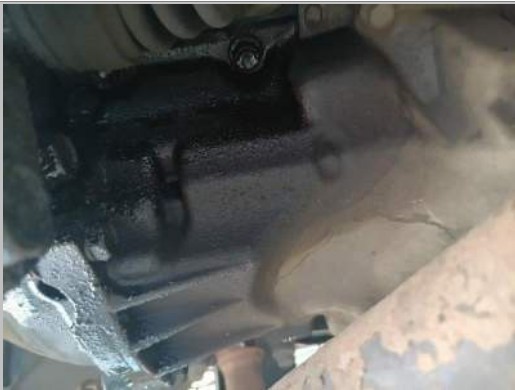
| Engine Oil Leak | Repair |

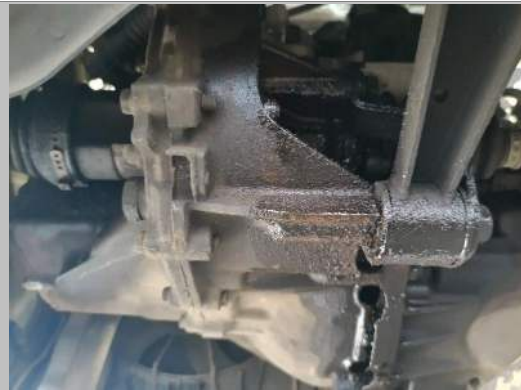
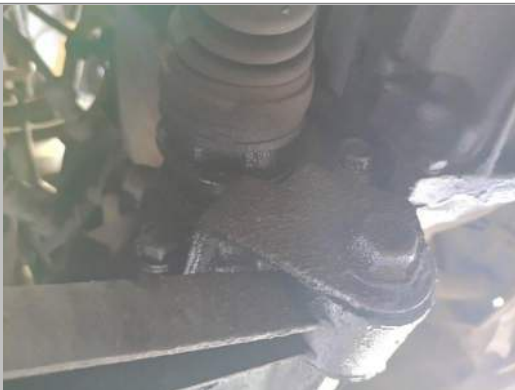
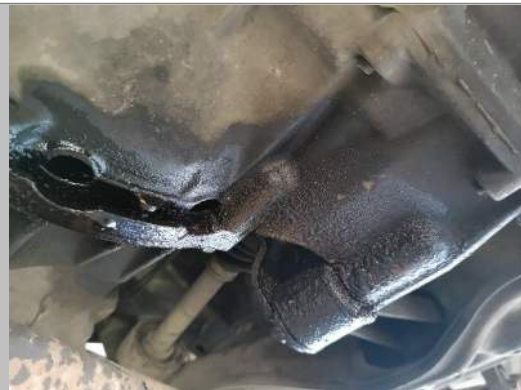
| Gearbox Oil Leak | Repair |

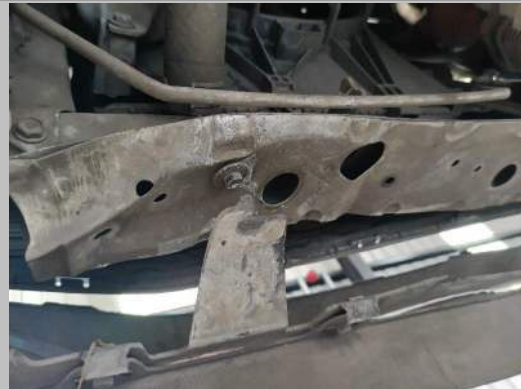
| Radiator Cradle Deformed | Repair |

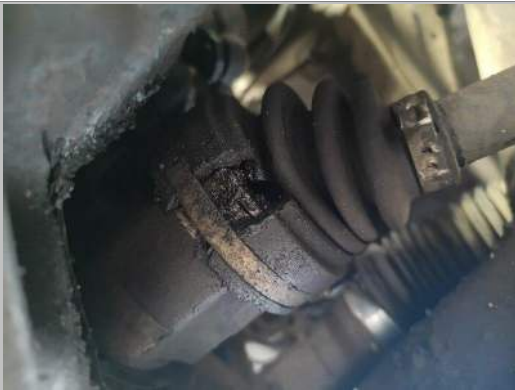
| CV Joint(s) Boot(s) Front Left (inner/outer) Damaged | Replace |

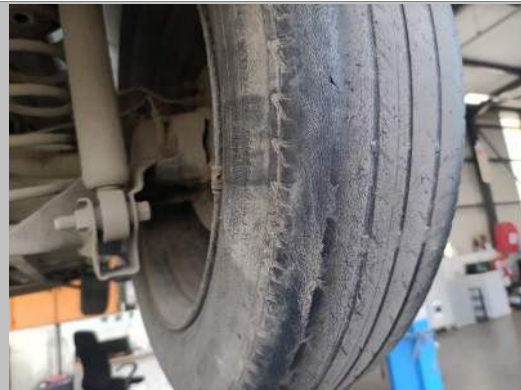
| Tyre Rear Right Smooth | Replace |

| | Size | Load/Speed Index | Manufacture | Model | Type* | Production Date | Tread Depth (mm) |
|---|---|---|---|---|---|---|---|
| Rear Right | 165/60R14 | 81S | Bridgestone | B250 | V | 0000 | 0 mm |

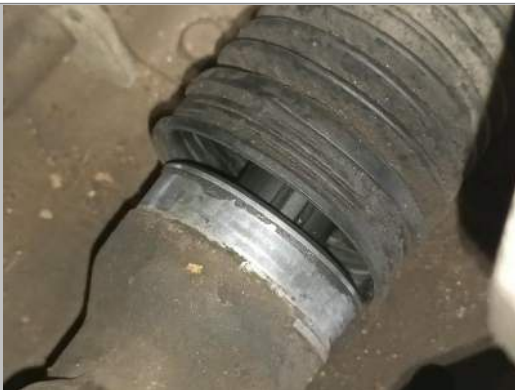
| Steering Rack Boot Left Torn / Cut | Replace |
