## CONDITION REPORT

Report No:  
2017294297  
DATE  
04/09/2026

| Manufacturer | NISSAN | Registration Number | JZP592EC |
| Model | NAVARA 2.3 LE D-CAB DSL 4X4 PU [2017-2019] | Register Number | |

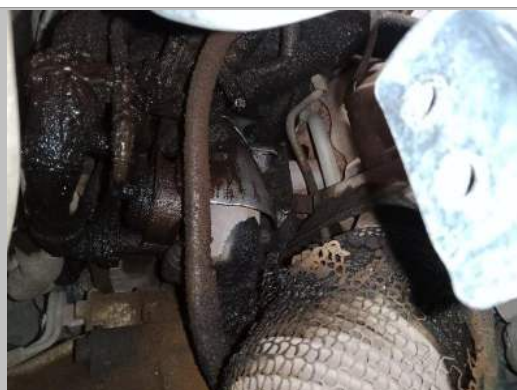
Turbo leak

General Comments: ACCORDING TO THE AGE AND MILEAGE OF THE VEHICLE, NORMAL WEAR AND TEAR MARKS ARE VISIBLE ON THE EXTERIOR AND INTERIOR ELECTRICAL AND MECHANICAL PARTS.Engine Compartment: Engine bay dirty.Oil sweat on brake booster.Oil leak on turbo  
Interior: Vehicle interior dirty and panels scratched.  
Body • Exterior: Dents and scratches on body panelsBody panels misaligned.  
Axle and Suspension: Aftermarket lift kit fitted to front suspension.

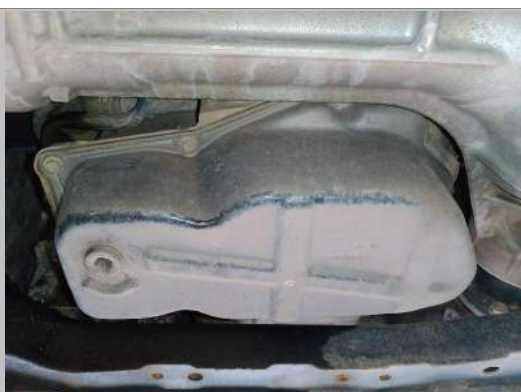
| Damage | Repair Way |
|---|---|
| Engine oil sump dented | Repair |

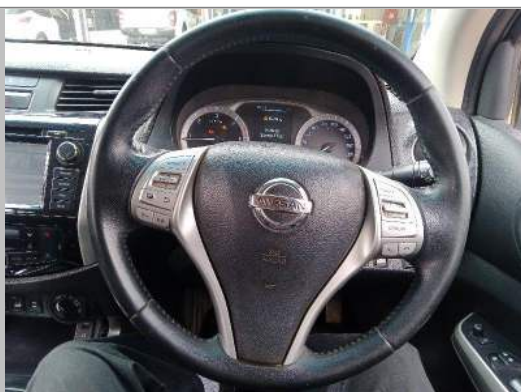
| Damage | Repair Way |
|---|---|
| Steering Wheel Trim Excessive Wear & Tear | Repair |

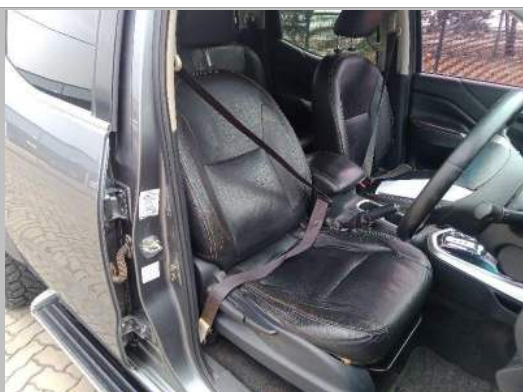
| Damage | Repair Way |
|---|---|
| Seat Front Right Damaged | Repair |

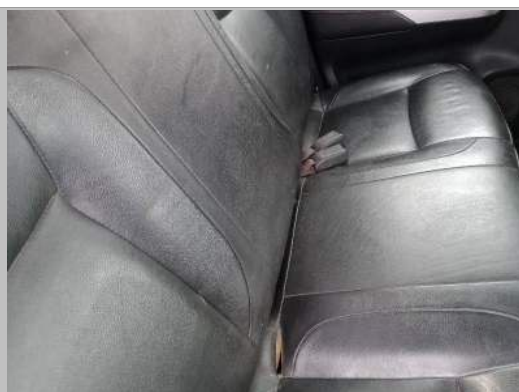
| Damage | Repair Way |
|---|---|
| Seat Belt Rear Middle Missing | Replace |

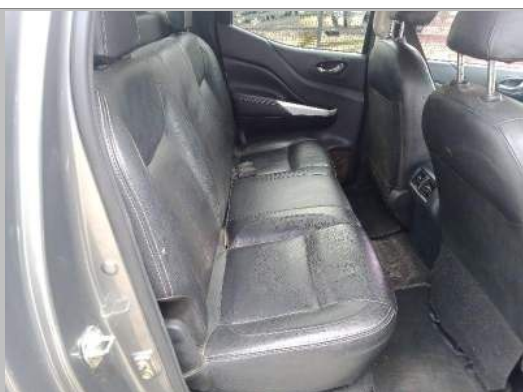
| Damage | Repair Way |
|---|---|
| Seat Rear Dirty | Repair |

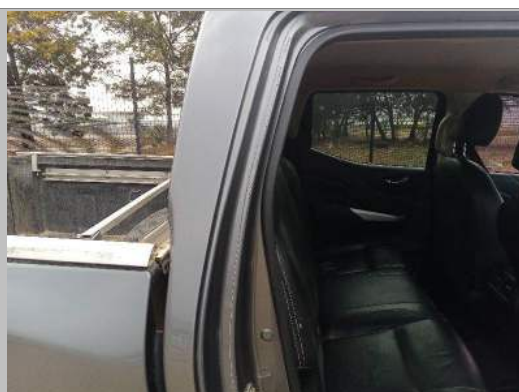
| Damage | Repair Way |
|---|---|
| C • Pillar Right Paintwork • Scratched | Repair |

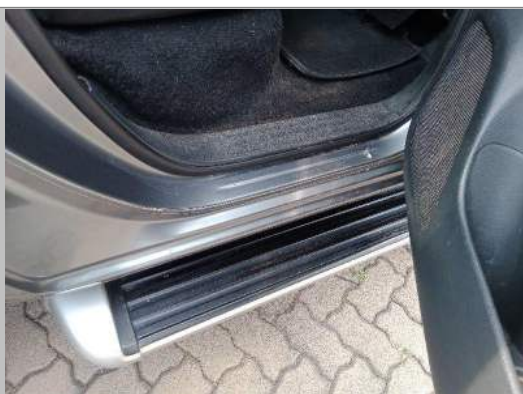
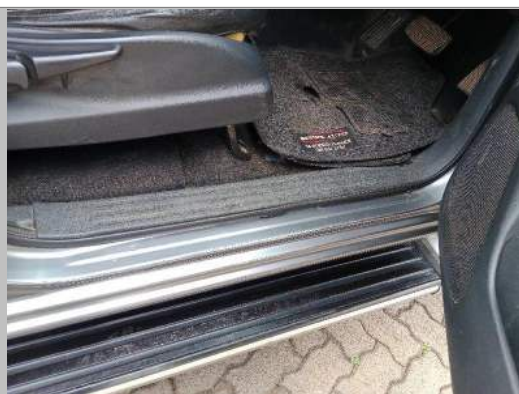
| Damage | Repair Way |
|---|---|
| Sill Panel Right Paintwork • Scratched | Repair |

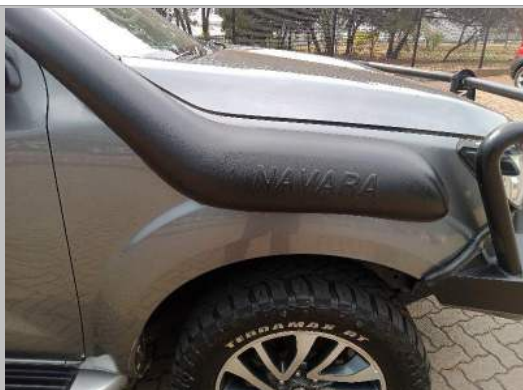
| Damage | Repair Way |
|---|---|
| Front Fender Right Damaged | Repair |

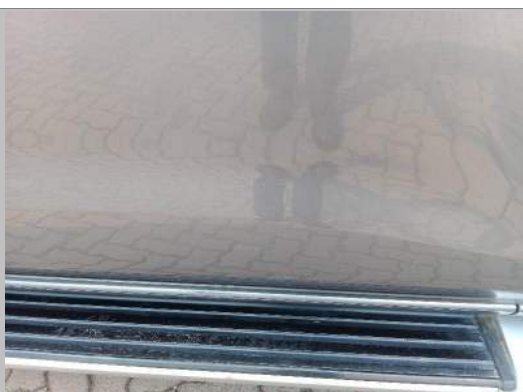
| Damage | Repair Way |
|---|---|
| Door Front Right Paintwork • Scratched | Repair |

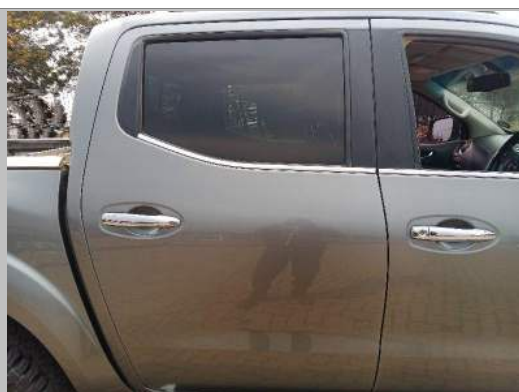
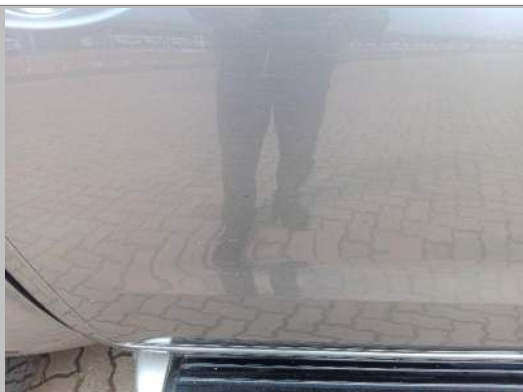
| Damage | Repair Way |
|---|---|
| Door Rear Right Paintwork • Scratched | Repair |

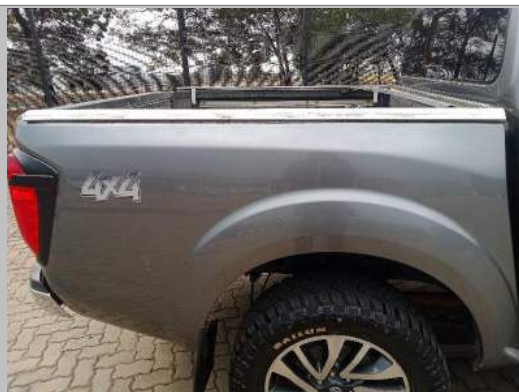
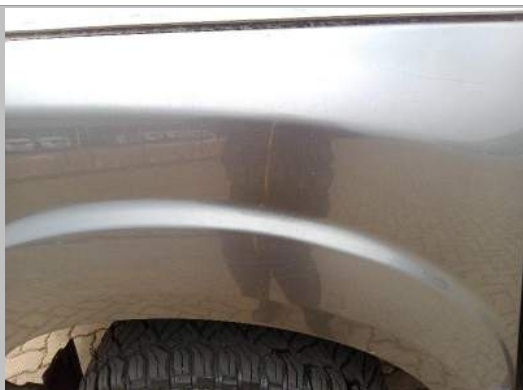
| Damage | Repair Way |
|---|---|
| Rear Fender Right Damaged | Repair |

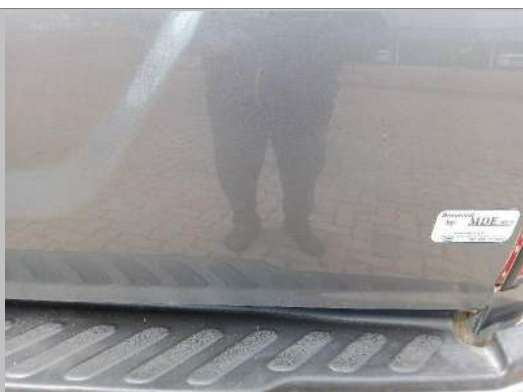
| Damage | Repair Way |
|---|---|
| Tailgate Damaged | Repair |

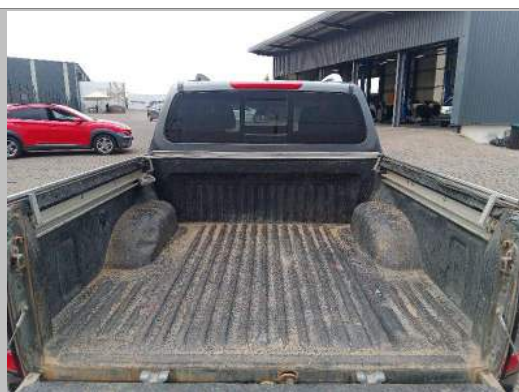
| Damage | Repair Way |
|---|---|
| Load Body Damaged | Repair |

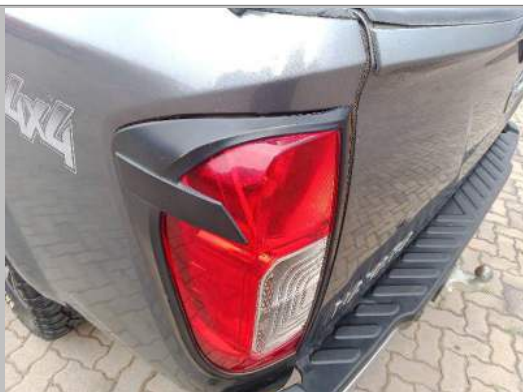
| Damage | Repair Way |
|---|---|
| Tail Light Left Defective | Repair |

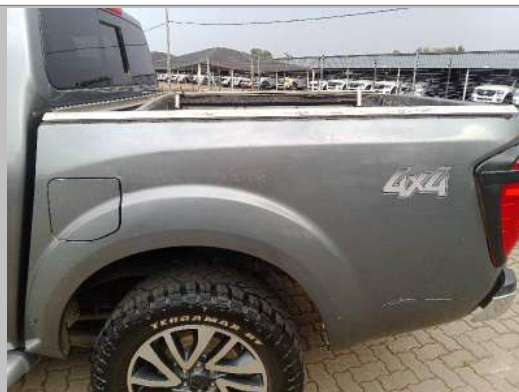
| Damage | Repair Way |
|---|---|
| Rear Fender Left Damaged | Repair |

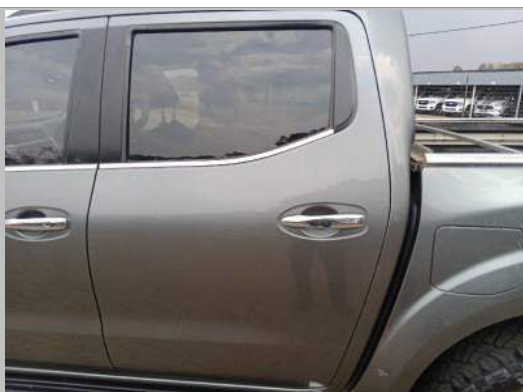
| Damage | Repair Way |
|---|---|
| Door Rear Left Damaged | Repair |

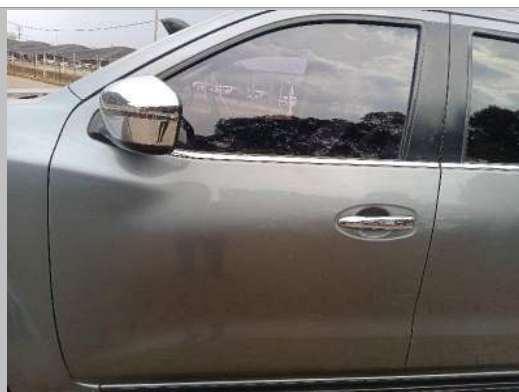
| Damage | Repair Way |
|---|---|
| Door Front Left Damaged | Repair |

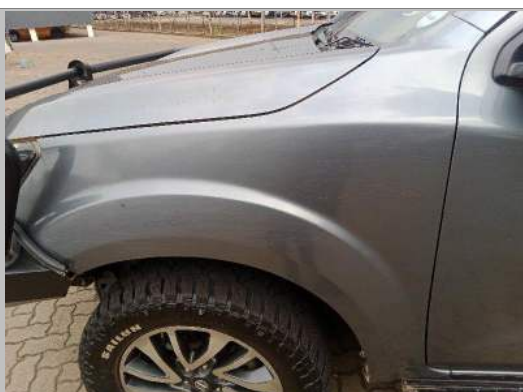
| Damage | Repair Way |
|---|---|
| Front Fender Left Damaged | Repair |

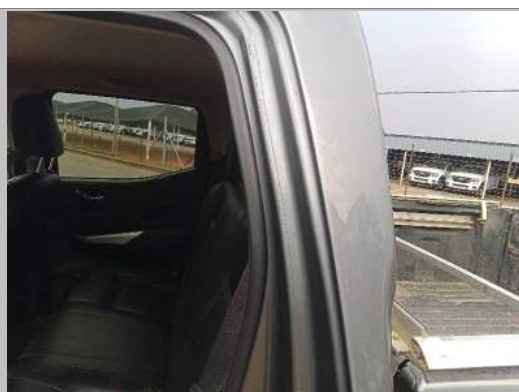
| Damage | Repair Way |
|---|---|
| C • Pillar Left Paintwork • Scratched | Repair |

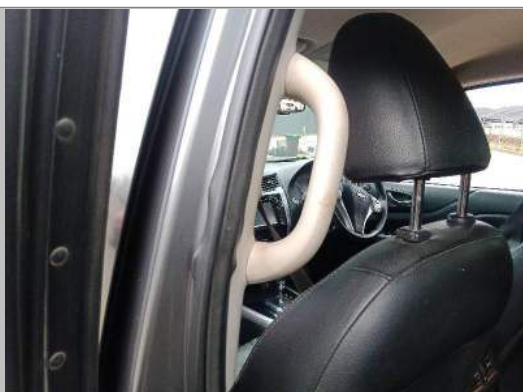
| Damage | Repair Way |
|---|---|
| Door Sealing Rubber Rear Left Defective | Replace |

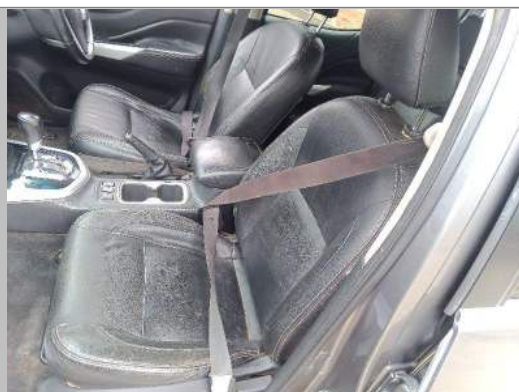
| Damage | Repair Way |
|---|---|
| Seat Front Left Damaged | Repair |

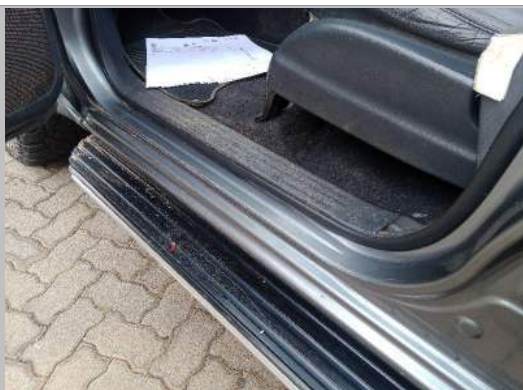
| Damage | Repair Way |
|---|---|
| Sill Panel Left Paintwork • Scratched | Repair |

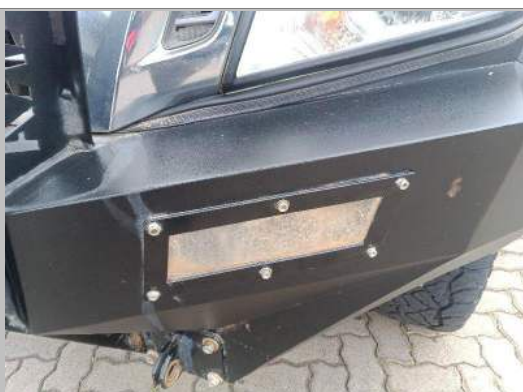
| Damage | Repair Way |
|---|---|
| Fog Light Front Left Damaged | Replace |

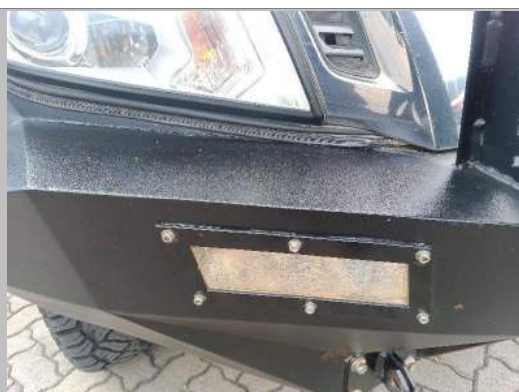
| Damage | Repair Way |
|---|---|
| Fog Light Front Right Damaged | Replace |

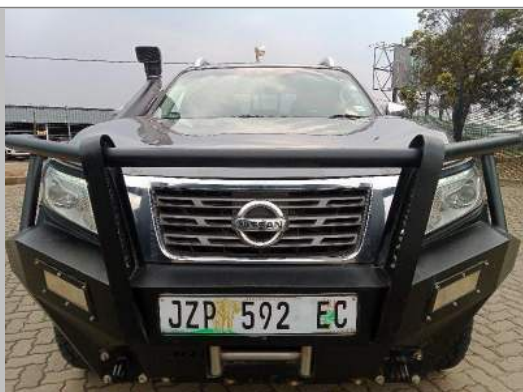
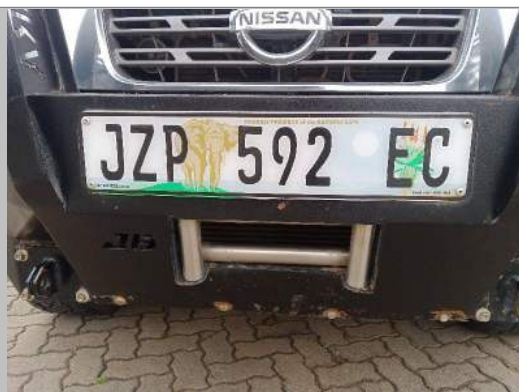
| Damage | Repair Way |
|---|---|
| Front Bumper Paintwork • Scratched | Repair |

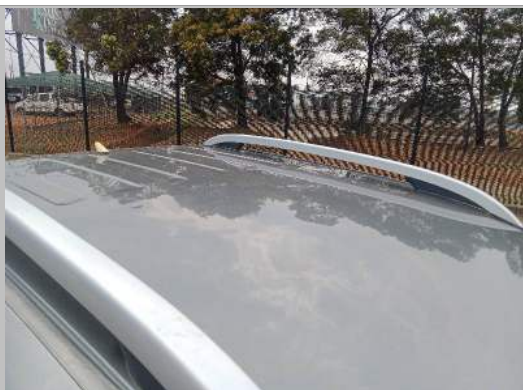
| Damage | Repair Way |
|---|---|
| Roof Dented | Repair |

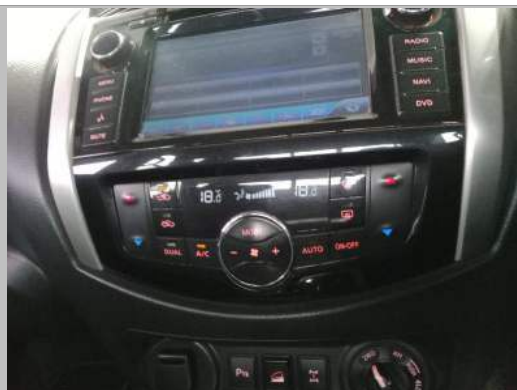
| Damage | Repair Way |
|---|---|
| Air Conditioner Insufficient | Replace |

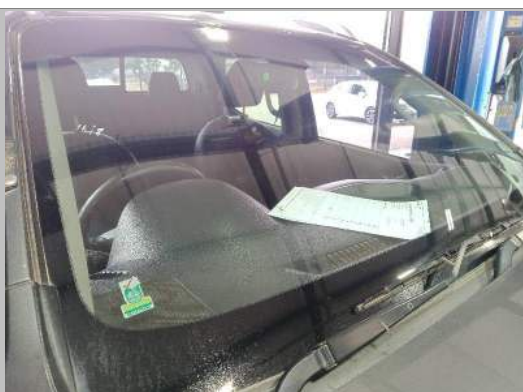
| Damage | Repair Way |
|---|---|
| Windscreen Chipped | Repair |

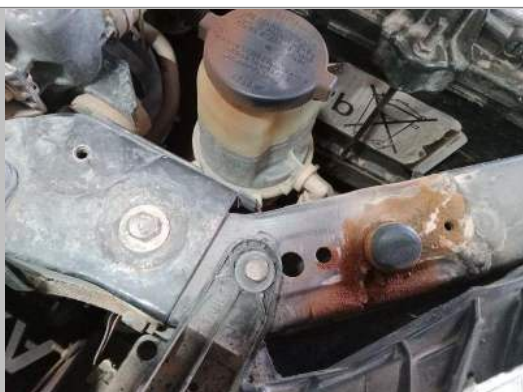
| Damage | Repair Way |
|---|---|
| Bonnet slam plate (Shock tower/ Inner tray) Welded | Replace |

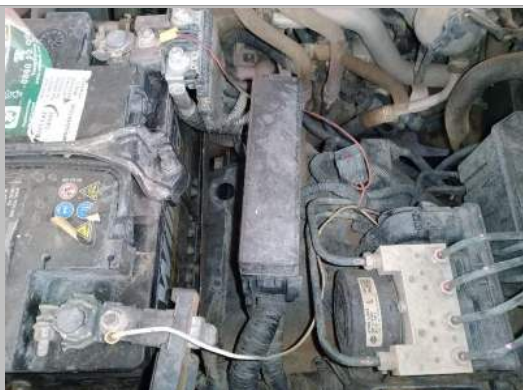
| Damage | Repair Way |
|---|---|
| Engine Wiring Defective | Repair |

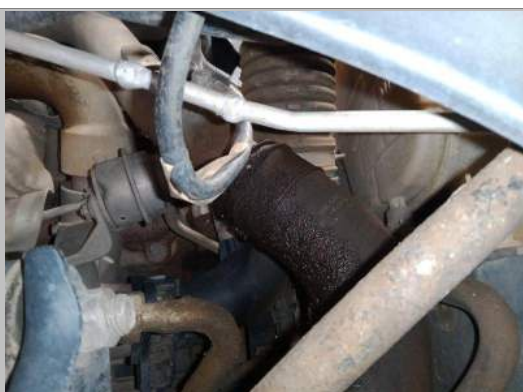
| Damage | Repair Way |
|---|---|
| Hoses Oil Leak | Replace |

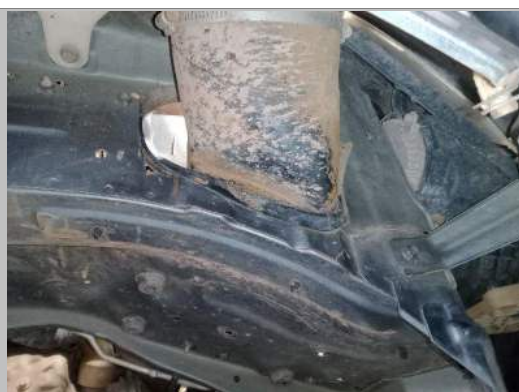
| Damage | Repair Way |
|---|---|
| Front Fender Right / Inner Tray Damaged | Repair |

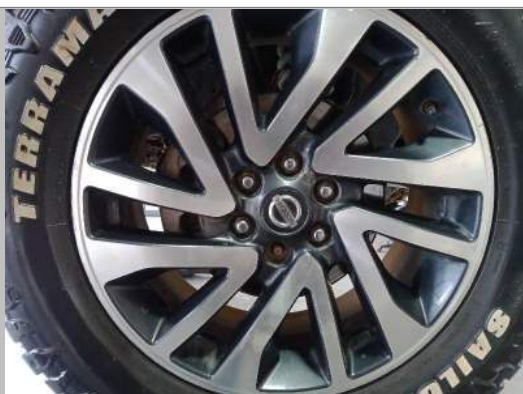
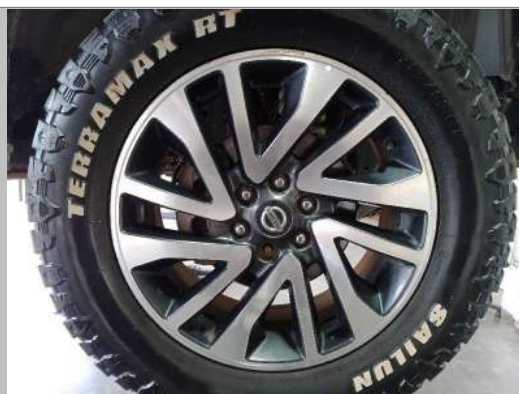
| Damage | Repair Way |
|---|---|
| Rim Front Right Scratched | Repair |

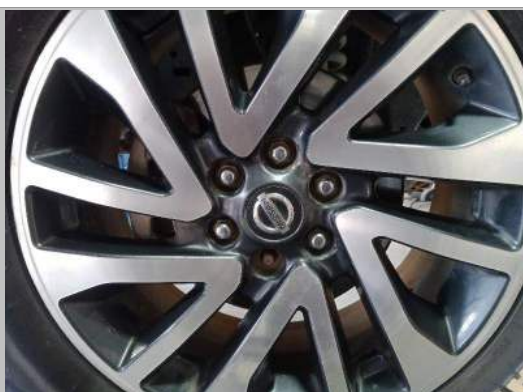
| Damage | Repair Way |
|---|---|
| Bolt(s) / Nut(s) Front Wheel Right Missing | Replace |

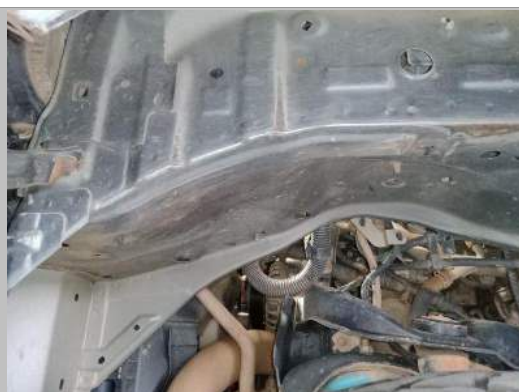
| Damage | Repair Way |
|---|---|
| Front Fender Left / Inner Tray Paintwork • Scratched | Smart Repair |

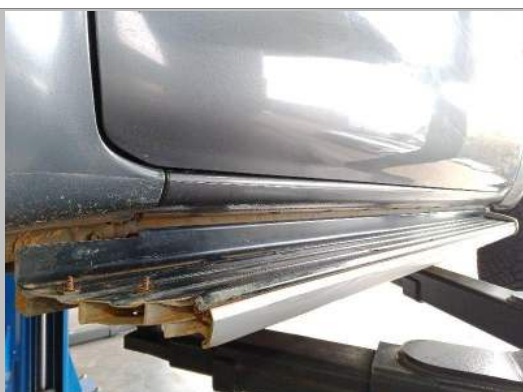
| Damage | Repair Way |
|---|---|
| Rocker Panel Left Damaged | Repair |

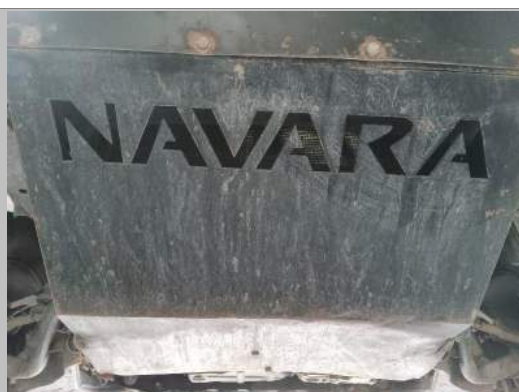
| Damage | Repair Way |
|---|---|
| Belly plates Damaged | Repair |

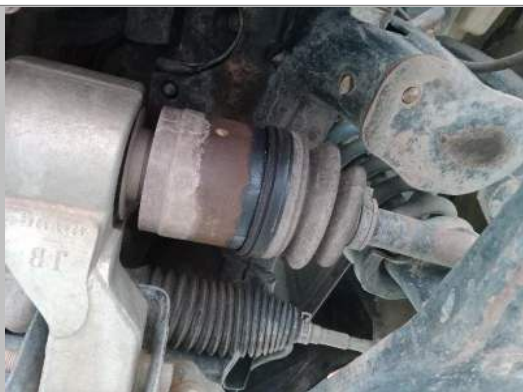
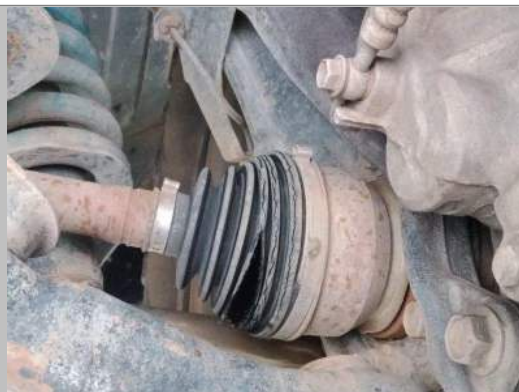
| Damage | Repair Way |
|---|---|
| CV Joint(s) Boot(s) Front Right (inner/outer) Damaged | Replace |

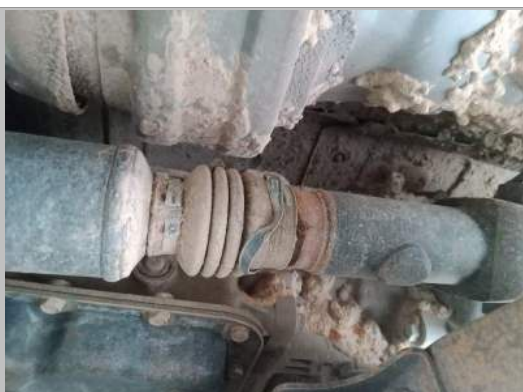
| Damage | Repair Way |
|---|---|
| Prop Shaft Defective | Replace |

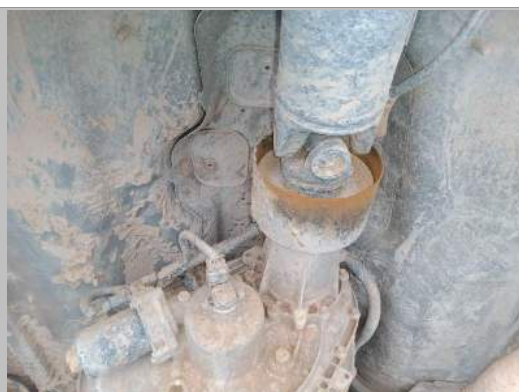
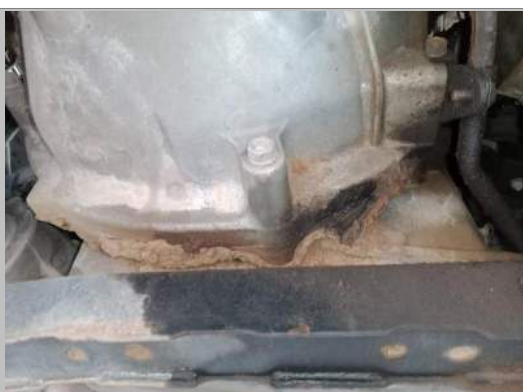
| Damage | Repair Way |
|---|---|
| Gearbox Oil Sweat | Repair |

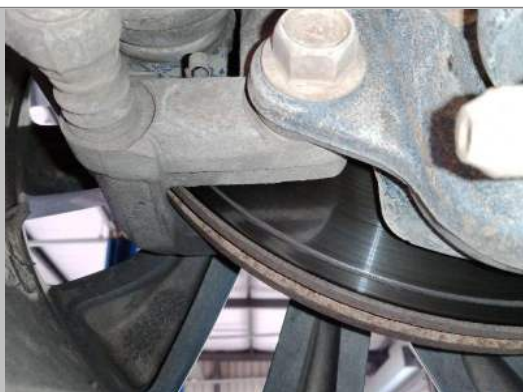
| Damage | Repair Way |
|---|---|
| Brake disc 1. Axle left Damaged | Replace |
