## CONDITION REPORT

Report No:  
2017296500  
DATE  
09/09/2026

| Manufacturer | NISSAN | Registration Number | FK52HCGP |
| Model | JUKE 1.6DIG-T TEKNA 5-DR [2016-2019] | Register Number | |

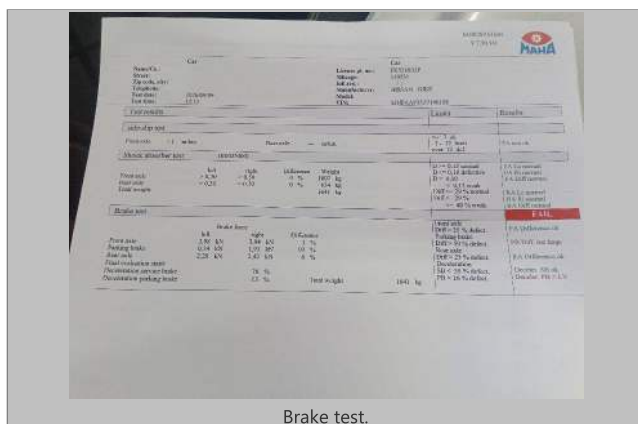
Brake test.

| Damage | Repair Way |
|---|---|
| Parking Brake Performance Left / Right Difference out of legal range | Repair |

| | Left | Right | | |
|---|---|---|---|---|
| Emergency / Parking | 0.14 | 1.91 | - | |

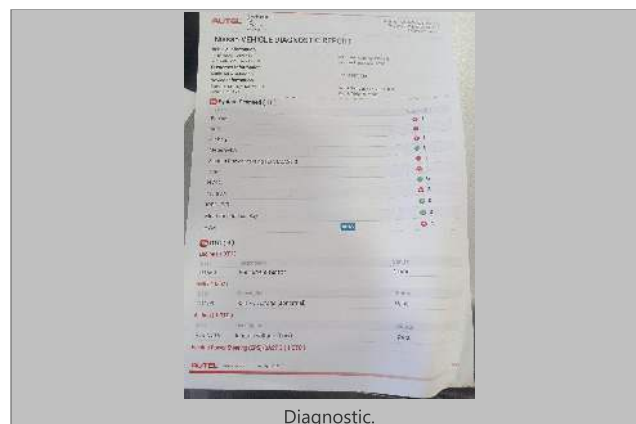
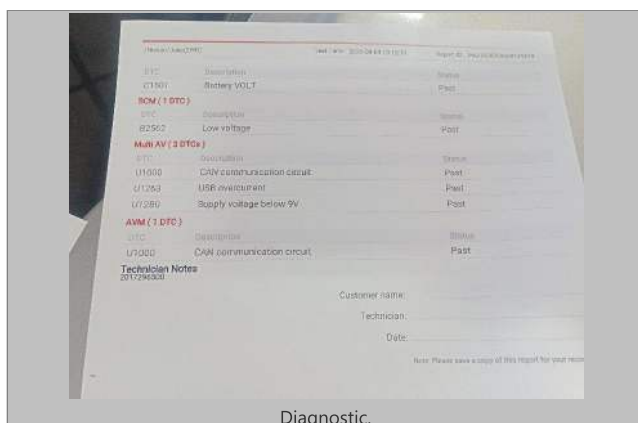
Diagnostic.

| No | System | Code | Description | Status |
|---|---|---|---|---|
| 1 | ENGINE | P1550 | BAT CURRENT SENSOR | |

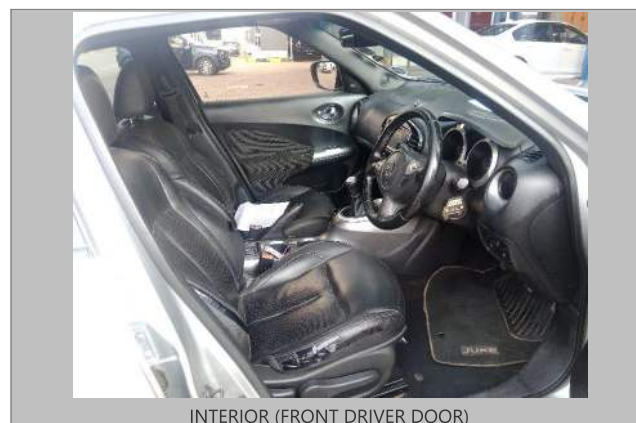
INTERIOR (FRONT DRIVER DOOR)

General Comments: ACCORDING TO THE AGE AND MILEAGE OF THE VEHICLE, NORMAL WEAR AND TEAR MARKS ARE VISIBLE ON THE INTERIOR, EXTERIOR, ELECTRICAL AND MECHANICAL PARTS. VEHICLE ELECTRONICS MALFUNCTIONING. 9 DTC'S AT TIME OF TESTING SEE DTC REPORT. Interior: driver side door does not open from outside.

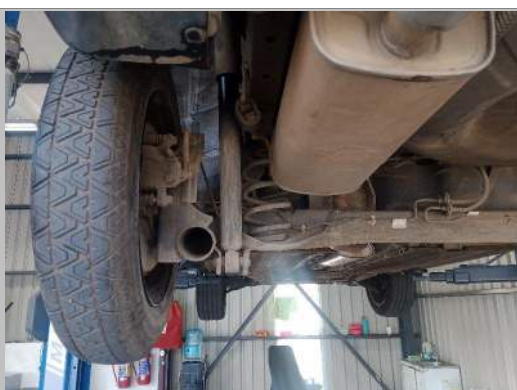
LR TYRE TREAD

| Damage | Repair Way |
|---|---|
| Rear tyres size differs | Replace |

| | Size | Load/Speed Index | Manufacture | Model | Type* | Production Date | Tread Depth (mm) |
|---|---|---|---|---|---|---|---|
| Rear Left | T135/90R16 | 102M | Continental | Temporary | V | 4015 | 2 mm |

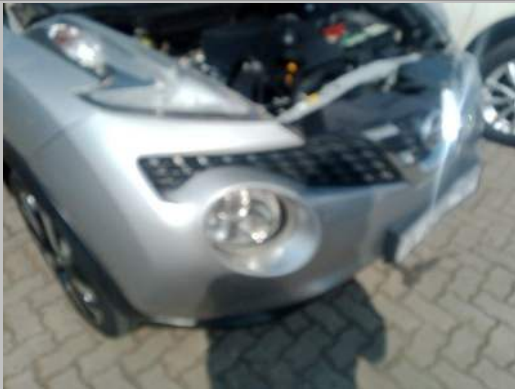
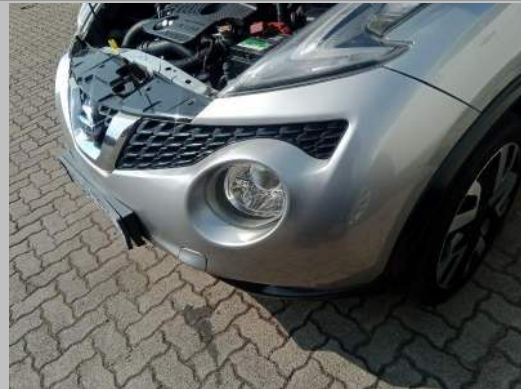
| Damage | Repair Way |
|---|---|
| Front Bumper Damaged | Repair |

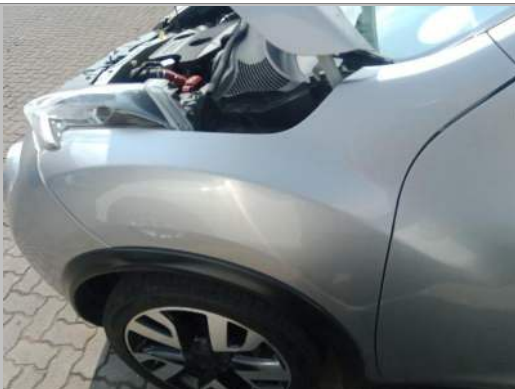
| Damage | Repair Way |
|---|---|
| Front Fender Left Damaged | Repair |

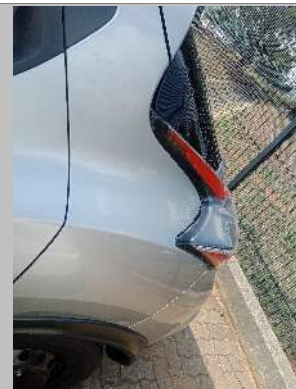
| Damage | Repair Way |
|---|---|
| Rear Fender Left Damaged | Repair |

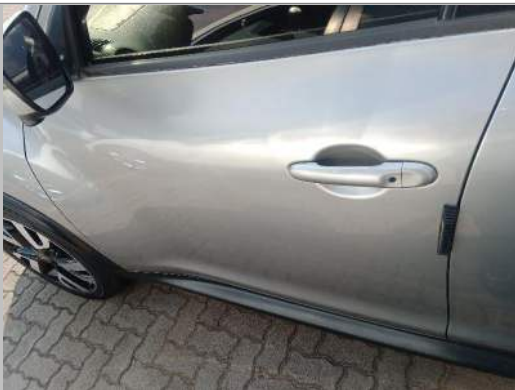
| Damage | Repair Way |
|---|---|
| Door Front Left Damaged | Repair |

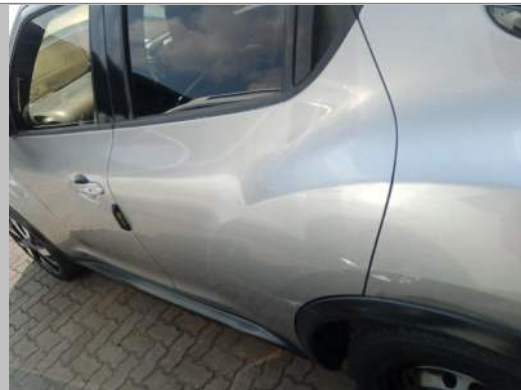
| Damage | Repair Way |
|---|---|
| Door Rear Left Damaged | Repair |

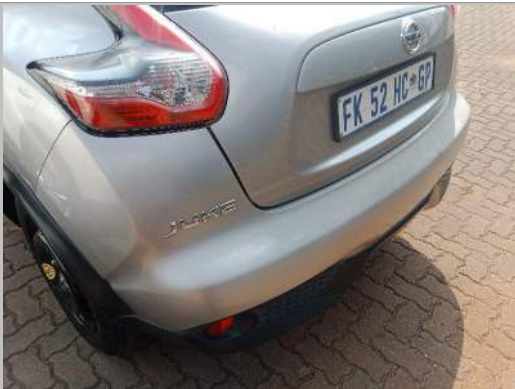
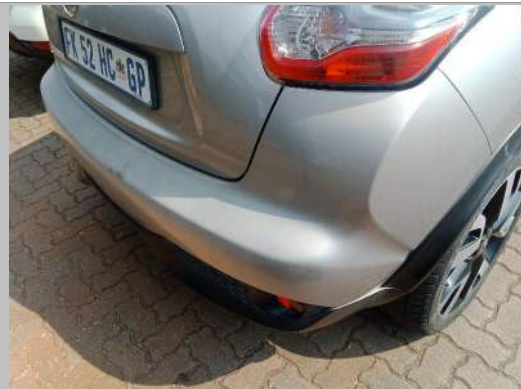
| Damage | Repair Way |
|---|---|
| Rear bumper Damaged | Repair |

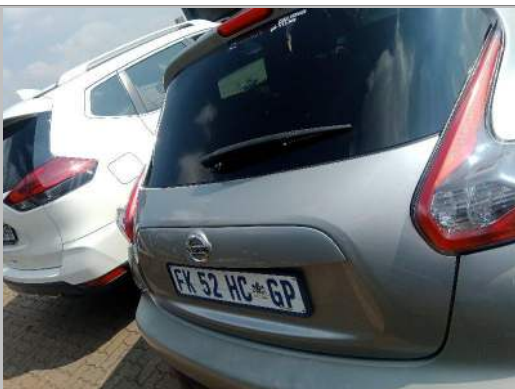
| Damage | Repair Way |
|---|---|
| Boot Lid / Hatch door Damaged | Repair |

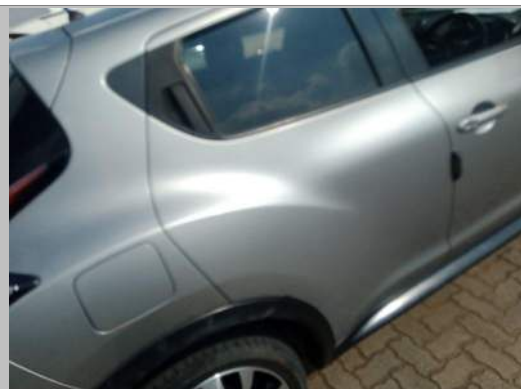
| Damage | Repair Way |
|---|---|
| Door Rear Right Damaged | Repair |

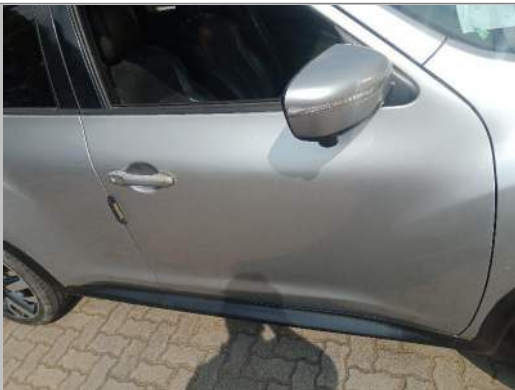
| Damage | Repair Way |
|---|---|
| Door Front Right Damaged | Repair |

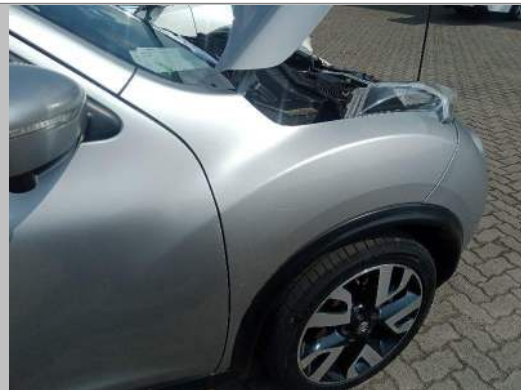
| Damage | Repair Way |
|---|---|
| Front Fender Right Damaged | Repair |

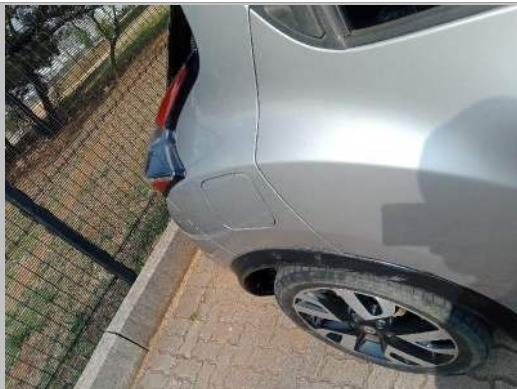
| Damage | Repair Way |
|---|---|
| Rear Fender Right Damaged | Repair |

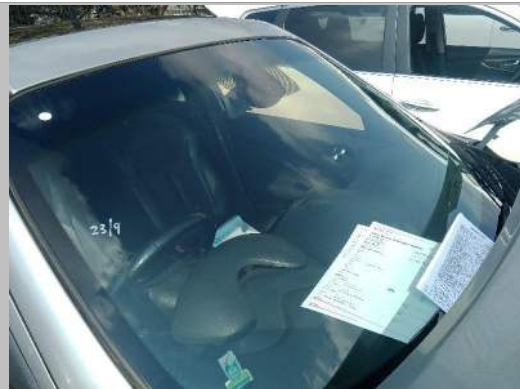
| Damage | Repair Way |
|---|---|
| Windscreen Cracked | Repair |

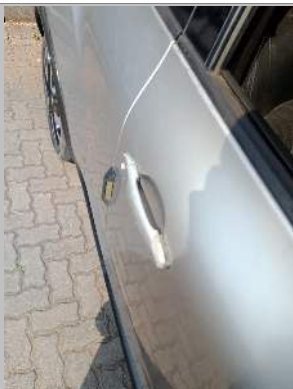
| Damage | Repair Way |
|---|---|
| Door Handle Front Right Damaged | Replace |

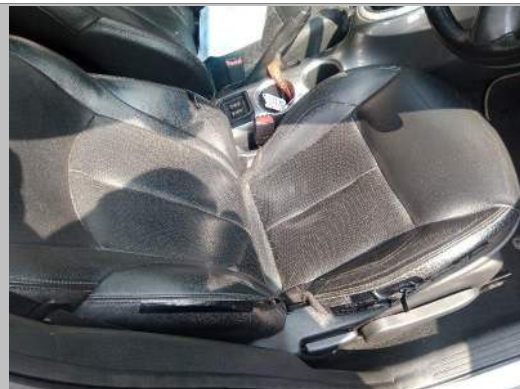
| Damage | Repair Way |
|---|---|
| Seat Front Right Damaged | Repair |

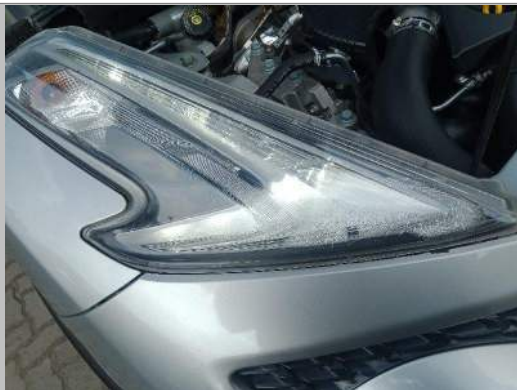
| Damage | Repair Way |
|---|---|
| Headlight Right Damaged | Replace |

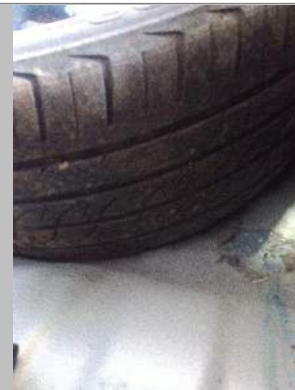
| Damage | Repair Way |
|---|---|
| Spare Tyre Worn | Replace |

| | Size | Load/Speed Index | Manufacture | Model | Type* | Production Date | Tread Depth (mm) |
|---|---|---|---|---|---|---|---|
| Spare | 225/45R18 | 95W | Toledo | Radial | V | 0000 | 0 mm |

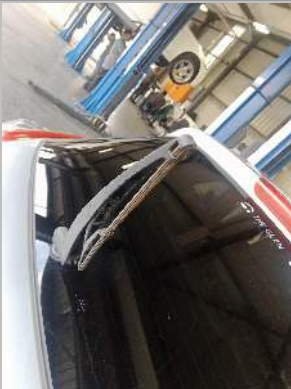
| Damage | Repair Way |
|---|---|
| Windscreen Wiper Damaged | Replace |

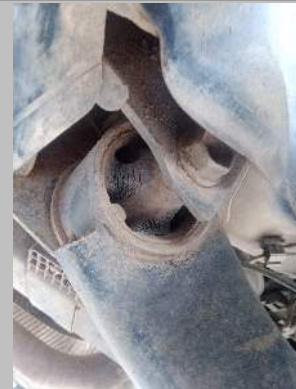
| Damage | Repair Way |
|---|---|
| Control Arm Bush(es) Rear Axle Left Cracked | Replace |

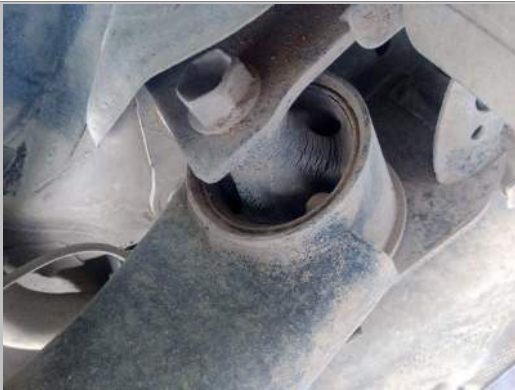
| Damage | Repair Way |
|---|---|
| Control Arm Bush(es) Rear Axle Right Cracked | Replace |

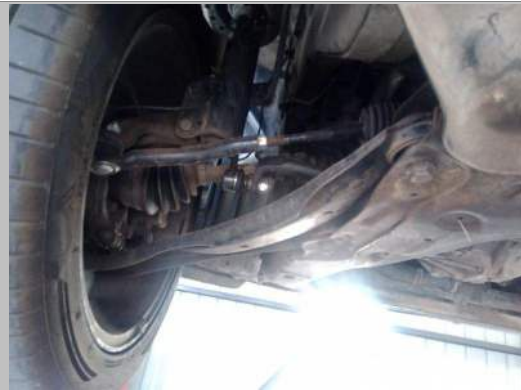
| Damage | Repair Way |
|---|---|
| Control Arm Bush(es) Front Axle Left Worn | Replace |

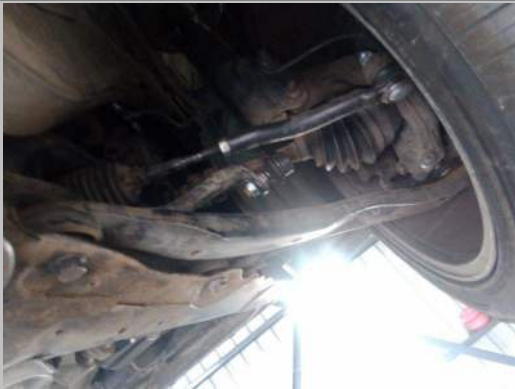
| Damage | Repair Way |
|---|---|
| Control Arm Bush(es) Front Axle Right Worn | Replace |
