## CONDITION REPORT

2017300372

| Manufacturer | NISSAN | Registration Number | KMV291NW |
| Model | QASHQAI 1.5 DCI ACENTA DSL 5-DR [2018-2020] | Register Number | |

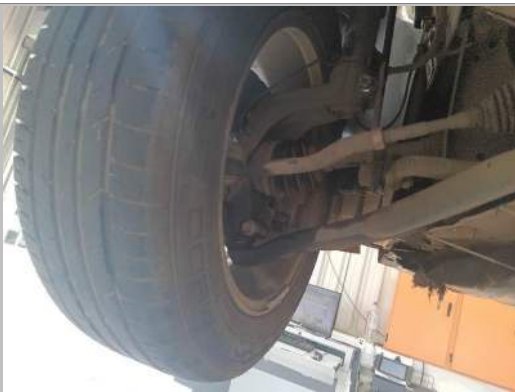
LF TYRE TREAD

| | Size | Load/Speed Index | Manufacture | Model | Type* | Production Date | Tread Depth (mm) |
|---|---|---|---|---|---|---|---|
| Front Left | 215/60R17 | 96H | Dunlop | Sport | V | 1628 | 5 mm |

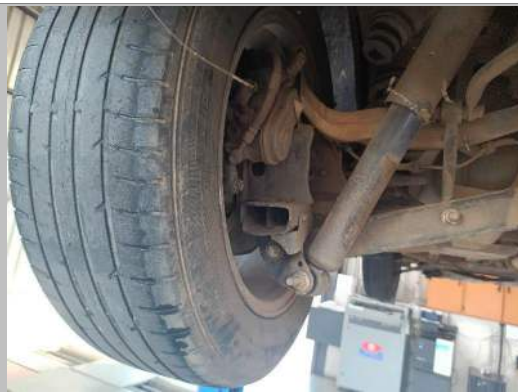
LR TYRE TREAD

| | Size | Load/Speed Index | Manufacture | Model | Type* | Production Date | Tread Depth (mm) |
|---|---|---|---|---|---|---|---|
| Rear Left | 215/60R17 | 96H | Dunlop | Sport | V | 3923 | 1 mm |

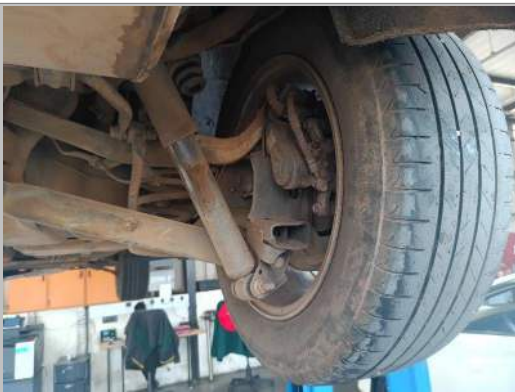
RR TYRE TREAD

| | Size | Load/Speed Index | Manufacture | Model | Type* | Production Date | Tread Depth (mm) |
|---|---|---|---|---|---|---|---|
| Rear Right | 215/60R17 | 96H | Bridgestone | Alenza | V | 3521 | 2 mm |

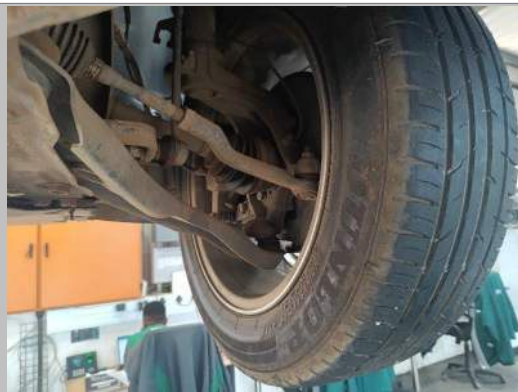
RF TYRE TREAD

| | Size | Load/Speed Index | Manufacture | Model | Type* | Production Date | Tread Depth (mm) |
|---|---|---|---|---|---|---|---|
| Front Right | 215/60R17 | 96H | Dunlop | Sport | V | 1625 | 3 mm |

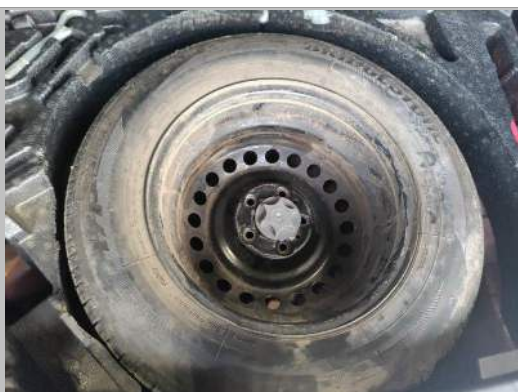
Sparewheel

| | Size | Load/Speed Index | Manufacture | Model | Type* | Production Date | Tread Depth (mm) |
|---|---|---|---|---|---|---|---|
| Spare | 215/65R16 | 98H | Bridgestone | Dueler | V | 0000 | 6 mm |

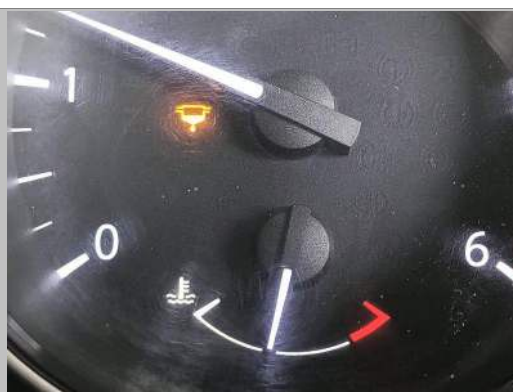
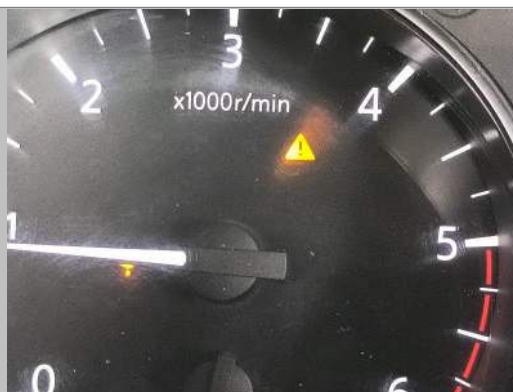
Warning lights illuminated

| No | System | Code | Description | Status |
|---|---|---|---|---|
| 1 | ENGINE | P0100:16 | AIR FLOW SENSOR CIRCUIT 1 DEF | |

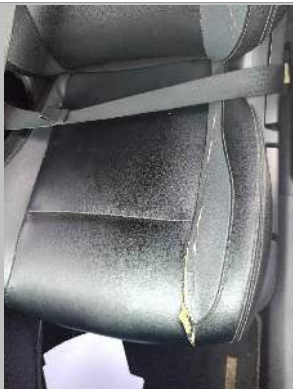
| Seat Front Left Torn / Cut | Repair |

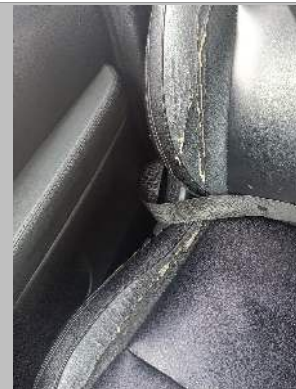
| Seat Front Right Torn / Cut | Repair |

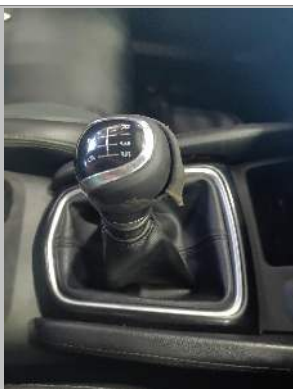
| Gear Lever Dust Boot Torn / Cut | Repair |

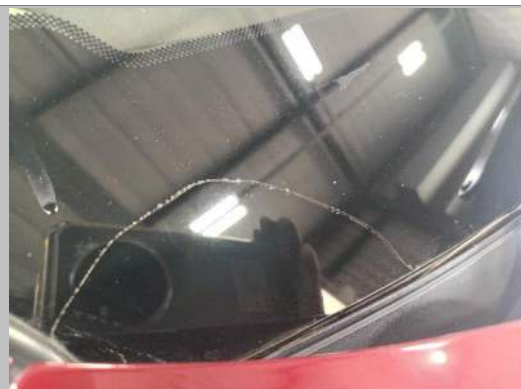
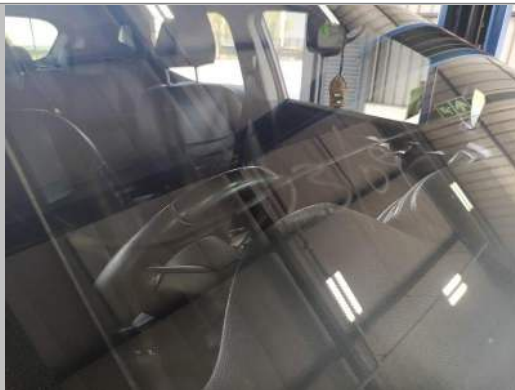
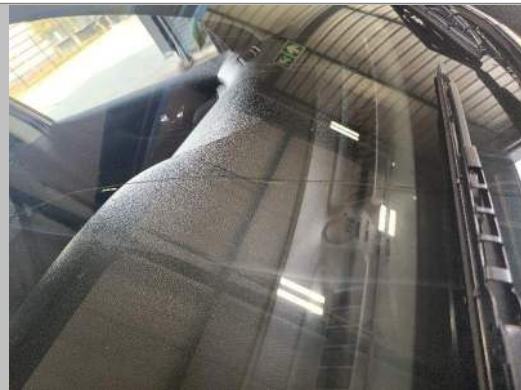
| Windscreen Cracked | Replace |

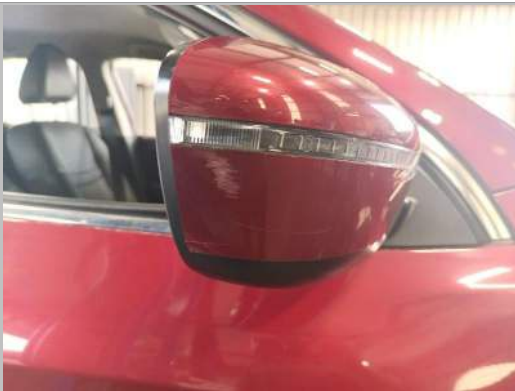
| Side Mirror Right Paintwork • Scratched | Repair |

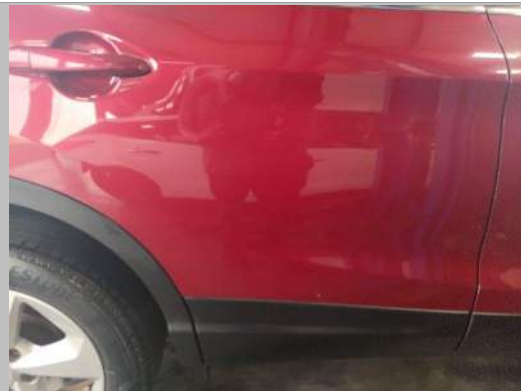
| Door Rear Right Paintwork • Scratched | Repair |

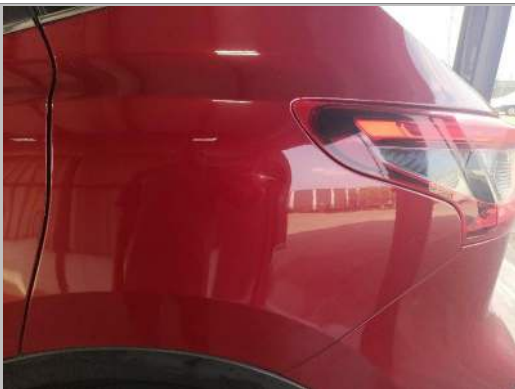
| Rear Fender Left Paintwork • Scratched | Repair |

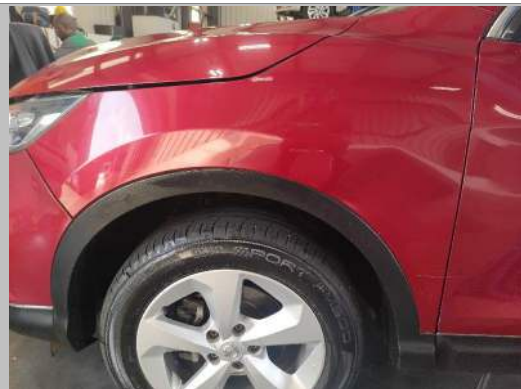
| Front Fender Left Dented | Repair |

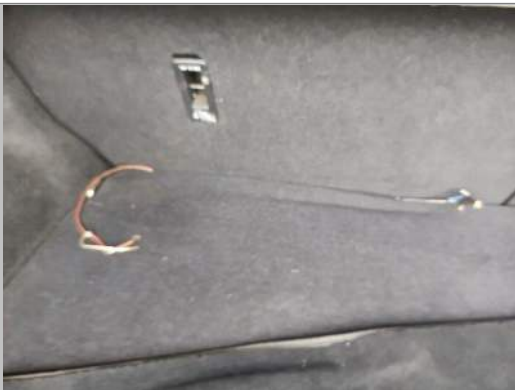
| Wiring connections Defective | Repair |

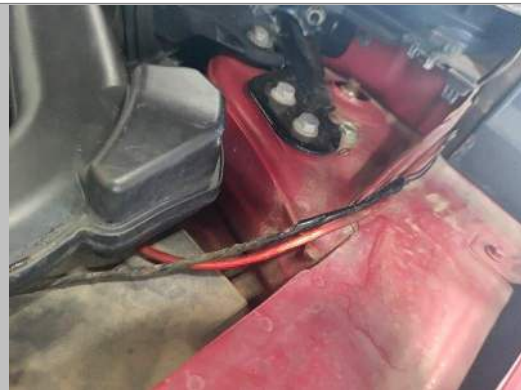
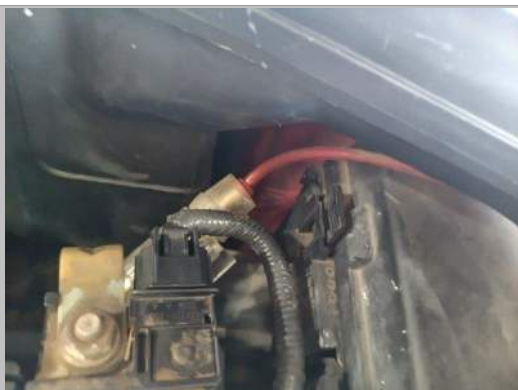
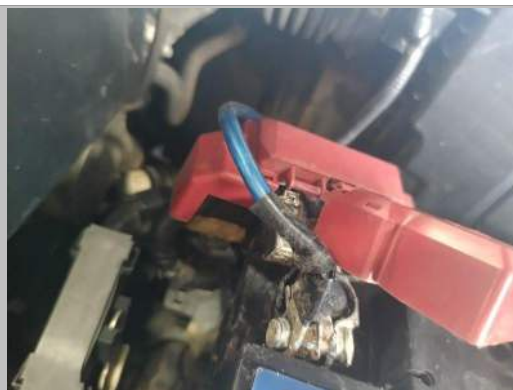
| Engine Wiring Defective | Repair |

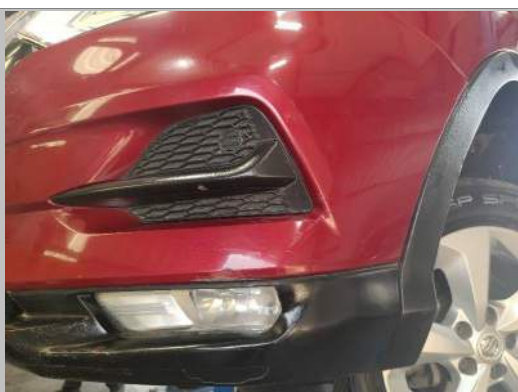
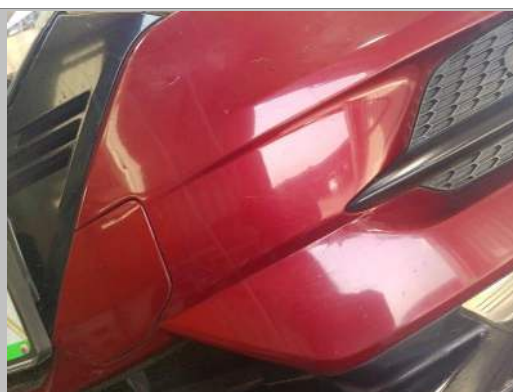
| Front Bumper Paintwork • Scratched | Repair |

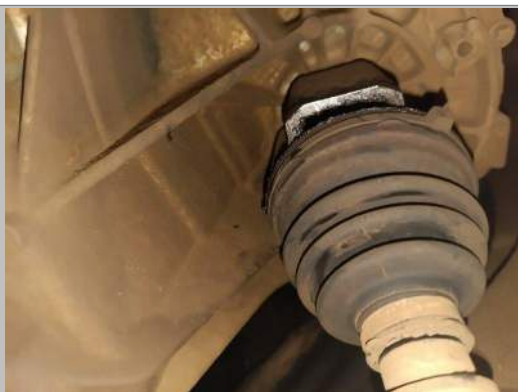
| CV Joint(s) Boot(s) Front Left (inner/outer) Damaged | Replace |

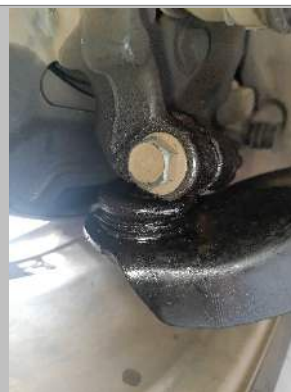
| Ball Joint(s) Front Axle Left Damaged | Replace |
