## CONDITION REPORT

Report No:  
2017296940  
DATE  
10/09/2026

| Manufacturer | RENAULT | Registration Number | DM69SGGP |
| Model | CLIO IV 0.9 TURBO DYNAMIQUE 5-DR [2013-2017] | Register Number | |

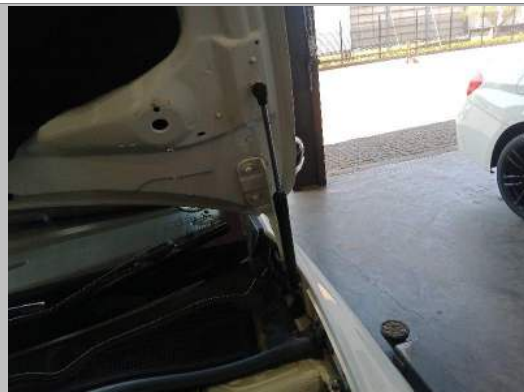
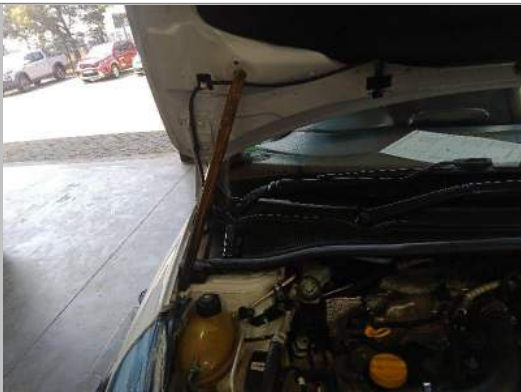
| Bonnet stay and shocks Defective | Repair |

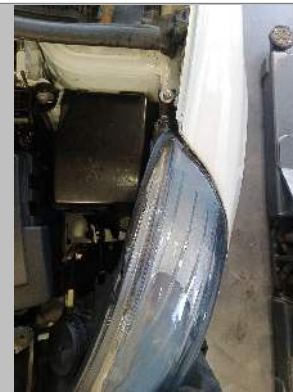
| Headlight Left Damaged | Repair |

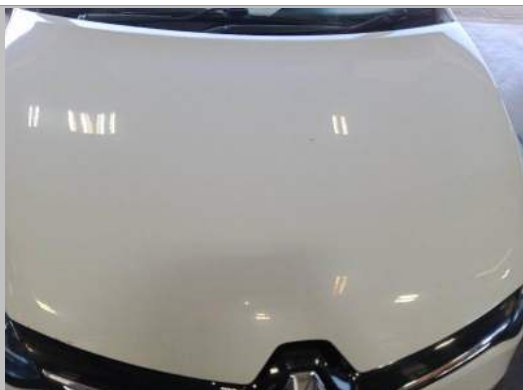
| Bonnet Paintwork • Scratched | Repair |

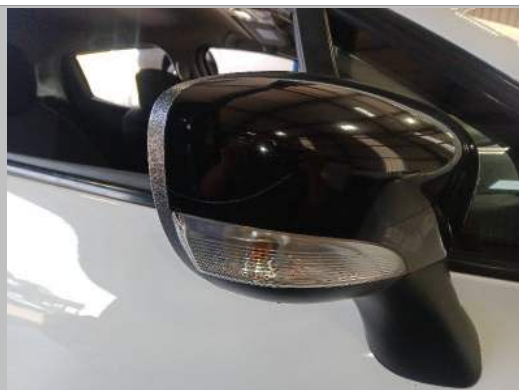
| Side Mirror Right Paintwork • Scratched | Repair |

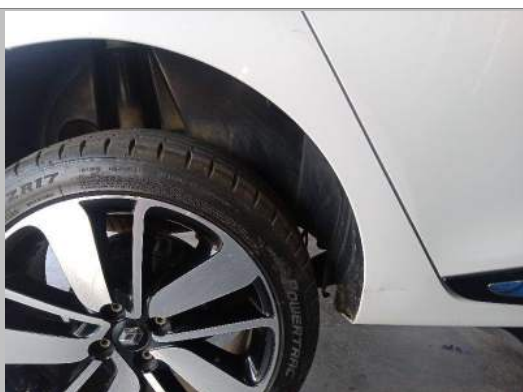
| Rear Fender Right Dented | Repair |

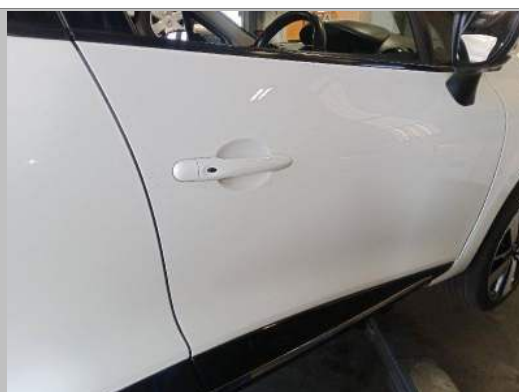
| Door Front Right Paintwork • Scratched | Repair |

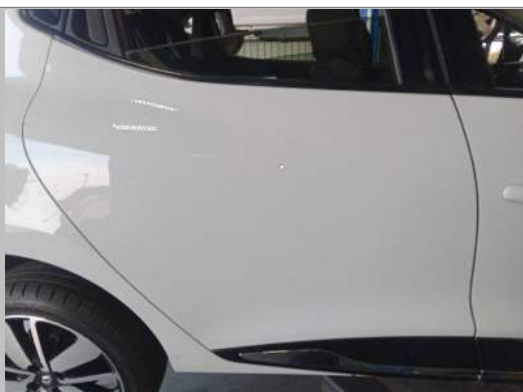
| Door Rear Right Paintwork • Scratched | Repair |

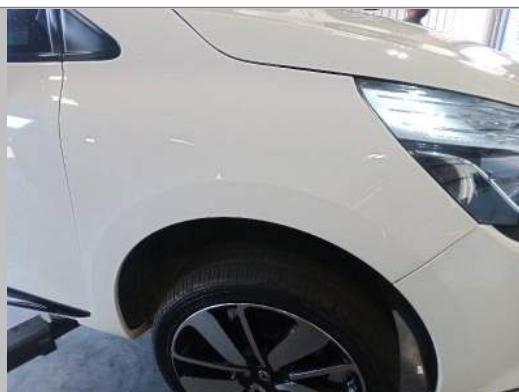
| Front Fender Right Paintwork • Scratched | Repair |

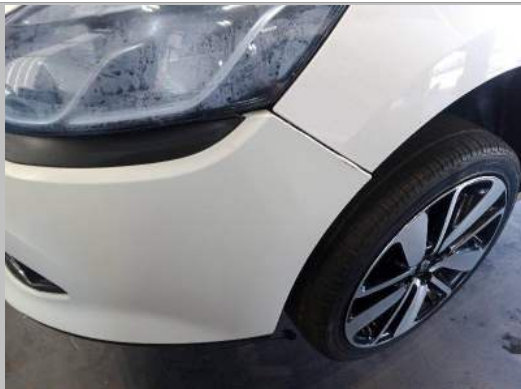
| Front Bumper Paintwork • Scratched | Repair |

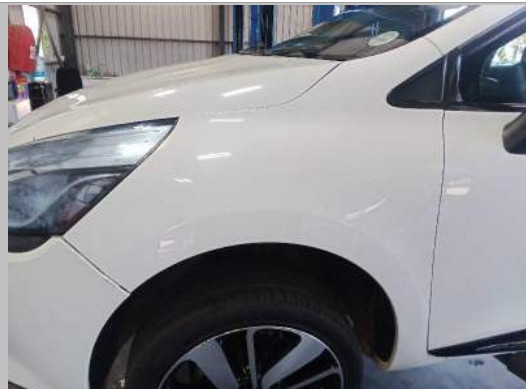
| Front Fender Left Paintwork • Chipmarks | Repair |

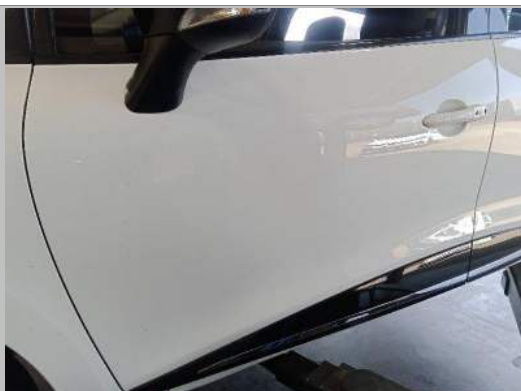
| Door Front Left Paintwork • Chipmarks | Repair |

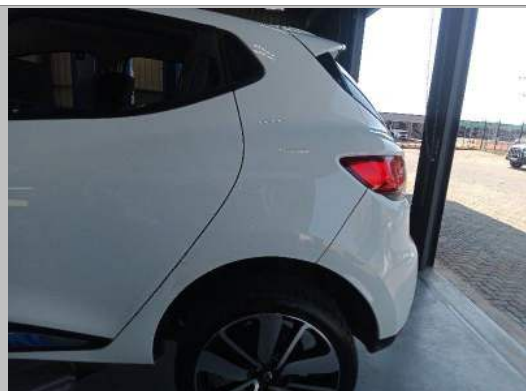
| Rear Fender Left Paintwork • Scratched | Repair |

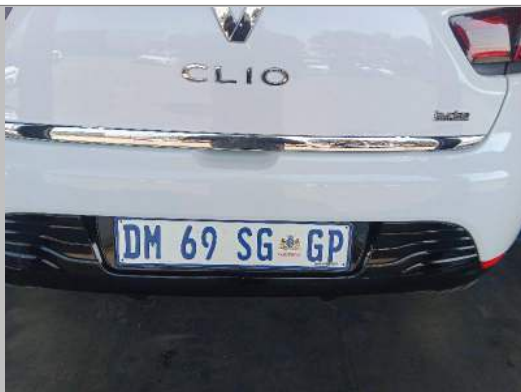
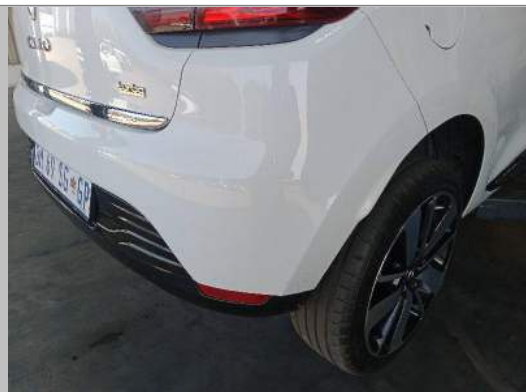
| Rear bumper Paintwork • Scratched | Repair |

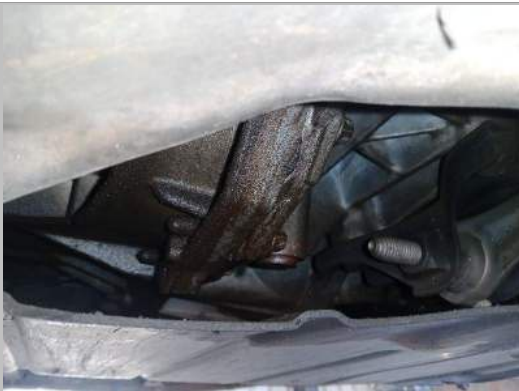
| Gearbox Oil Leak | Repair |

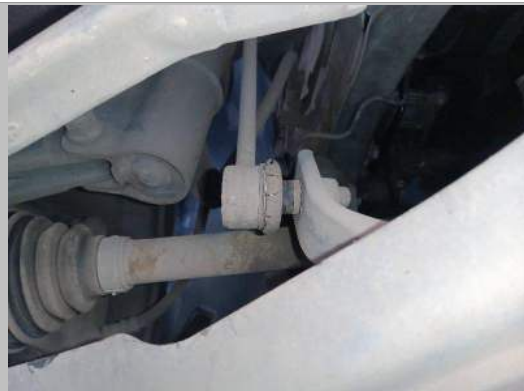
| Stabilizer Mounting Front Left Damaged | Replace |

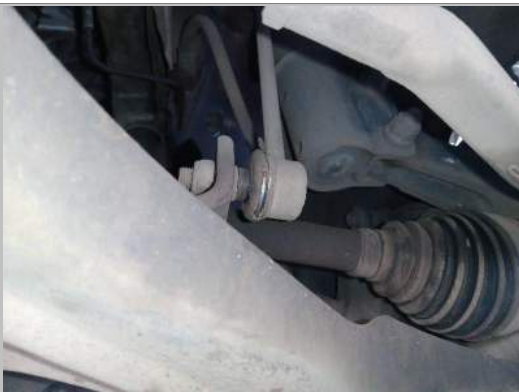
| Stabilizer Mounting Front Right Damaged | Replace |
