## CONDITION REPORT

Report No:  
2017296281  
DATE  
09/09/2026

MFC Auction House  
M57 Pretoria Rd, Glenmarais, KEMPTON PARK  
Gauteng

| Manufacturer | RENAULT | Registration Number | HD95NTGP |

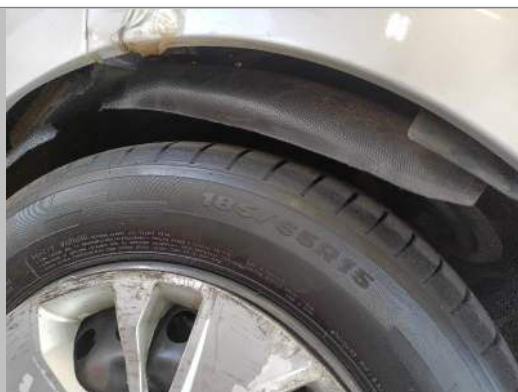
LEFT FRONT FENDER LINER LOOSE

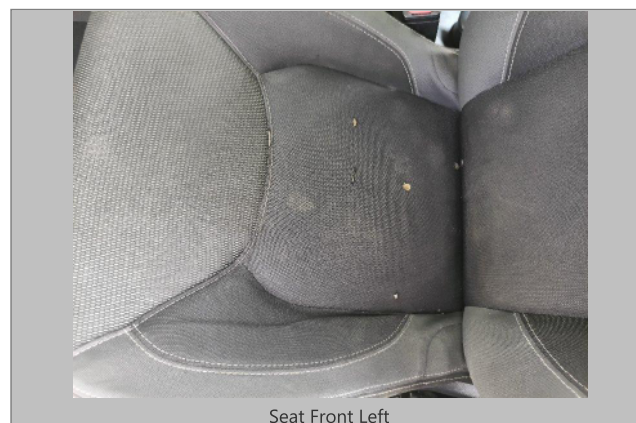
| Seat Front Left Torn / Cut | Repair |

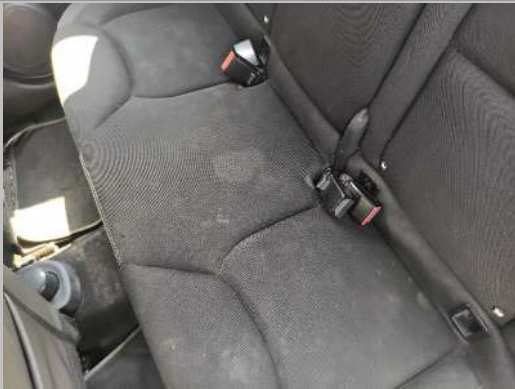
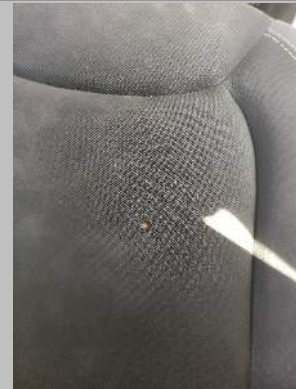
| Seat Rear Torn / Cut | Repair |

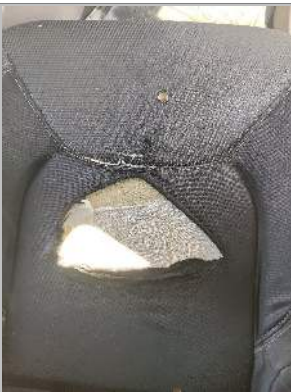
| Seat Front Right Torn / Cut | Repair |

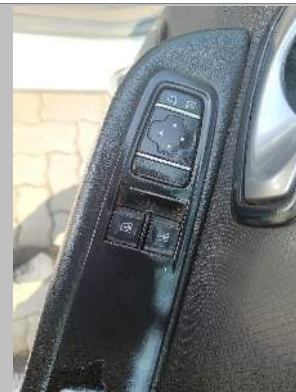
| Switch Electrical Window Winder front right Defective | Repair |
| R/F electric window not working | Repair |

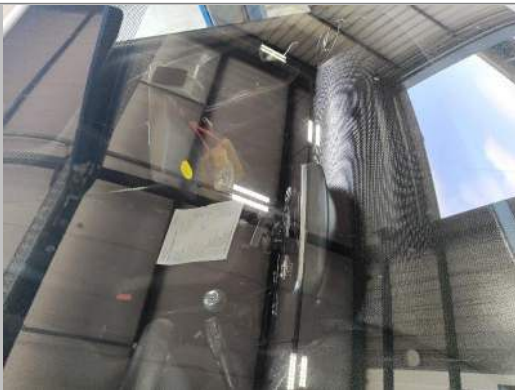
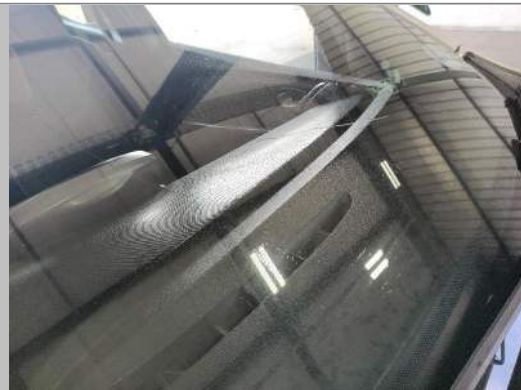
| Windscreen Cracked | Replace |

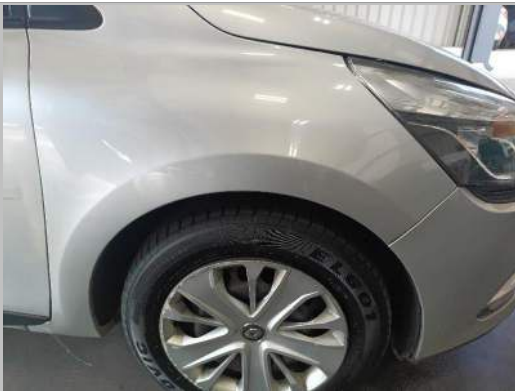
| Front Fender Right Paintwork • Scratched | Repair |

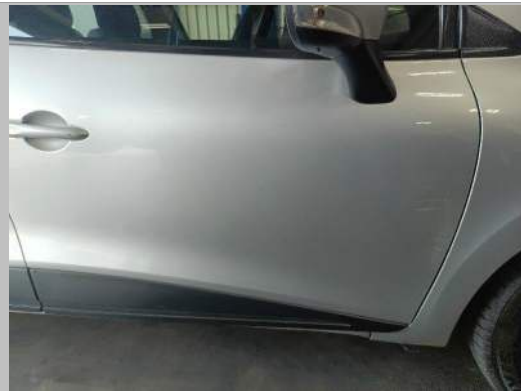
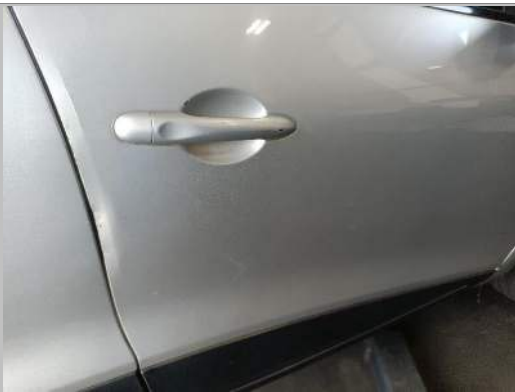
| Door Front Right Paintwork • Scratched | Repair |

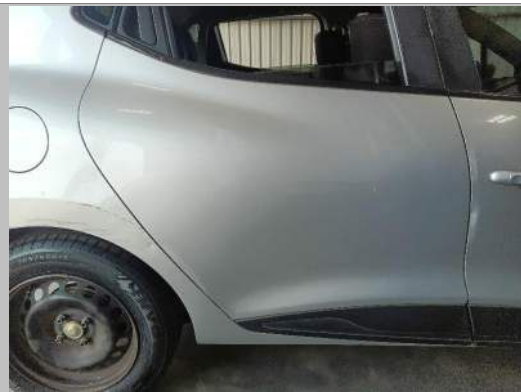
| Door Rear Right Paintwork • Scratched | Repair |

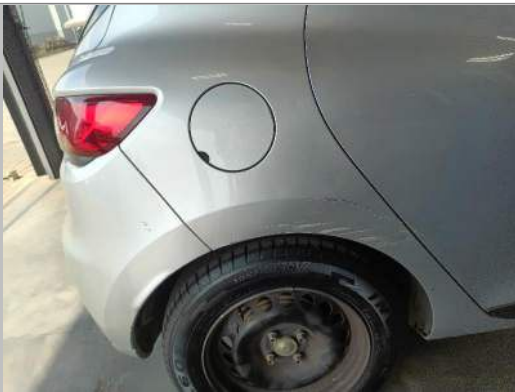
| Rear Fender Right Paintwork • Scratched | Repair |

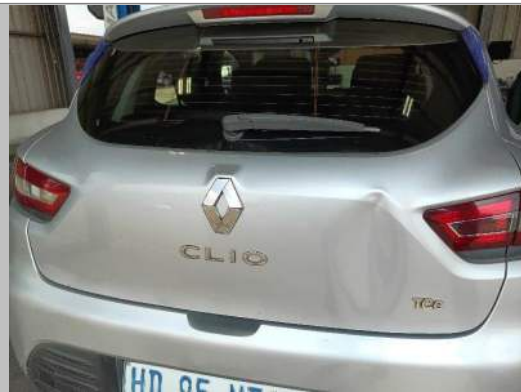
| Boot Lid / Hatch door Dented | Repair |

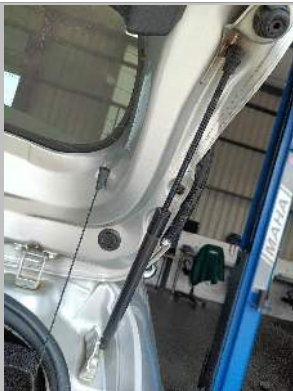
| Boot Lid / Hatch Door Shock Right Defective | Replace |

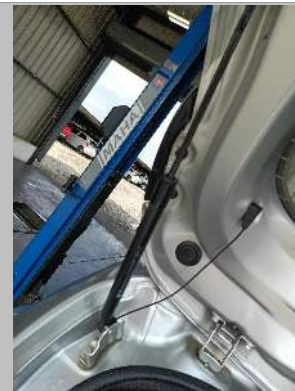
| Boot Lid / Hatch Door Shock Left Defective | Replace |

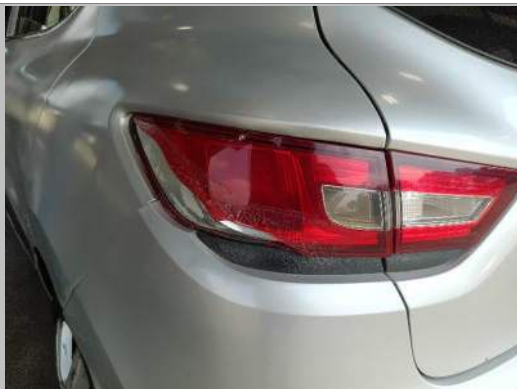
| Tail Light Left Damaged | Replace |

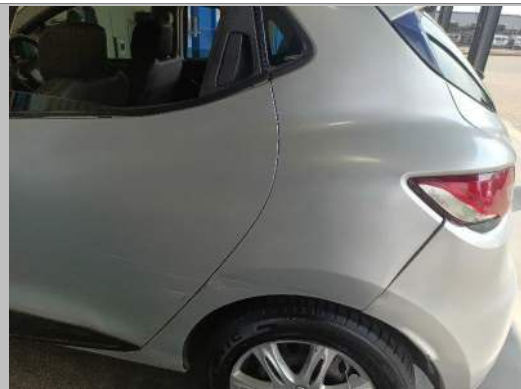
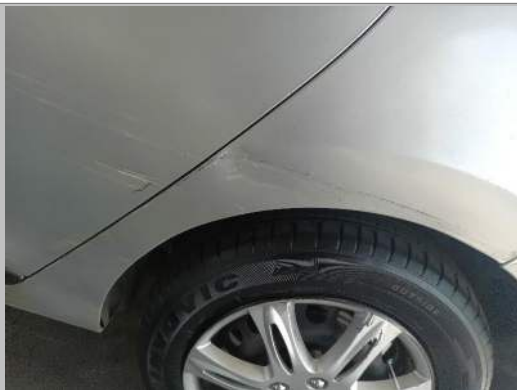
| Rear Fender Left Residual Traces of Repair | Repair |

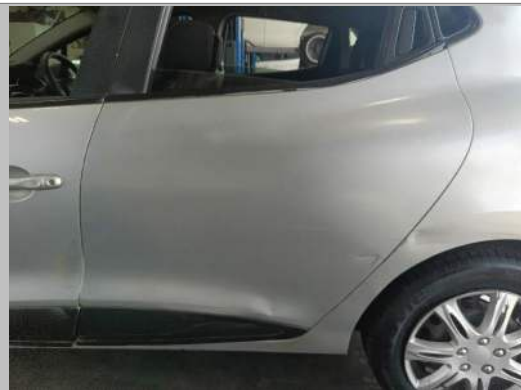
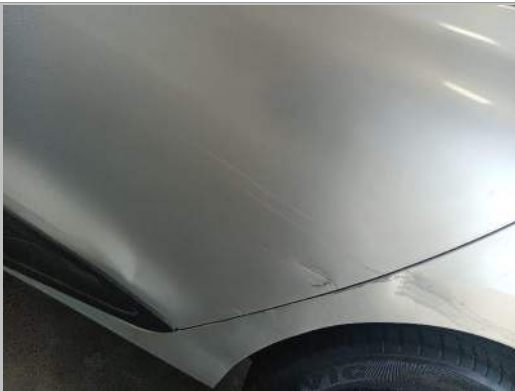
| Door Rear Left Residual Traces of Repair | Repair |

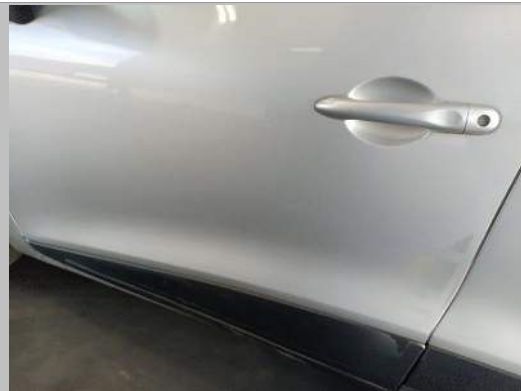
| Door Front Left Paintwork • Scratched | Repair |

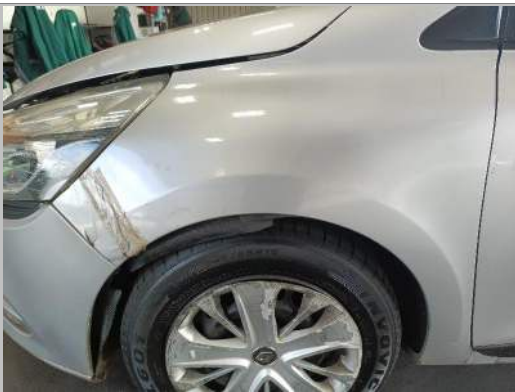
| Front Fender Left Residual Traces of Repair | Repair |

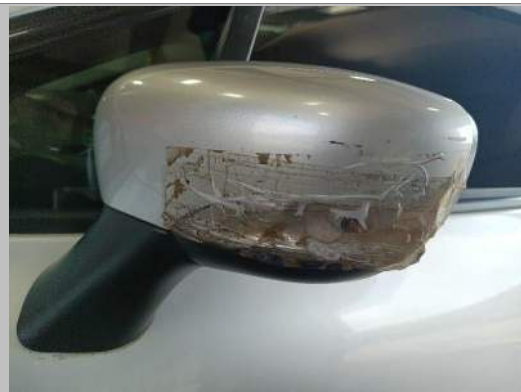
| Side Mirror Left Damaged | Repair |

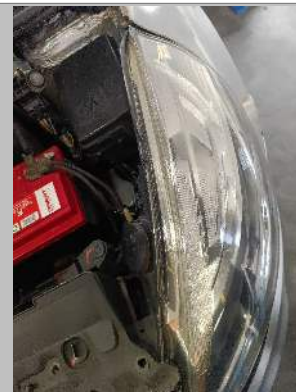
| Headlight Left Damaged | Replace |

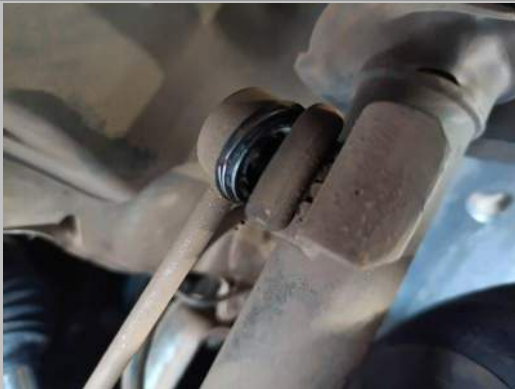
| Stabilizer Mounting Front Right Damaged | Replace |
| Front suspension excessive knocking noise | Repair |

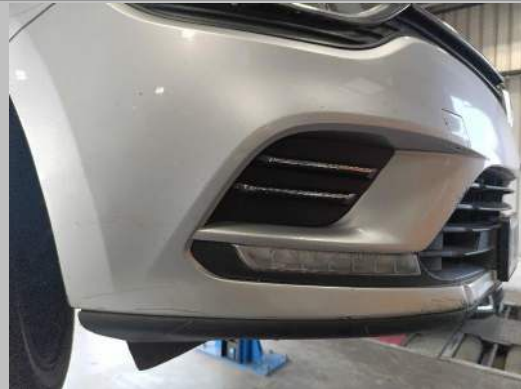
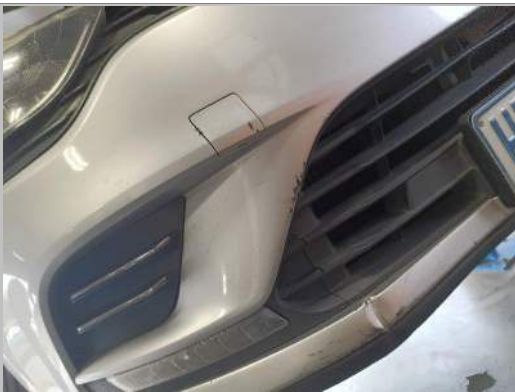
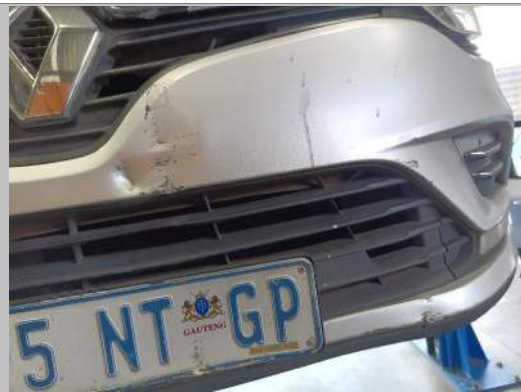
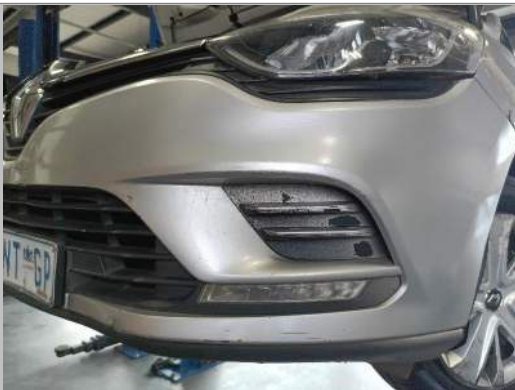
| Front Bumper Paintwork • Scratched | Repair |

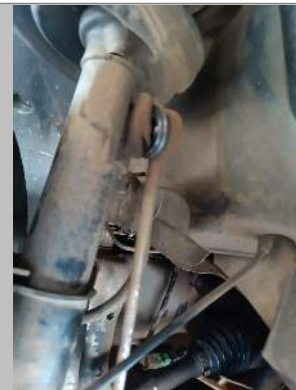
| Stabilizer Mounting Front Left Damaged | Replace |

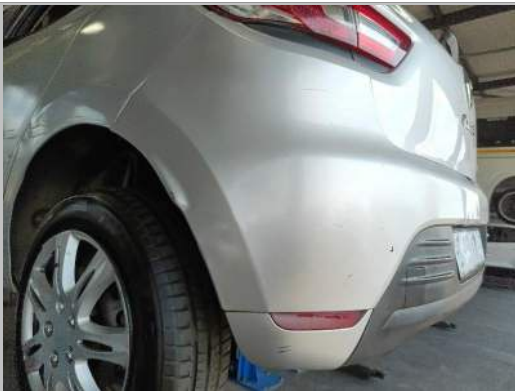
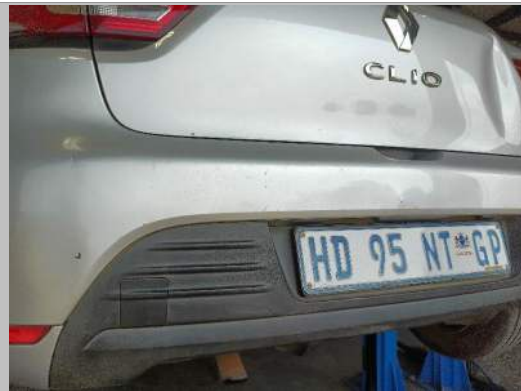
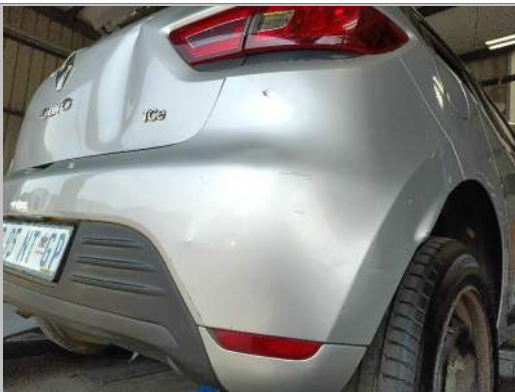
| Rear bumper Paintwork • Scratched | Repair |

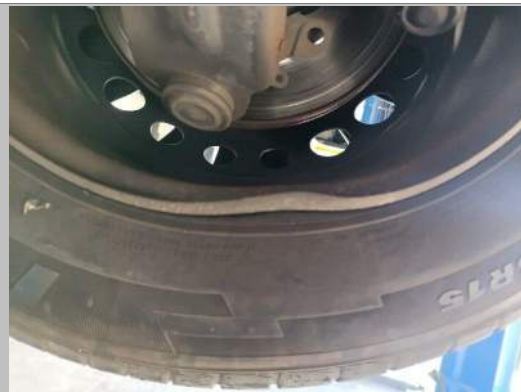
| Rim Front Right Deformed | Repair |

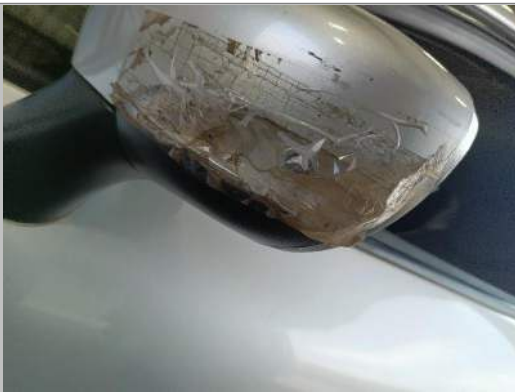
| Indicator Light Front Left Damaged | Replace |
