## CONDITION REPORT

Report No:  
2017296582  
DATE  
09/09/2026

| Manufacturer | RENAULT | Registration Number | HG40PVGP |
| Model | KADJAR | Register Number | |

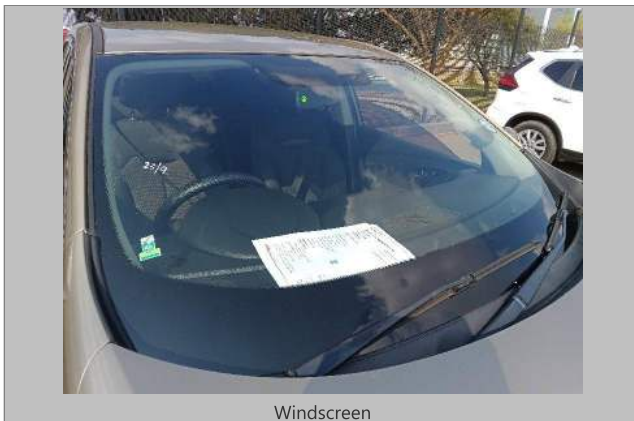
| Windscreen Chipped | Repair |

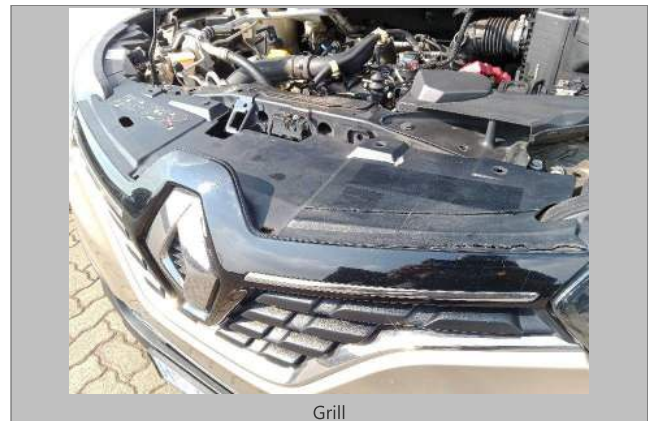
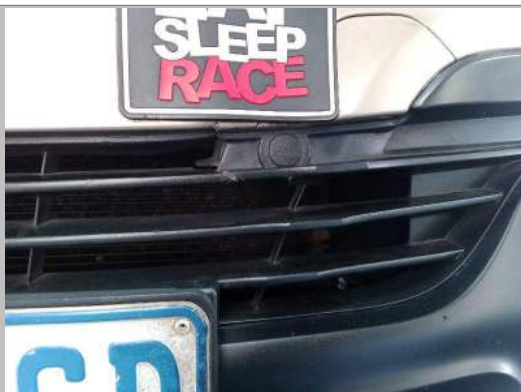
| Grill Damaged | Replace |

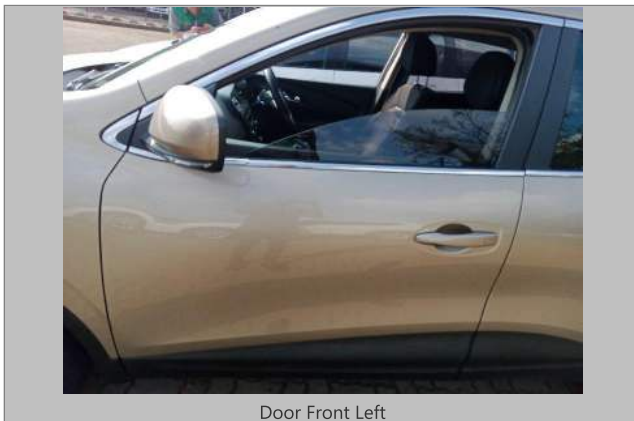
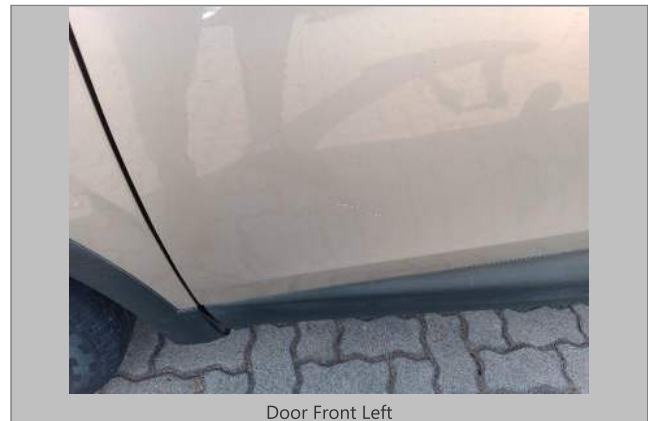
| Door Front Left Paintwork • Scratched | Repair |

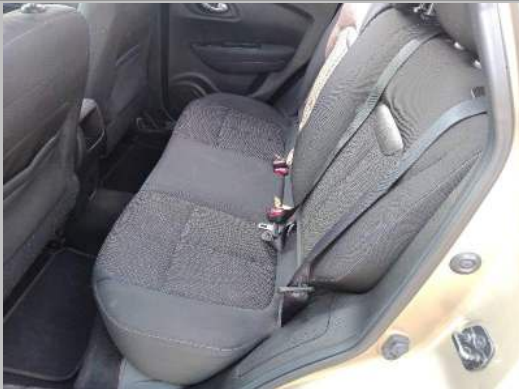
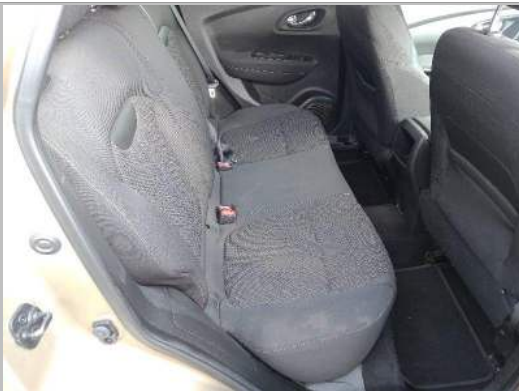
| Seat Rear Dirty | Repair |

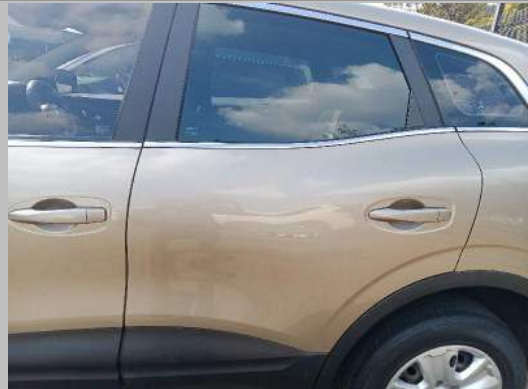
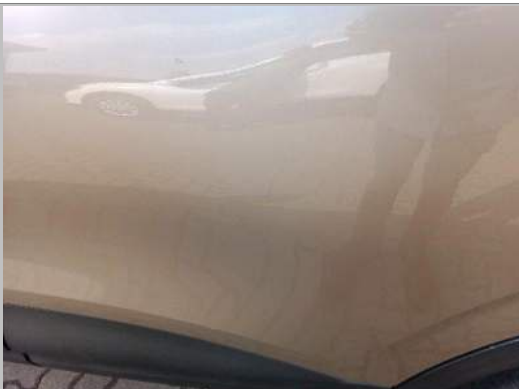
| Door Rear Left Paintwork • Scratched | Repair |

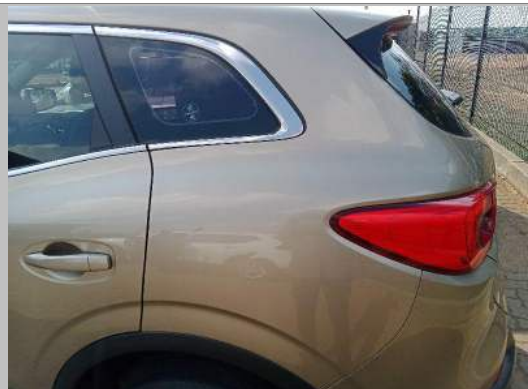
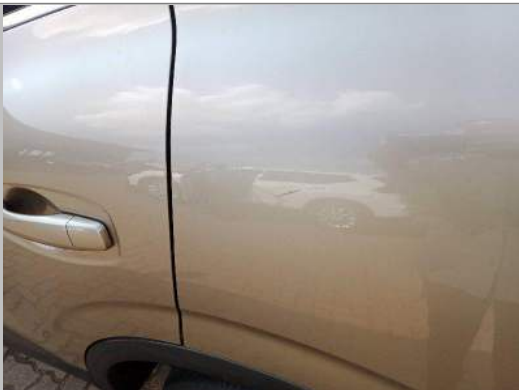
| Rear Fender Left Paintwork • Scratched | Repair |

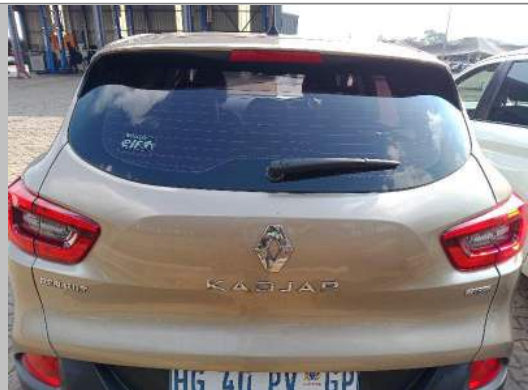
| Boot Lid / Hatch door Dented | Repair |

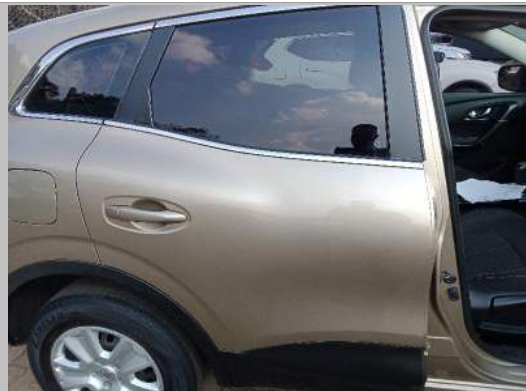
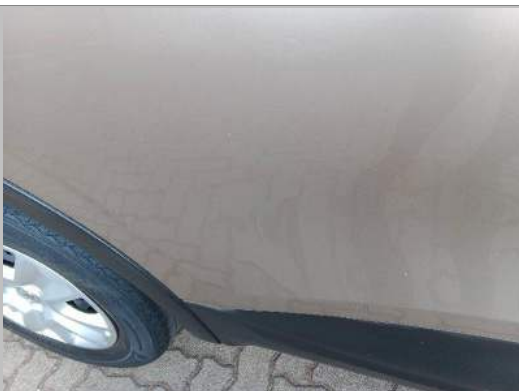
| Door Rear Right Paintwork • Scratched | Repair |

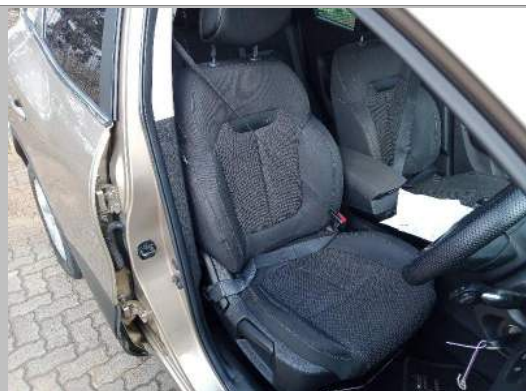
| Seat Front Right Damaged | Repair |

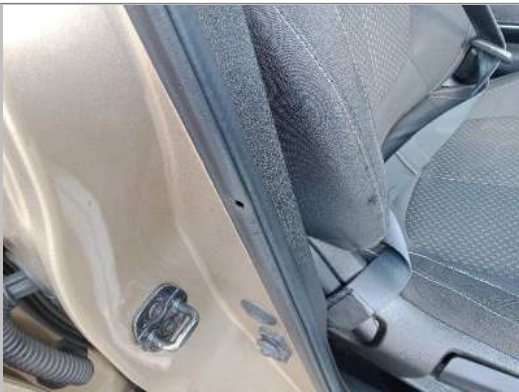
| Door Sealing Rubber Front Right Torn / Cut | Replace |

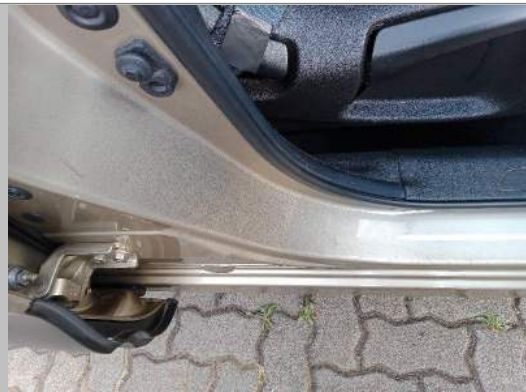
| B • Pillar Right Paintwork • Scratched | Repair |

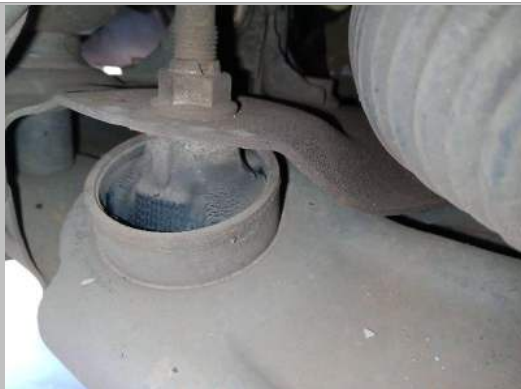
| Control Arm Bush(es) Front Axle Right Cracked | Replace |

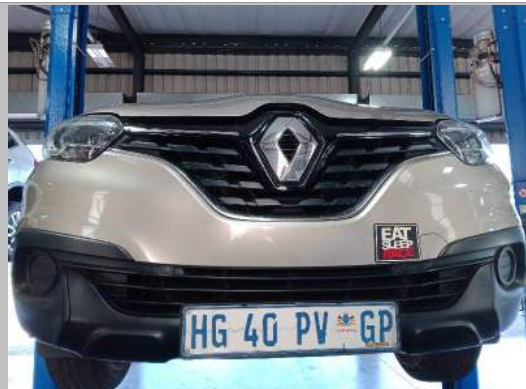
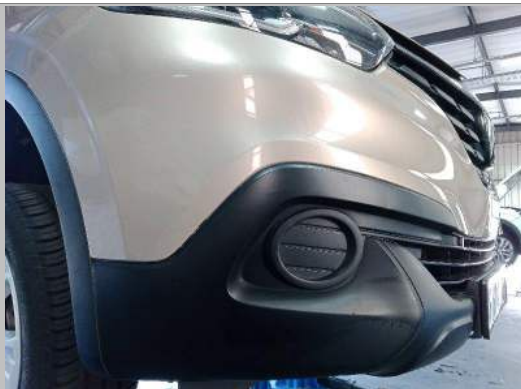
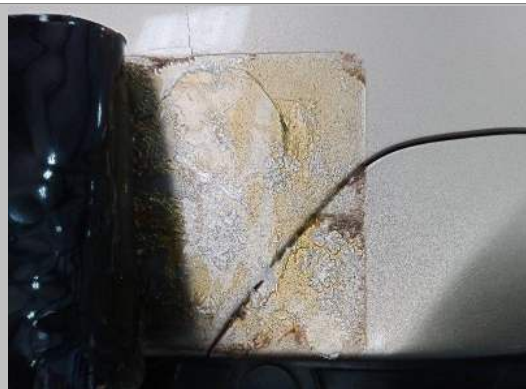
| Front Bumper Damaged | Repair |

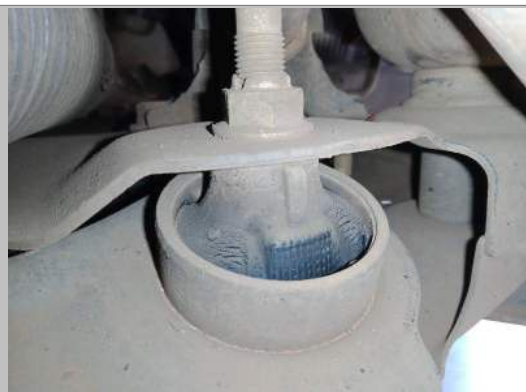
| Control Arm Bush(es) Front Axle Left Cracked | Replace |

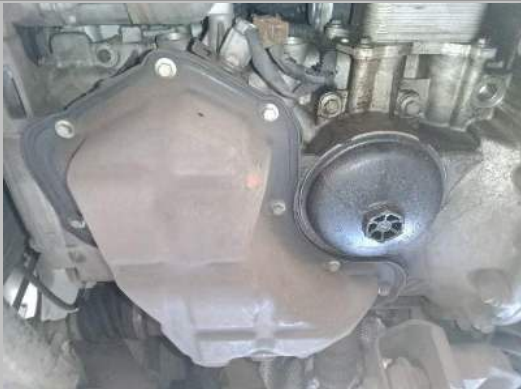
| Engine Oil Leak | Repair |

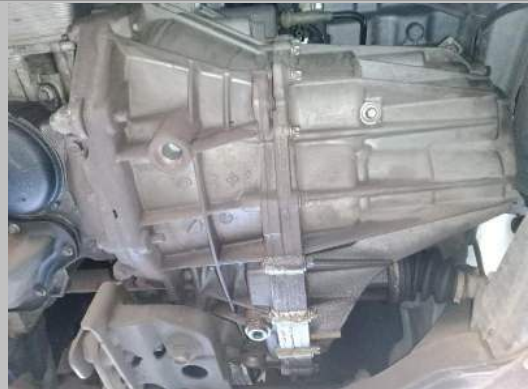
| Gearbox Oil Leak | Repair |

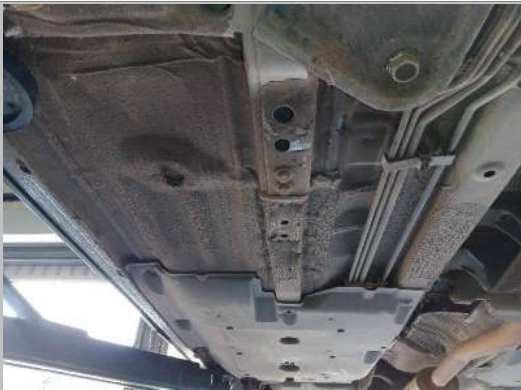
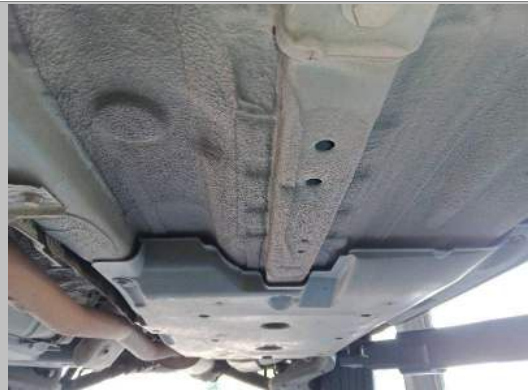
| Chassis Damaged | Repair |

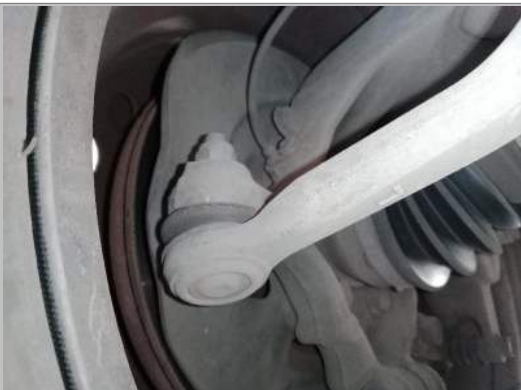
| Tie Rod End left Cracked | Replace |

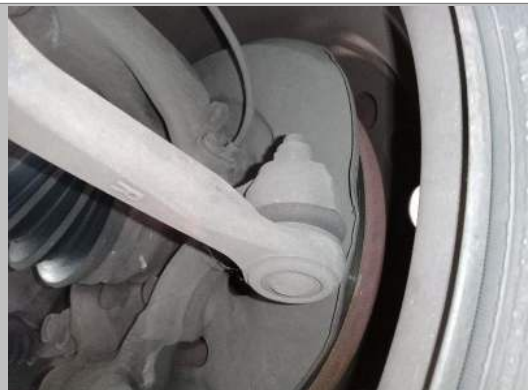
| Tie Rod End right Cracked | Replace |

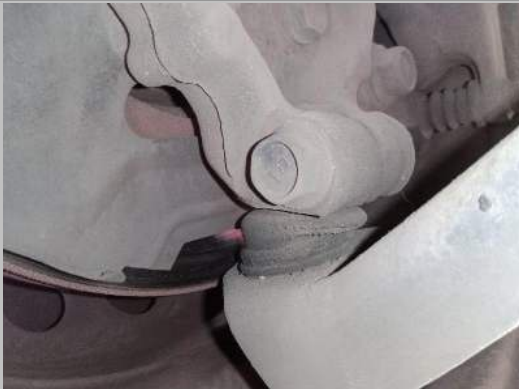
| Ball Joint(s) Front Axle Left Cracked | Replace |

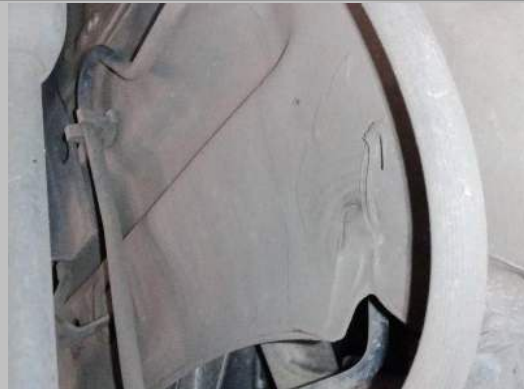
| Main Beam Left Damaged | Repair |

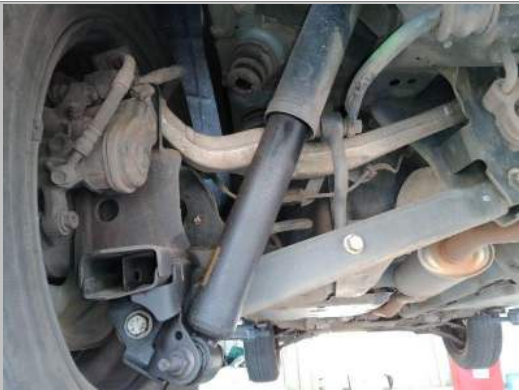
| Shock Absorber Rear Left Leak | Replace |

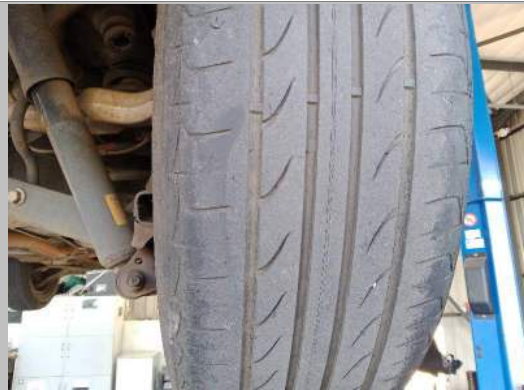
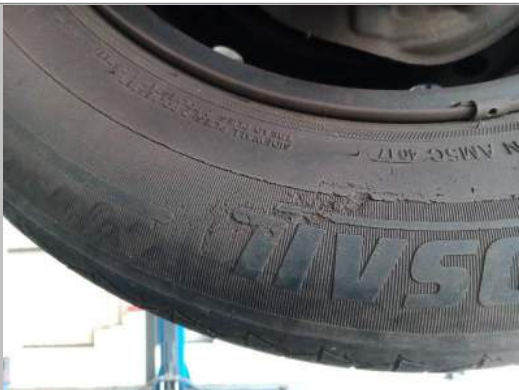
| Tyre Rear Right Damaged | Replace |

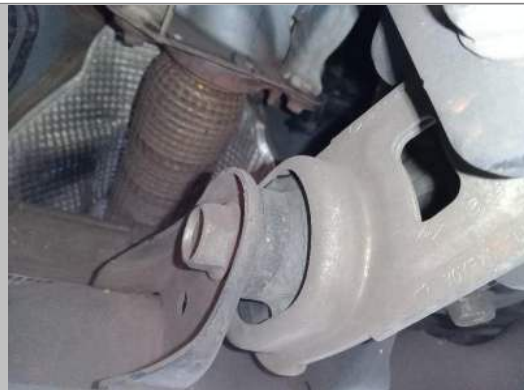
| Gearbox Mountings Cracked | Replace |

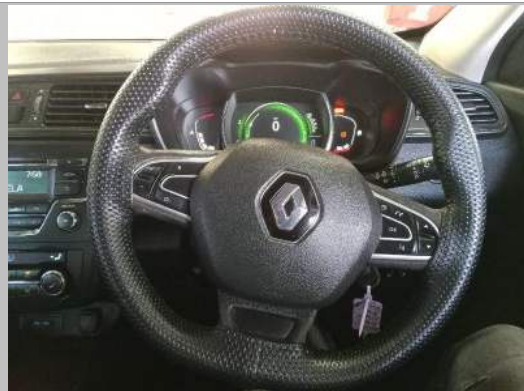
| Steering Wheel Trim Excessive Wear & Tear | Repair |

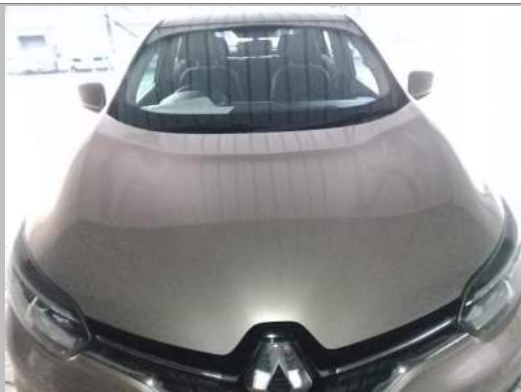
| Bonnet Dented | Repair |
