## CONDITION REPORT

Report No:  
2017293979  
DATE  
03/09/2026

| Manufacturer | OPEL | Registration Number | LBR738NW |
| Model | CORSA 1.2 EDITION 5-DR [2021-2022] | Register Number | |

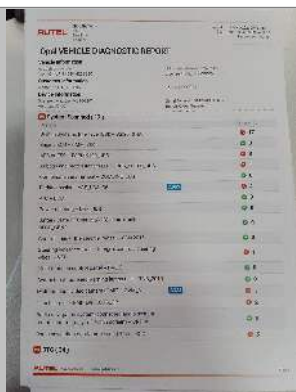
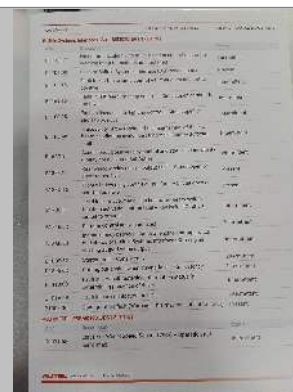
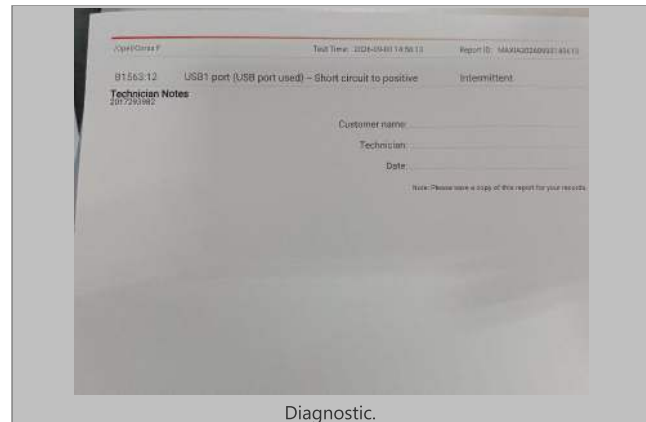
Diagnostic.

| No | System | Code | Description | Status |
|---|---|---|---|---|
| 1 | BUILT-IN SYSTEMS LNTERFACE | U1F3B:87 | NO COMMUNICATION WITH MULTIFUNCTIONING CONTROL<br>UNI | |

General Comments: ACCORDING TO THE AGE AND MILEAGE OF THE VEHICLE, NORMAL WEAR AND TEAR MARKS ARE VISIBLE ON THE EXTERIOR AND INTERIOR ELECTRICAL AND MECHANICAL PARTS.34 DTC'S AT THE TIME OF TESTING; SEE DTC REPORT.Engine Compartment: micro cracks visible in timing belt, timing belt needs to be replaced.

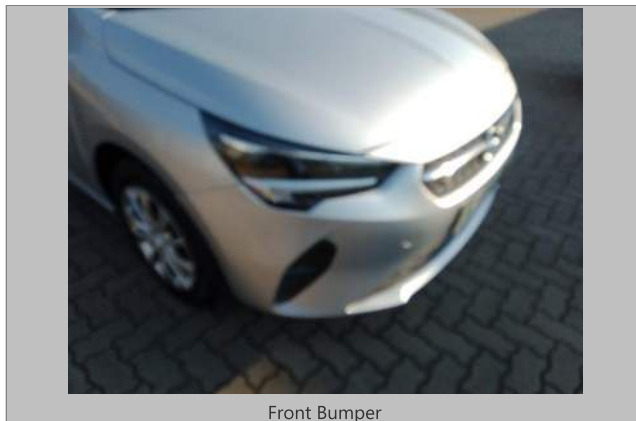
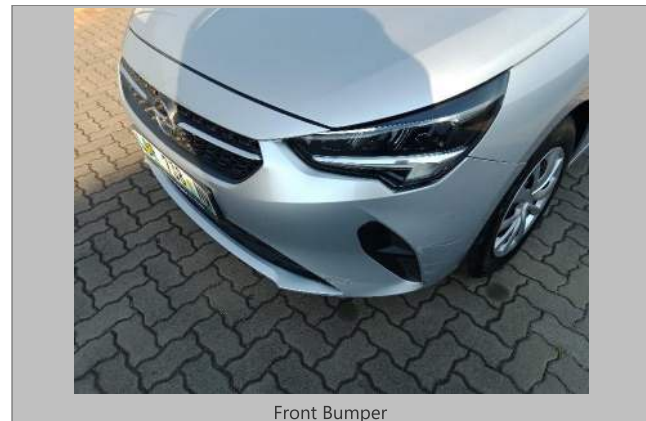
| Damage | Repair Way |
|---|---|
| Front Bumper Damaged | Repair |

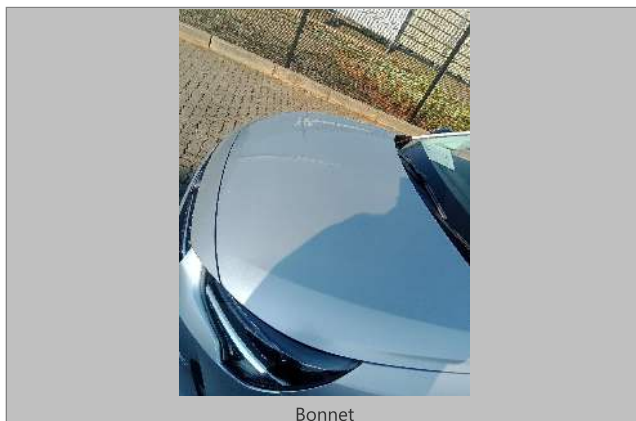
| Damage | Repair Way |
|---|---|
| Bonnet Damaged | Repair |

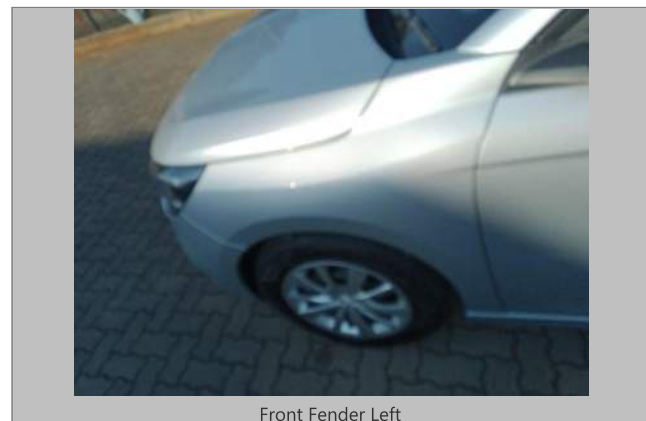
| Damage | Repair Way |
|---|---|
| Front Fender Left Damaged | Repair |

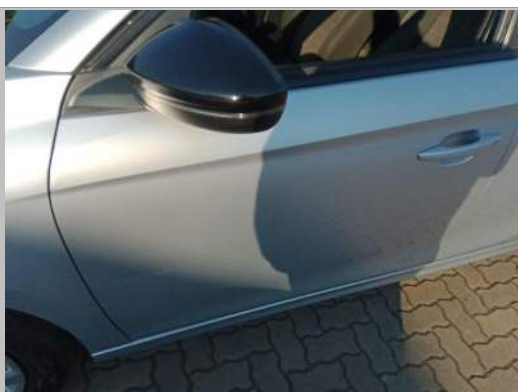
| Damage | Repair Way |
|---|---|
| Door Front Left Damaged | Repair |

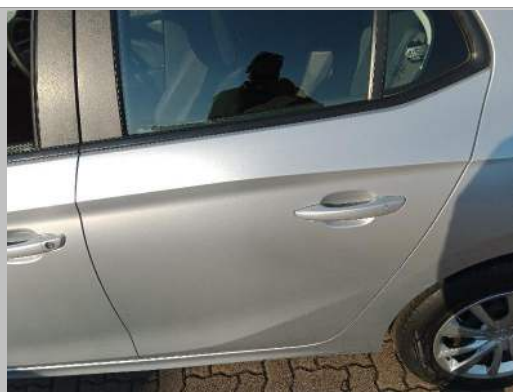
| Damage | Repair Way |
|---|---|
| Door Rear Left Damaged | Repair |

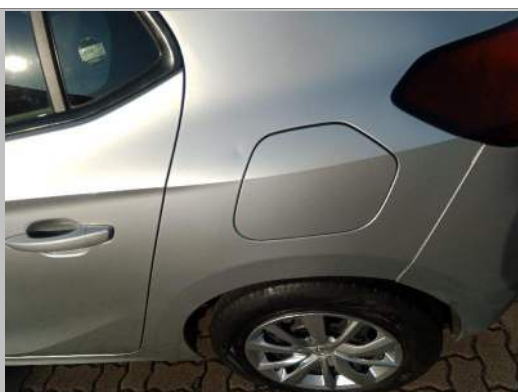
| Damage | Repair Way |
|---|---|
| Rear Fender Left Damaged | Repair |

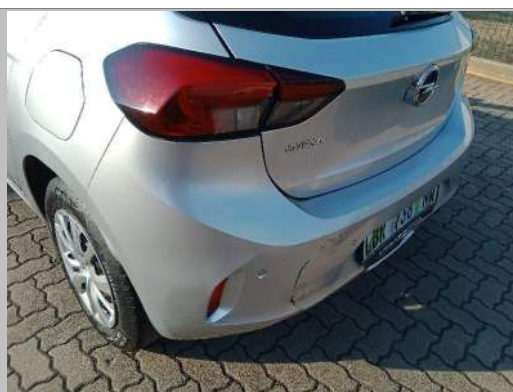
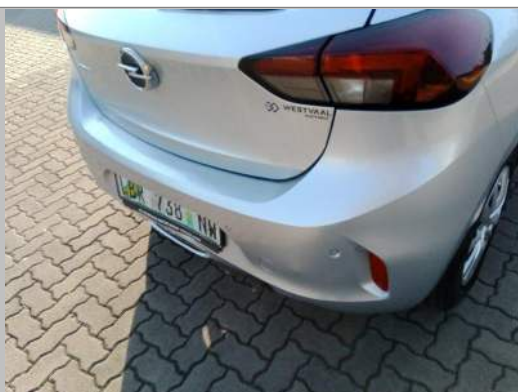
| Damage | Repair Way |
|---|---|
| Rear bumper Damaged | Repair |

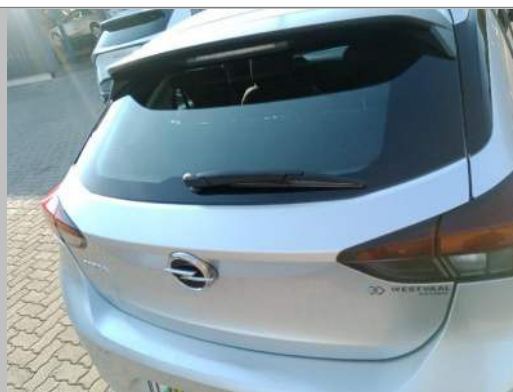
| Damage | Repair Way |
|---|---|
| Boot Lid / Hatch door Damaged | Repair |

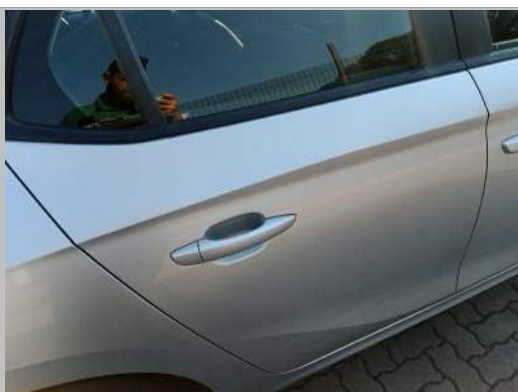
| Damage | Repair Way |
|---|---|
| Door Rear Right Damaged | Repair |

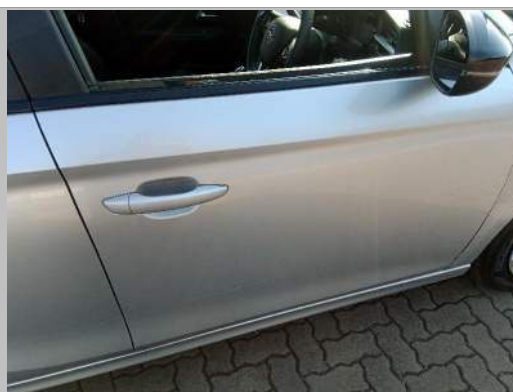
| Damage | Repair Way |
|---|---|
| Door Front Right Damaged | Repair |

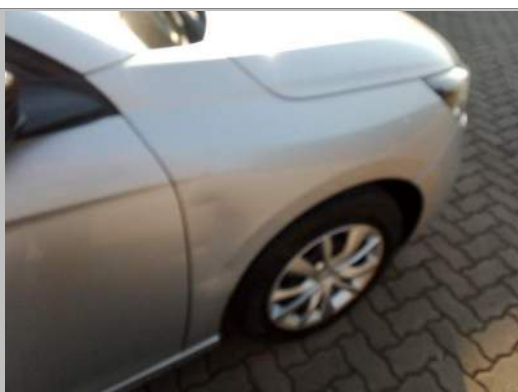
| Damage | Repair Way |
|---|---|
| Front Fender Right Damaged | Repair |

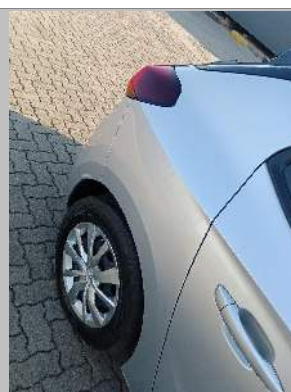
| Damage | Repair Way |
|---|---|
| Rear Fender Right Damaged | Repair |

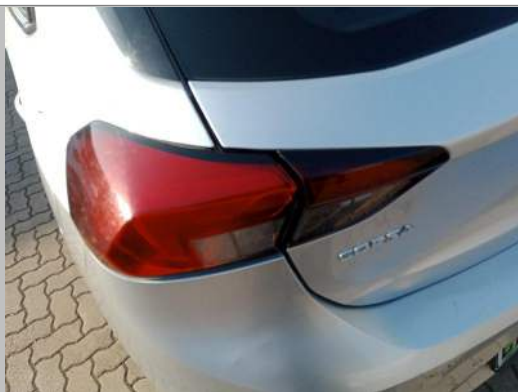
| Damage | Repair Way |
|---|---|
| Tail Light Left Damaged | Replace |

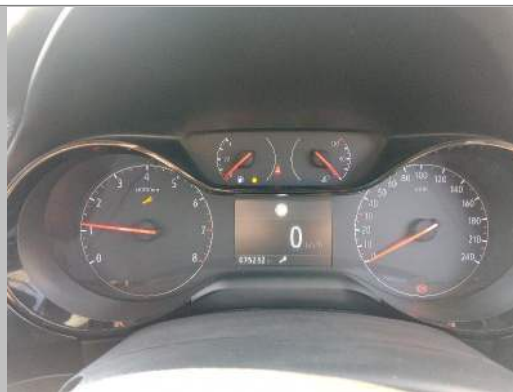
| Damage | Repair Way |
|---|---|
| Engine Management Lights Set | Repair |

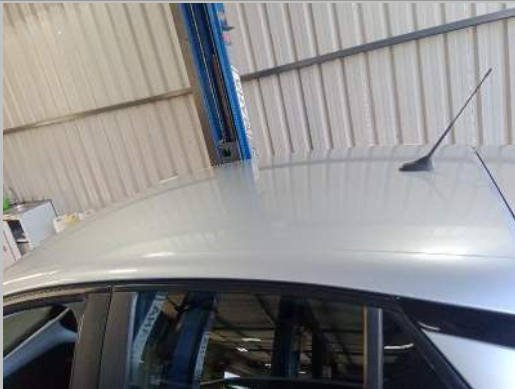
| Damage | Repair Way |
|---|---|
| Roof Damaged | Repair |

Vehicle body in poor condition. Signs of hail damage to some body panels.

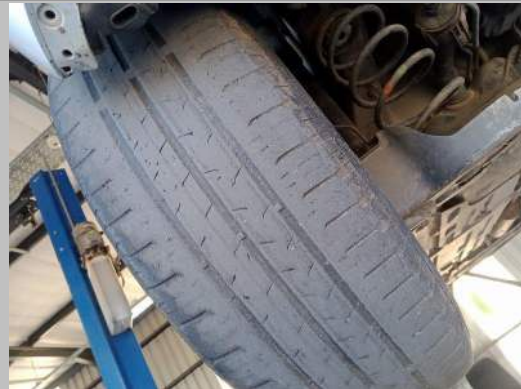
| Damage | Repair Way |
|---|---|
| Tyre Rear Left Worn | Replace |

| | Size | Load/Speed Index | Manufacture | Model | Type* | Production Date | Tread Depth (mm) |
|---|---|---|---|---|---|---|---|
| Rear Left | 185/65R15 | 88H | Continental | Eco | V | 1622 | 0 mm |

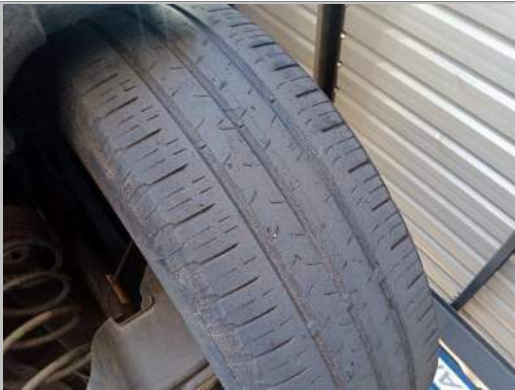
| Damage | Repair Way |
|---|---|
| Tyre Rear Right Worn | Replace |

| | Size | Load/Speed Index | Manufacture | Model | Type* | Production Date | Tread Depth (mm) |
|---|---|---|---|---|---|---|---|
| Rear Right | 185/65R15 | 88H | Continental | Eco | V | 1222 | 2 mm |
