CONDITION REPORT

Report No:
2016972411
DATE
07/08/2025

Vehicle Type	PASSENGER VEHICLE	Registered Owner	
Manufacturer	AUDI	Registration Number	DV49SHGP
Model	A6 2.0T FSI MULTITRONIC [2014-2015]	Register Number	
VIN	WAUZZZ4G4EN203974	Date Of First Licensing	
Engine Number		Last COR	
Doors	4	License Expiry Date	30/11/2022
Color	GREY	Power / Displacement	
Year Model	2015	Paint Finish	TWO COAT METALLIC
Km Reading	217,680 KM	Fuel	PETROL
Cab / Body Type	SEDAN	Transmission	AUTOMATIC

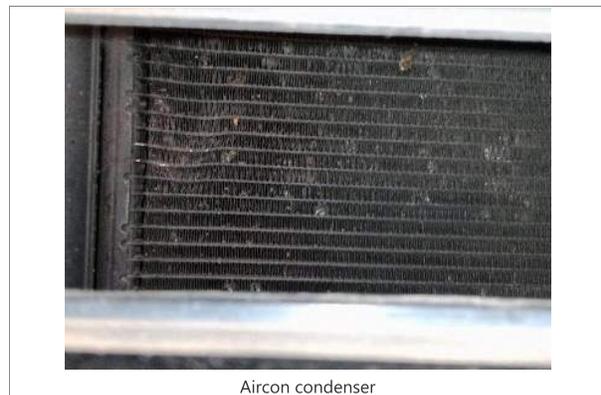
Control Arm Bush(es) Front Axle Left Cracked	Replace
Control Arm Bush(es) Front Axle Right Cracked	Replace
Tyre Front Left Worn	Replace
Tyre Front Right Damaged	Replace
Tyre Rear Left Damaged	Replace
Tyre Rear Right Damaged	Replace
Spare Tyre Damaged	Replace
Rim Front Left Scratched	Repair
Rim Rear Left Scratched	Repair
Rim Rear Right Scratched	Repair
Sub Frame Dented	Repair
Belly plates Damaged	Replace
Gearbox Oil Sweat	Repair
Engine Performance Idling / Hunting	Repair
Gear Selections Slippy Hesitation	Repair
Warning lights illuminated on dashboard	Repair
Foreign substance on oil cap	Repair
Aircon condenser dented	Repair
Front left and right tyre sizes different	Replace

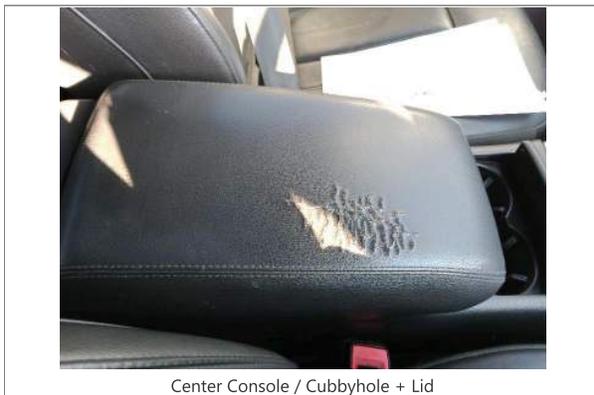
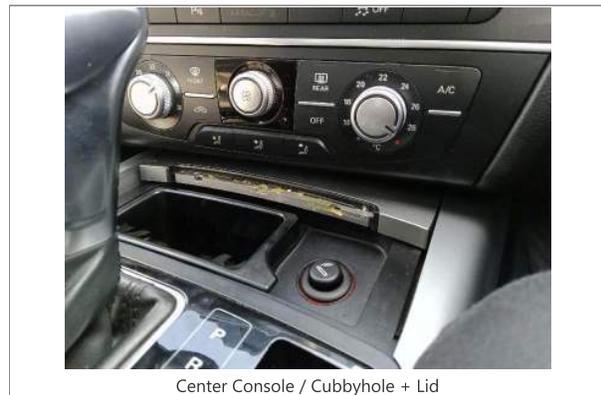
Damage	Repair Way
Water level Insufficient	Replace
Center Console / Cubbyhole + Lid Damaged	Repair
Headlight Left Cracked	Replace
Seat Belt Rear Middle Defective	Replace
Side Mirror Right Paintwork • Scratched	Repair
Front Bumper Damaged	Repair
Bonnet Paintwork • Scratched	Repair
Front Fender Right Paintwork • Scratched	Repair
Rear Fender Left Dented	Repair
Rear Fender Right Paintwork • Scratched	Repair
Front Fender Right / Inner Tray Damaged	Replace
Door Front Left Paintwork • Scratched	Repair
Door Front Right Paintwork • Scratched	Repair
Door Rear Left Paintwork • Scratched	Repair
Door Rear Right Paintwork • Scratched	Repair
Boot Lid / Hatch door Paintwork • Scratched	Repair
Rear bumper Paintwork • Scratched	Repair
Fuel Flap Damaged	Repair
Sill Panel Left Paintwork • Scratched	Repair
Windscreen Chipped	Repair
Parking Brake Performance Insufficient	Repair
Shock Absorber Front Left Leak	Replace
Shock Absorber Rear Left Leak	Replace

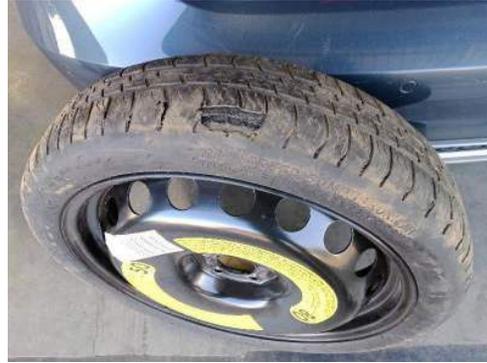
Spare Tyre

Size	Load/Speed Index	Manufacture	Model	Type*	Production Date	Tread Depth (mm)
Front Left	255/35Z R19	96Y	Michelin	Pilot Sport	V	1619	0 mm
Front Right	255/40Z R19	100Y	Hankook	Ventus	V	4618	1 mm
Rear Left	255/40Z R19	96W	Pirelli	Pzero	V	4914	0 mm
Rear Right	255/40Z R19	100Y	Kumho	Ecsta	V	5217	0 mm
Spare	T145/60 R20	105M	Hankook	Temporary	V	2914	0 mm
