MFC Auction House  
M57 Pretoria Rd, Glenmarais, KEMPTON PARK  
Gauteng

Vehicle Type	PASSENGER VEHICLE	Registered Owner	MFC AUCTION HOUSE
Manufacturer	AUDI	Registration Number	CD57MPGP
Model	A4	Register Number	
VIN	WAUZZZ8K8DA111853	Date Of First Licensing	
Engine Number		Last COR	
Doors	4	License Expiry Date	31/10/2023
Color	WHITE	Power / Displacement	
Year Model		Paint Finish	C - COMMON
Km Reading	217,350 KM	Fuel	PETROL
Cab / Body Type	SEDAN	Transmission	AUTOMATIC

## CONDITION REPORT

Report No: 2016335030

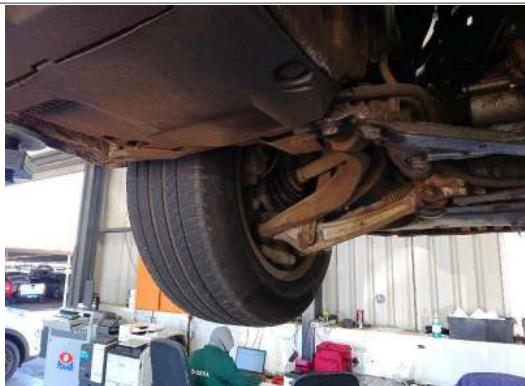
LF TYRE TREAD

Size	Load/Speed Index	Manufacture	Model	Type*	Production Date	Tread Depth (mm)
Front Left	225/55R16	95W	Michelin	Primacy	V	4820	3 mm
Front Right	225/55R16	95W	Michelin	Primacy	V	4820	3 mm
Rear Left	225/55R16	95W	Michelin	Primacy	V	2320	2 mm
Rear Right	225/55R16	95W	Michelin	Primacy	V	2320	2 mm
Spare	T125/70R19	100M	Hankook	S300	V	1512	4 mm

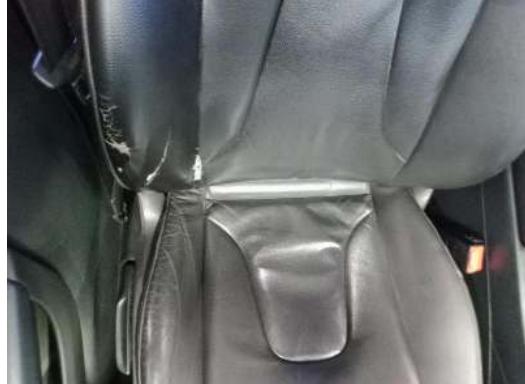
Damage	Repair Way
Seat Front Right Torn / Cut	Repair
Front Bumper Paintwork • Scratched	Repair
A • Pillar Right Paintwork • Scratched	Repair
Front Fender Left Paintwork • Pitmarks	Repair
Front Fender Right Paintwork • Pitmarks	Repair
Rear Fender Right Paintwork • Scratched	Repair
Door Front Right Paintwork • Scratched	Repair
Door Rear Right Paintwork • Scratched	Repair
Rear bumper Paintwork • Scratched	Repair
Engine to silencer pipe Welded	Repair
Gearbox Oil Leak	Repair
Engine Performance Idling / Hunting	Repair
Gear Selections Insufficient	Repair
None standard exhaust fitted	Repair
Engine management lights illuminated	Repair
