## CONDITION REPORT

2017299072

MFC Auction House  
M57 Pretoria Rd, Glenmarais, KEMPTON PARK  
Gauteng

| Manufacturer | AUDI | Registration Number | CK43BHGP |

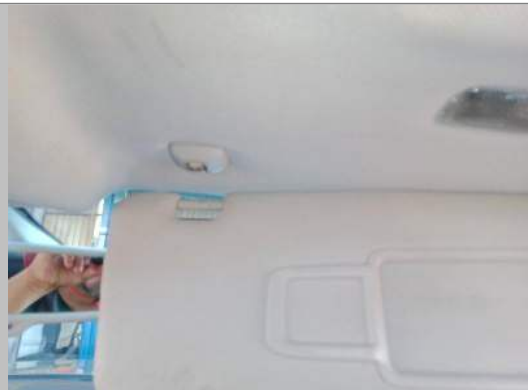
| Damage | Repair Way |
|---|---|
| Sun Visor Right Damaged | Repair |

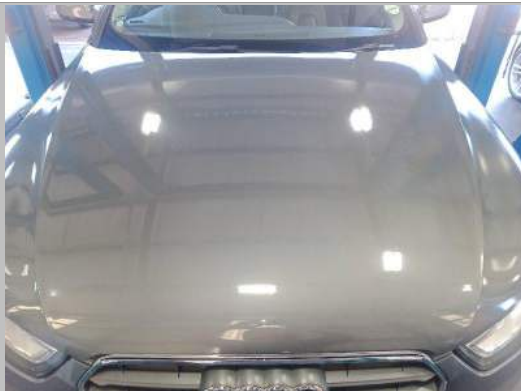
| Damage | Repair Way |
|---|---|
| Bonnet Residual Traces of Repair | Repair |

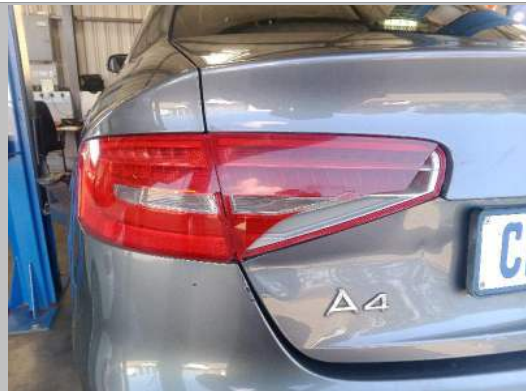
| Damage | Repair Way |
|---|---|
| Tail Light Left Damaged | Replace |

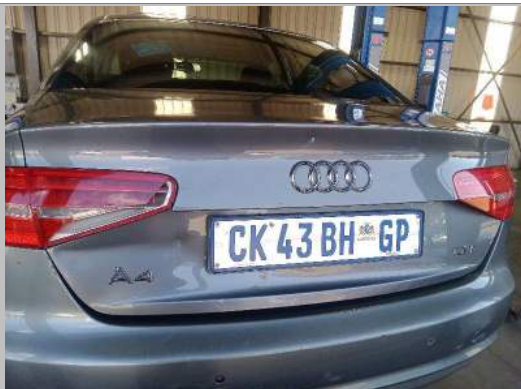
| Damage | Repair Way |
|---|---|
| Boot Lid / Hatch door Dented | Repair |

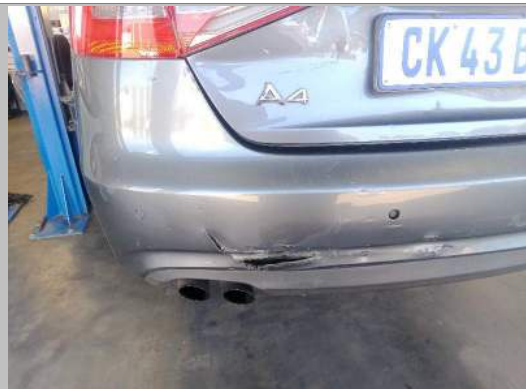
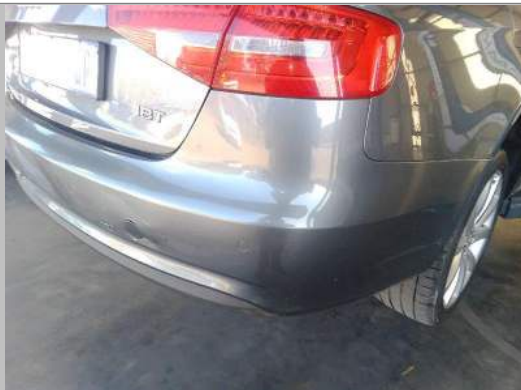
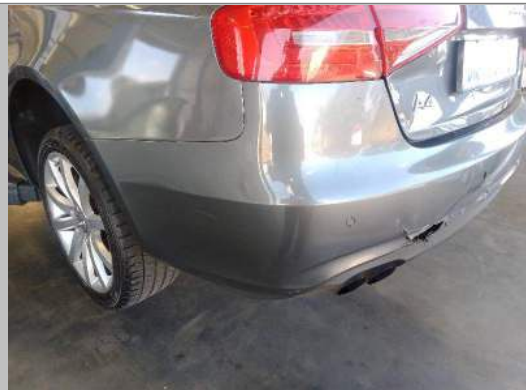
| Damage | Repair Way |
|---|---|
| Rear bumper Damaged | Repair |

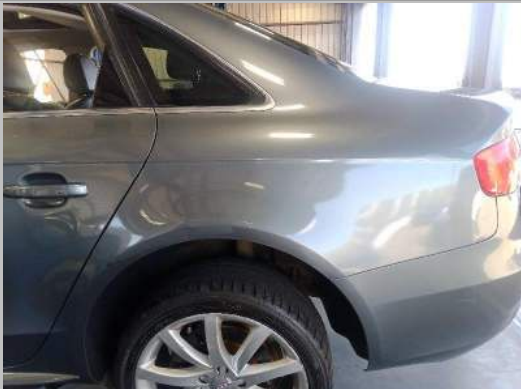
| Damage | Repair Way |
|---|---|
| Rear Fender Left Dented | Repair |

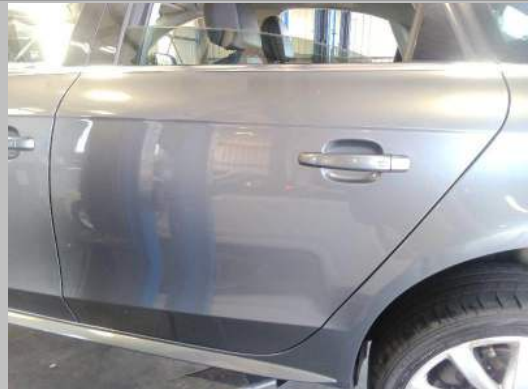
| Damage | Repair Way |
|---|---|
| Door Rear Left Paintwork • Scratched | Repair |

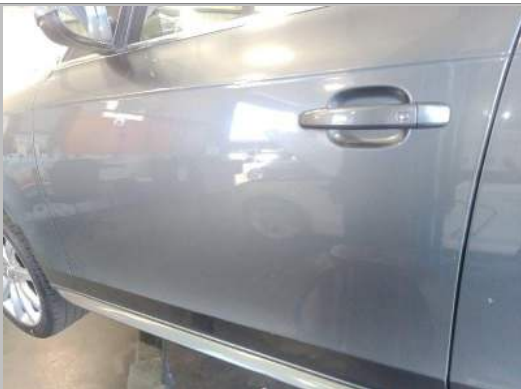
| Damage | Repair Way |
|---|---|
| Door Front Left Paintwork • Scratched | Repair |

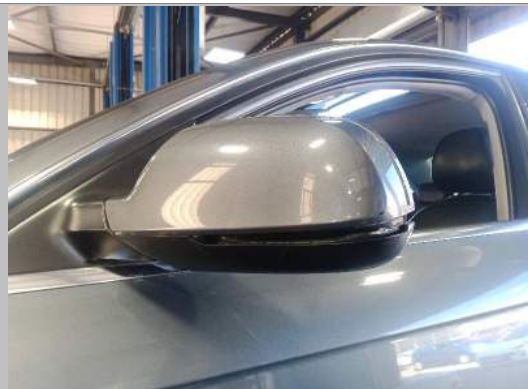
| Damage | Repair Way |
|---|---|
| Side Mirror Left Damaged | Repair |

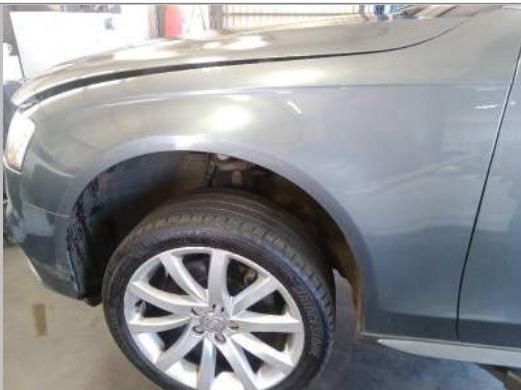
| Damage | Repair Way |
|---|---|
| Front Fender Left Paintwork • Scratched | Repair |

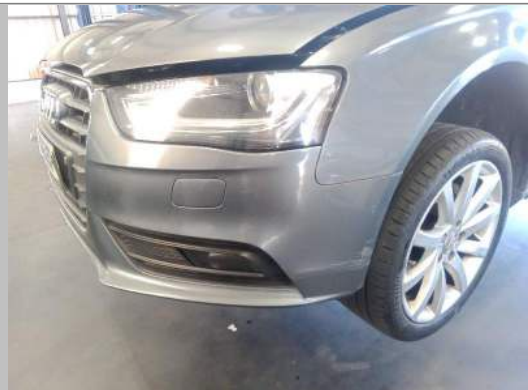
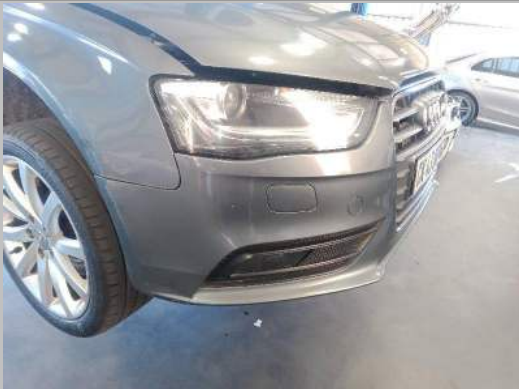
| Damage | Repair Way |
|---|---|
| Front Bumper Paintwork • Scratched | Repair |

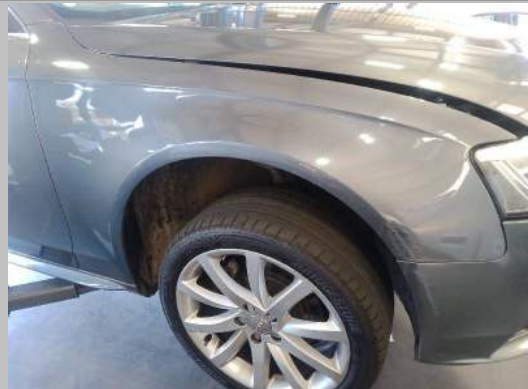
| Damage | Repair Way |
|---|---|
| Front Fender Right Dented | Repair |

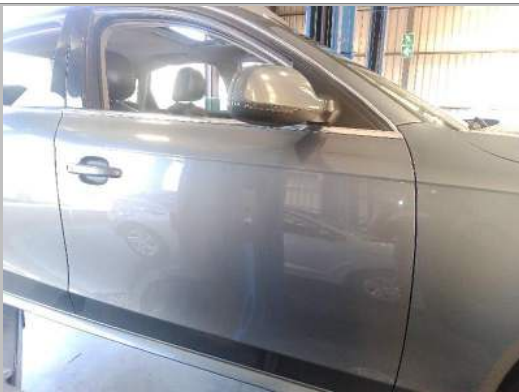
| Damage | Repair Way |
|---|---|
| Door Front Right Dented | Repair |

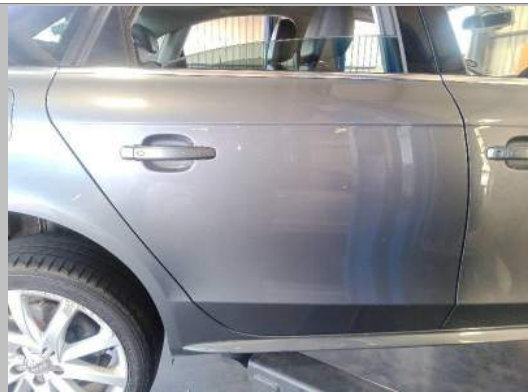
| Damage | Repair Way |
|---|---|
| Door Rear Right Paintwork • Scratched | Repair |

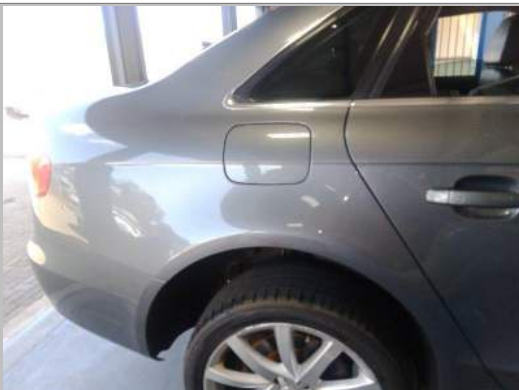
| Damage | Repair Way |
|---|---|
| Rear Fender Right Dented | Repair |

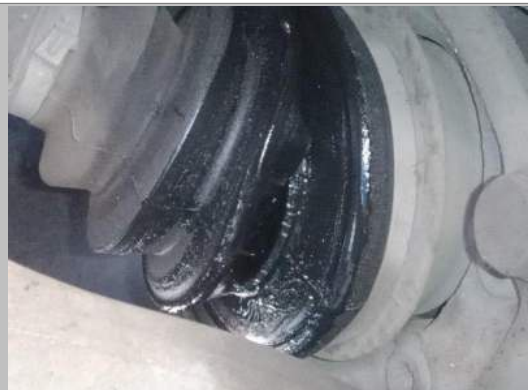
| Damage | Repair Way |
|---|---|
| CV Joint(s) Boot(s) Front Right (inner/outer) Damaged | Replace |

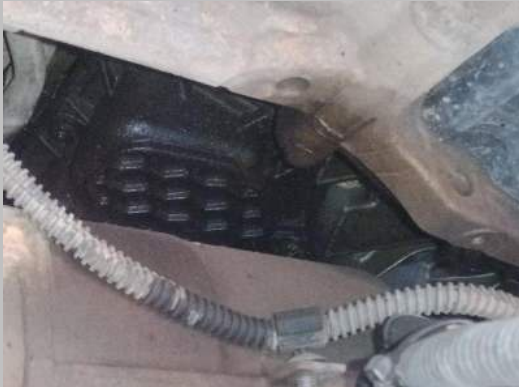
| Damage | Repair Way |
|---|---|
| Engine Oil Leak | Repair |

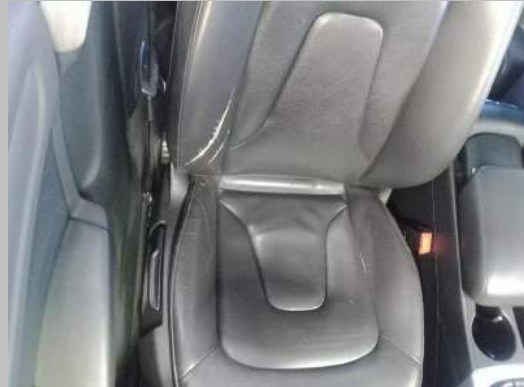
| Damage | Repair Way |
|---|---|
| Seat Front Right Torn / Cut | Repair |

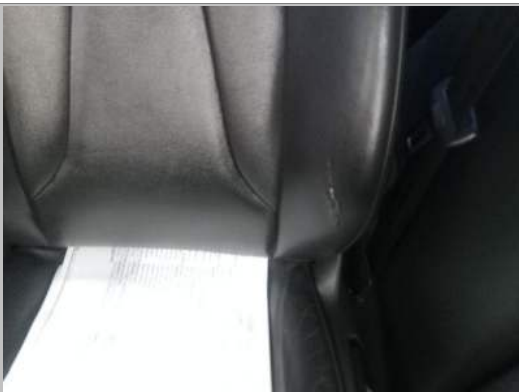
| Damage | Repair Way |
|---|---|
| Seat Front Left Cracked | Repair |
