CONDITION REPORT

Report No: 2016204208

MFC Auction House  
M57 Pretoria Rd, Glenmarais, KEMPTON PARK  
Gauteng

| Manufacturer | BMW | Registration Number | HV42SJGP |

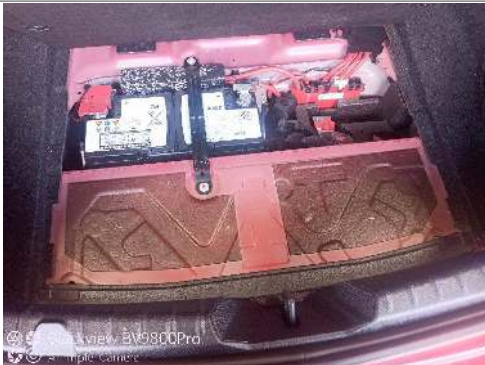
No spare wheel

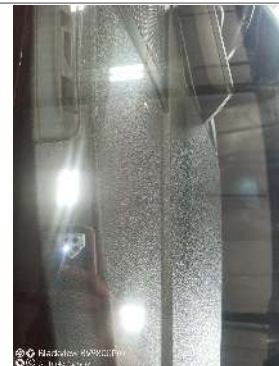
| Damage | Repair Way |
|---|---|
| Windscreen Cracked | Replace |

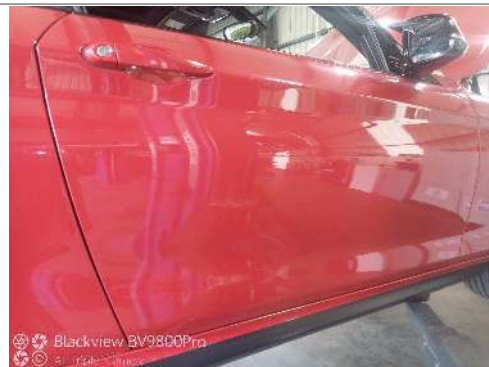
| Damage | Repair Way |
|---|---|
| Door Front Right Paintwork • Scratched | Repair |

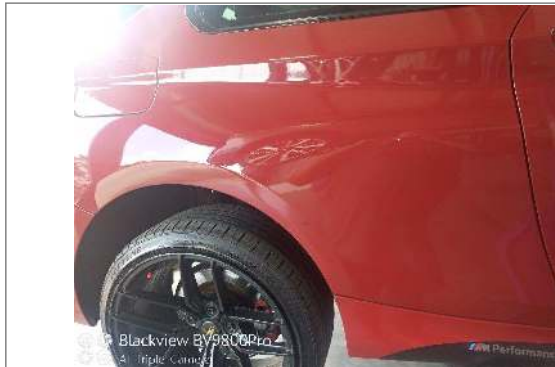
| Damage | Repair Way |
|---|---|
| Rear Fender Right Paintwork • Scratched | Repair |

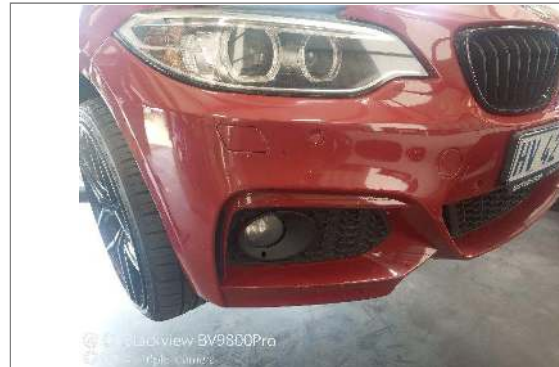
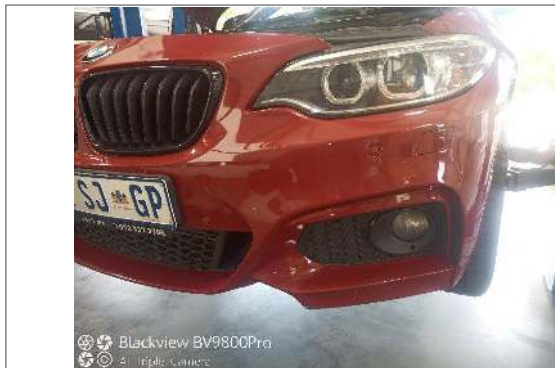
| Damage | Repair Way |
|---|---|
| Front Bumper Paintwork • Chipmarks | Repair |

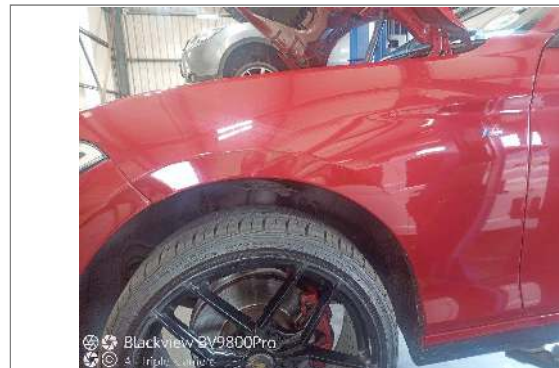
| Damage | Repair Way |
|---|---|
| Front Fender Left Paintwork • Scratched | Repair |

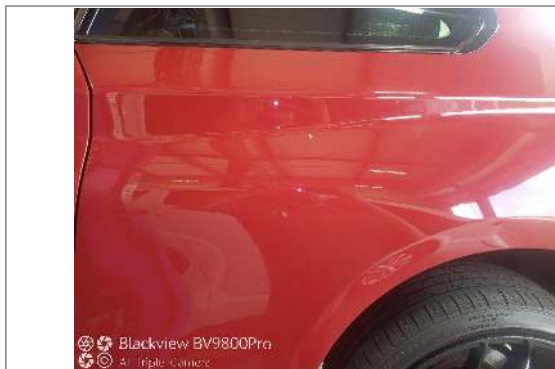
| Damage | Repair Way |
|---|---|
| Rear Fender Left Paintwork • Chipmarks | Repair |

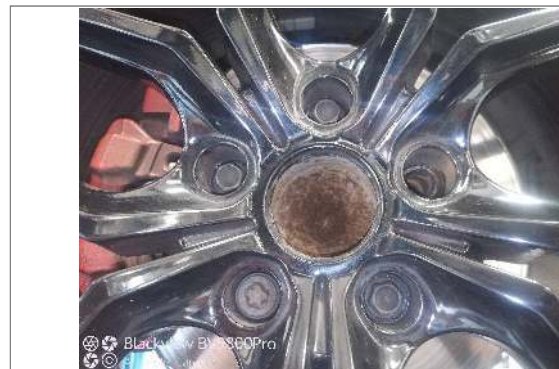
| Damage | Repair Way |
|---|---|
| Bolt(s) / Nut(s) Front Wheel Right Missing | Replace |
