## CONDITION REPORT

Report No:  
2017297947  
DATE  
11/09/2026

| Manufacturer | MERCEDES-BENZ | Registration Number | CBS56453 |
| Model | C320 CDI ELEGANCE 7-SP DSL AT [2007-2009] | Register Number | |

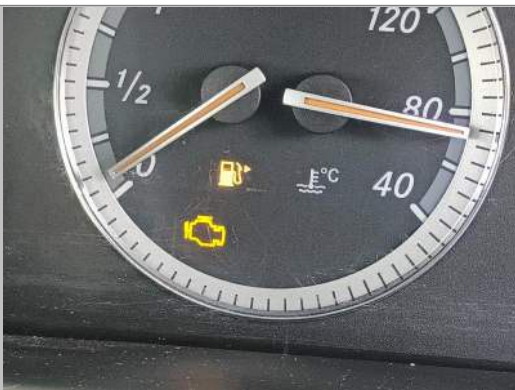
| Warning lights illuminated | Repair |

Warning lights illuminated

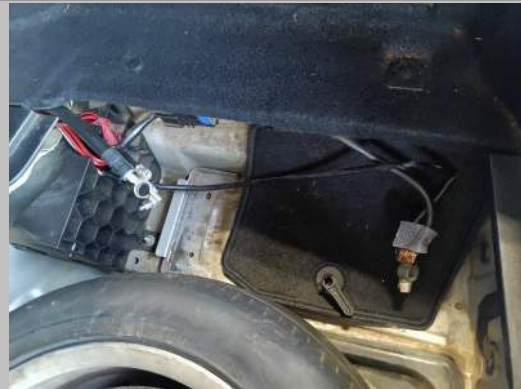
| No battery | Replace |

No battery

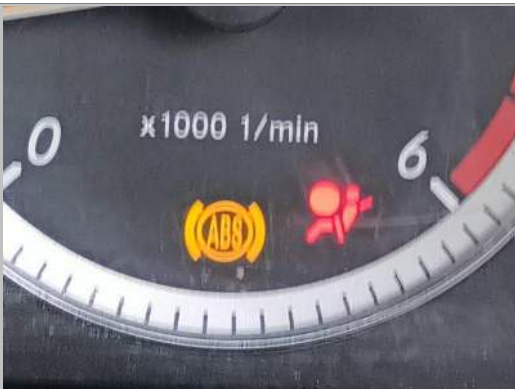
Warning lights illuminated

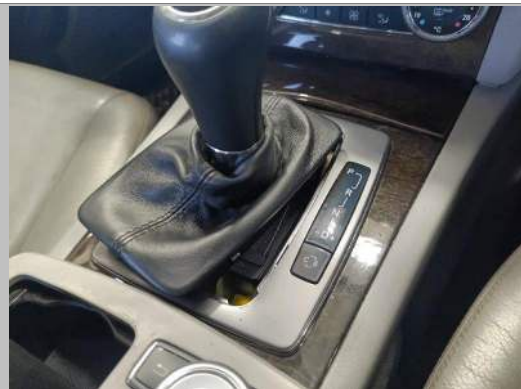
| Gear Lever Dust Boot Torn / Cut | Repair |

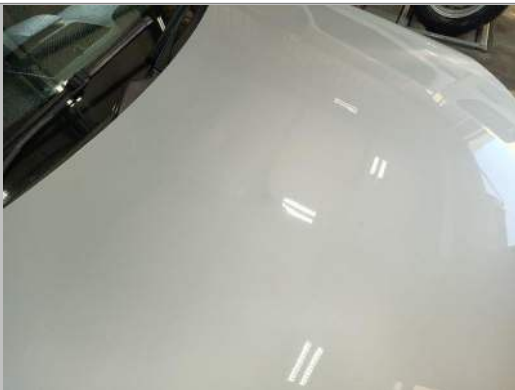
| Bonnet Dented | Repair |

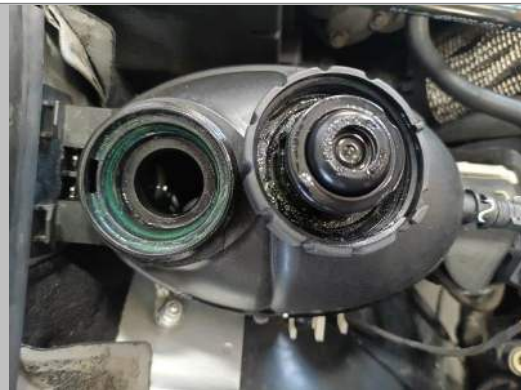
| Water level Insufficient | Repair |

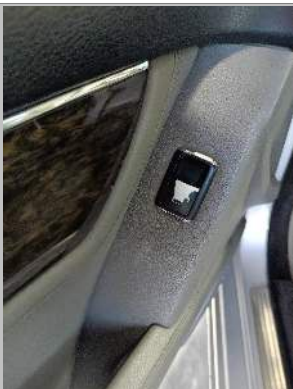
| Switch Electrical Window Winder front left Defective | Repair |

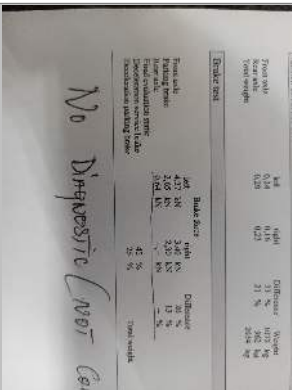
| Service Brake Performance Rear Axle Left / Right | Repair |
| Difference out of legal range | Repair |

| | Left | Right | | |
|---|---|---|---|---|
| Rear | 0.6 | 0.0 | - | |

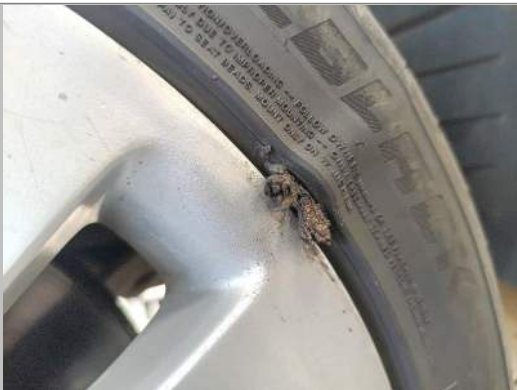
| Tyre Front Right Damaged | Replace |

| | Size | Load/Speed Index | Manufacture | Model | Type* | Production Date | Tread Depth (mm) |
|---|---|---|---|---|---|---|---|
| Front Right | 225/45R17 | 94W | Royal black | Mile | V | 3523 | 0 mm |

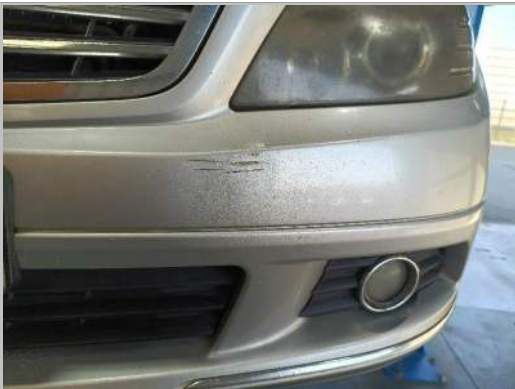
| Front Bumper Paintwork • Scratched | Repair |

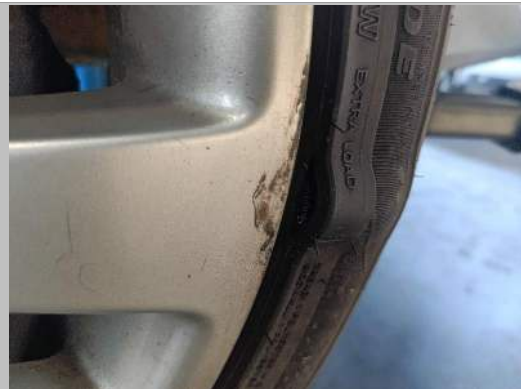
| Tyre Front Left Torn / Cut | Replace |

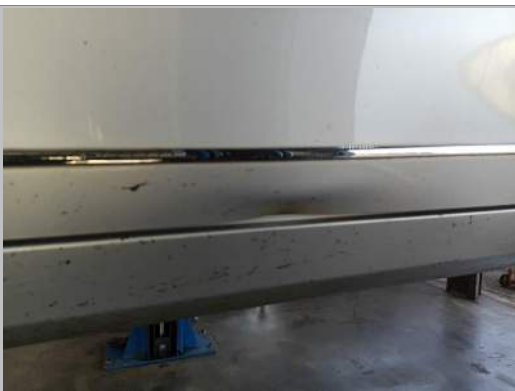
| Door Front Left Dented | Repair |

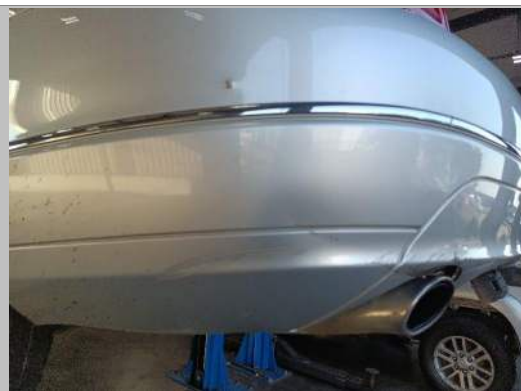
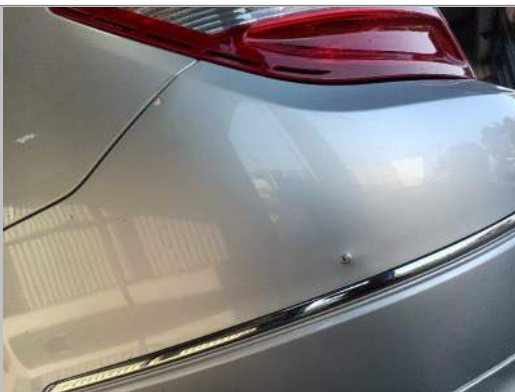
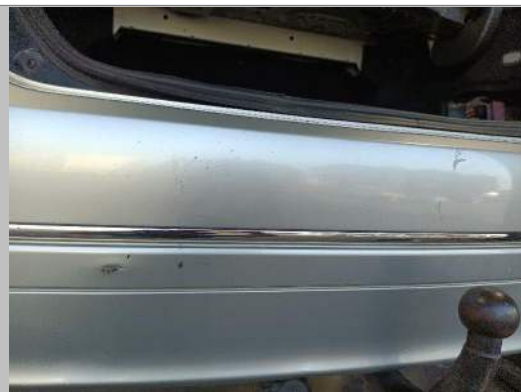
| Rear bumper Paintwork • Scratched | Repair |

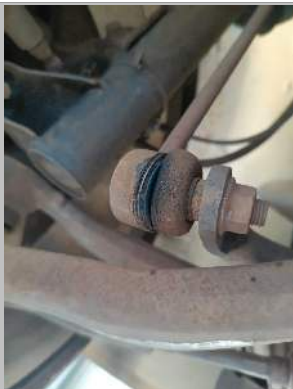
| Stabilizer Mounting Front Left Damaged | Replace |

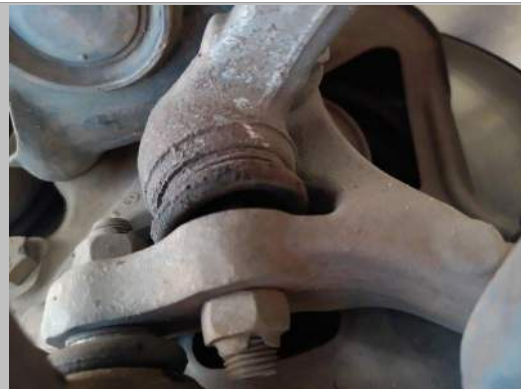
| Ball Joint(s) Front Axle Left Damaged | Replace |

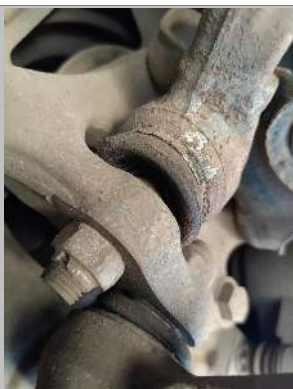
| Radius Rod(s) Front Axle Right Damaged | Replace |

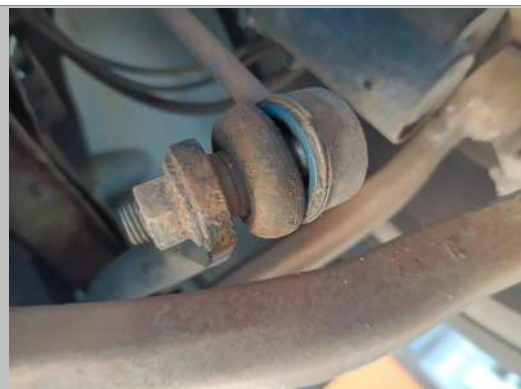
| Stabilizer Mounting Front Right Damaged | Replace |

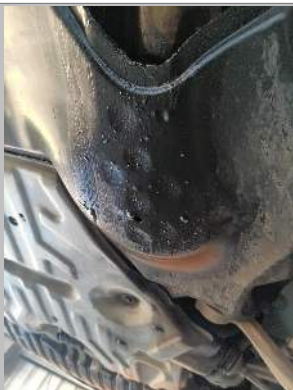
| Engine Oil Leak | Repair |

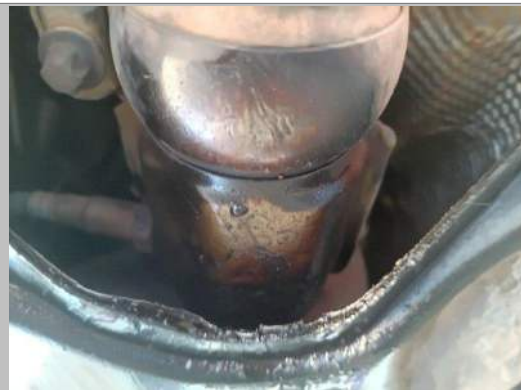
| Engine to silencer pipe Leak | Repair |

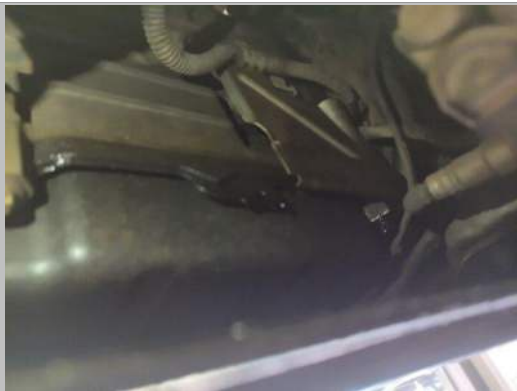
| Gearbox Oil Leak | Repair |

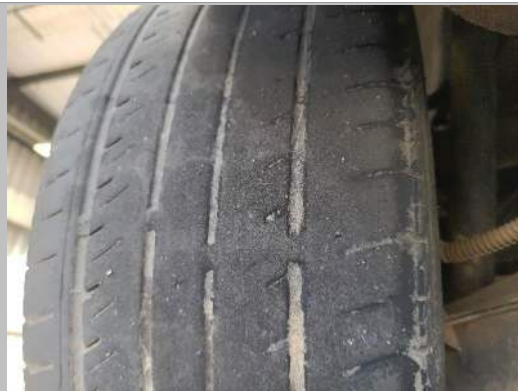
| Tyre Rear Left Smooth | Replace |

| | Size | Load/Speed Index | Manufacture | Model | Type* | Production Date | Tread Depth (mm) |
|---|---|---|---|---|---|---|---|
| Rear Left | 225/45R17 | 94W | Goodride | SA | V | 3024 | 0 mm |

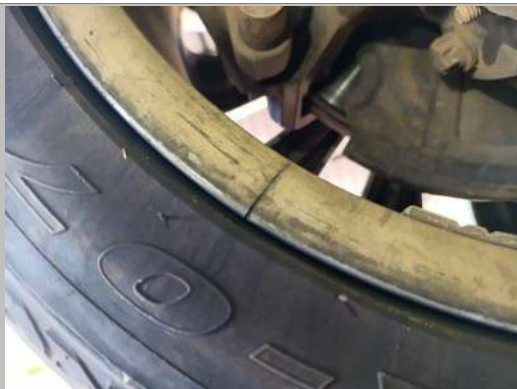
| Rim Rear Left Cracked | Repair |

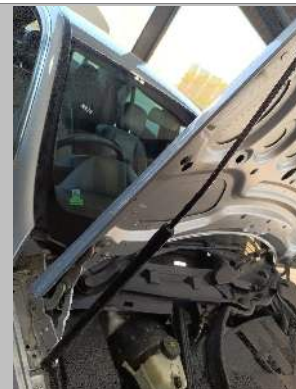
| Bonnet stay and shocks Defective | Repair |

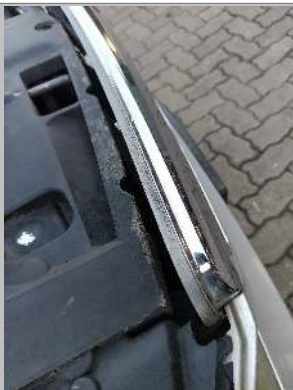
| Grill Damaged | Repair |

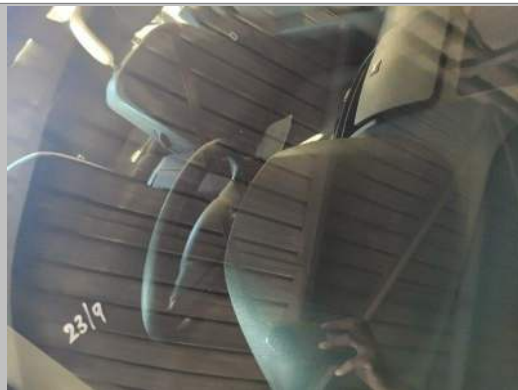
| Windscreen Chipped | Replace |
