## CONDITION REPORT

Report No:  
2017286376  
DATE  
20/08/2026

| Manufacturer | FORD | Registration Number | FT37DDGP |
| Model | FOCUS 2.0 ECOBOOST ST3 5-DR [2015-2019] | Register Number | |

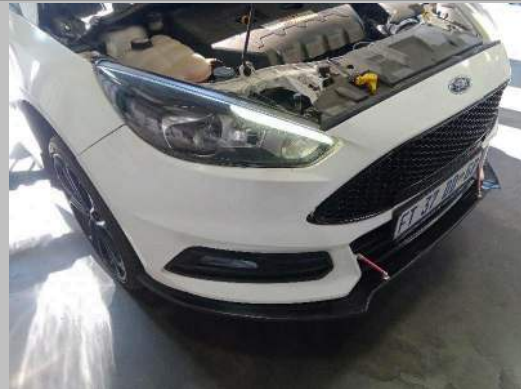
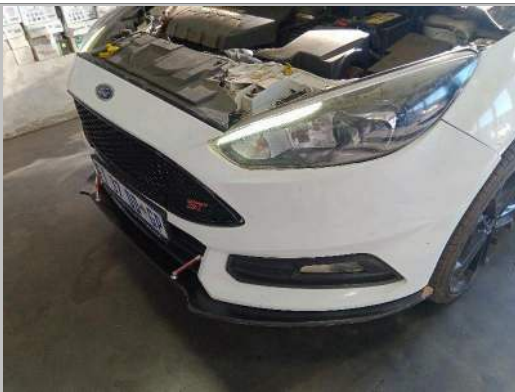
| Damage | Repair Way |
|---|---|
| Front Bumper Damaged | Repair |

Front Bumper

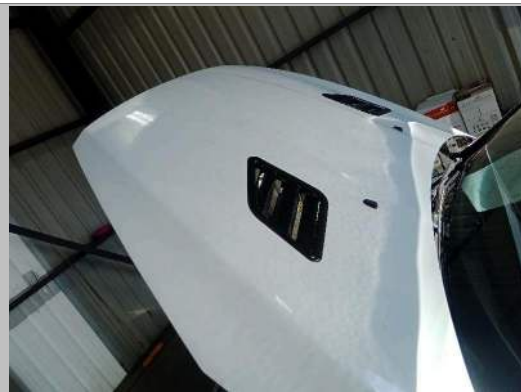
| Damage | Repair Way |
|---|---|
| Bonnet Damaged | Repair |

Bonnet

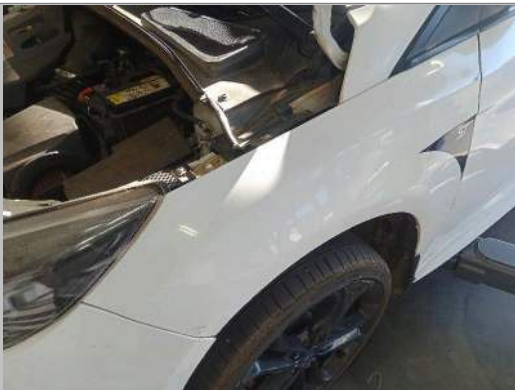
| Damage | Repair Way |
|---|---|
| Front Fender Left Damaged | Repair |

Front Fender Left

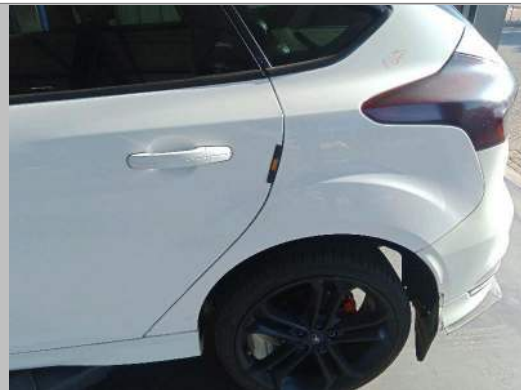
| Damage | Repair Way |
|---|---|
| Rear Fender Left Damaged | Repair |

Rear Fender Left

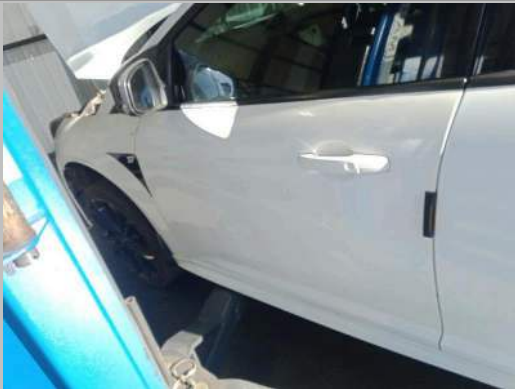
| Damage | Repair Way |
|---|---|
| Door Front Left Residual Traces of Repair | Repair |

Door Front Left

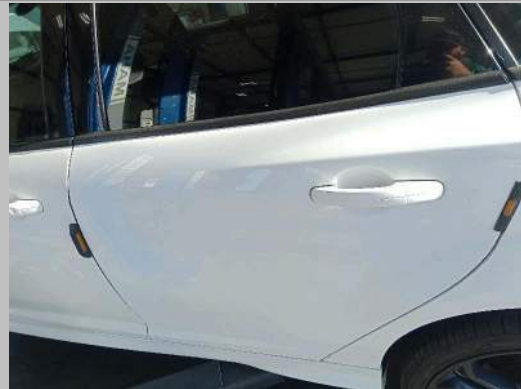
| Damage | Repair Way |
|---|---|
| Door Rear Left Residual Traces of Repair | Repair |

Door Rear Left

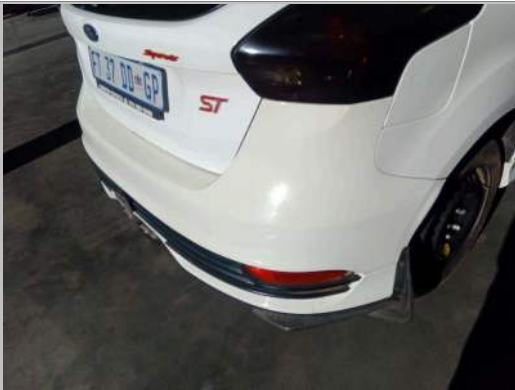
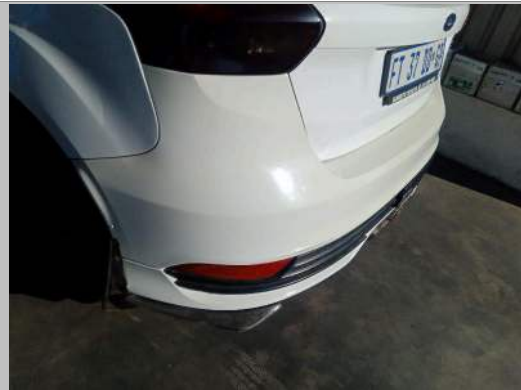
| Damage | Repair Way |
|---|---|
| Rear bumper Residual Traces of Repair | Repair |

Rear bumper

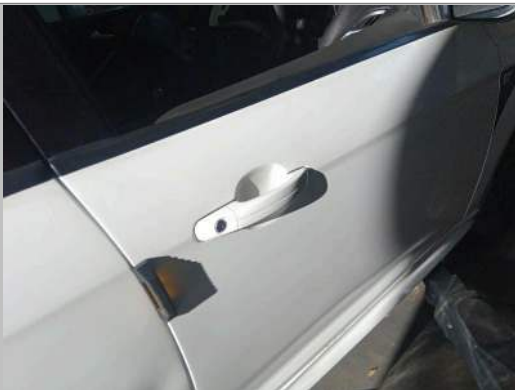
| Damage | Repair Way |
|---|---|
| Door Front Right Residual Traces of Repair | Repair |

Door Front Right

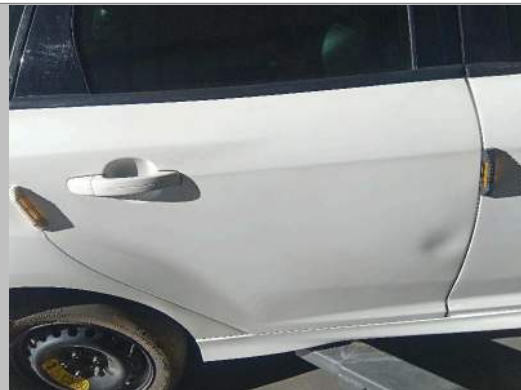
| Damage | Repair Way |
|---|---|
| Door Rear Right Damaged | Repair |

Door Rear Right

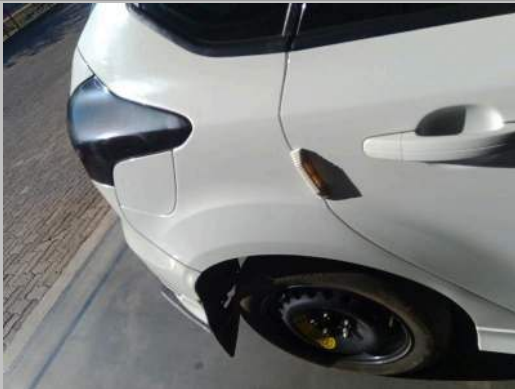
| Damage | Repair Way |
|---|---|
| Rear Fender Right Damaged | Repair |

Rear Fender Right

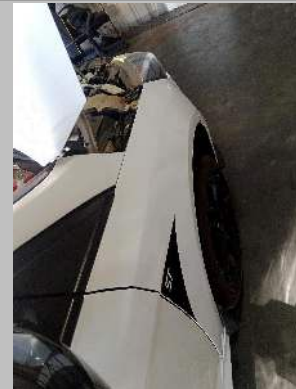
| Damage | Repair Way |
|---|---|
| Front Fender Right Damaged | Repair |

Front Fender Right

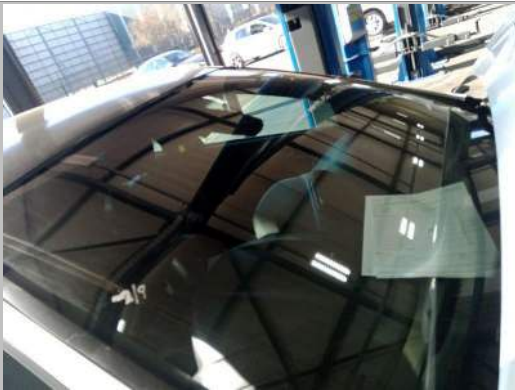
| Damage | Repair Way |
|---|---|
| Windscreen Damaged | Repair |

Windscreen

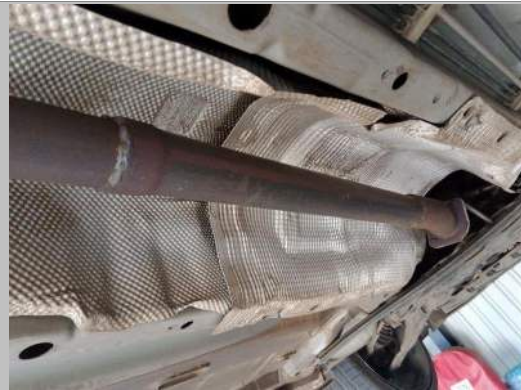
| Damage | Repair Way |
|---|---|
| Engine to silencer pipe Welded | Replace |

Engine to silencer pipe

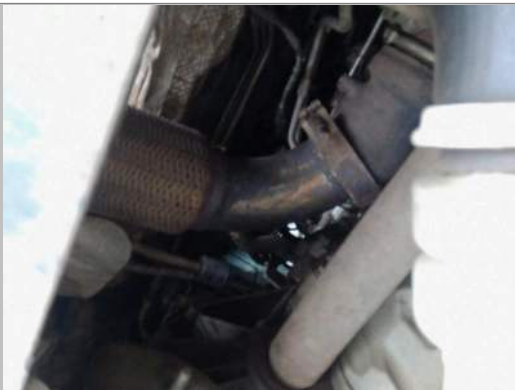
| Damage | Repair Way |
|---|---|
| Catalytic converter Missing | Replace |

Catalytic converter

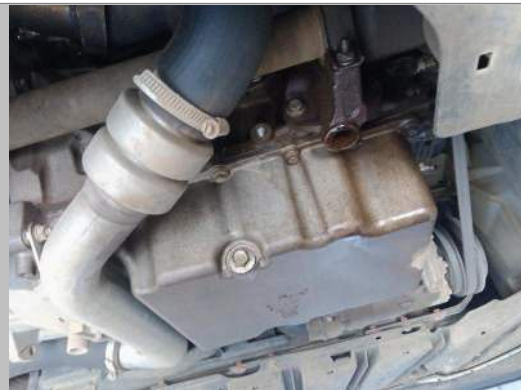
| Damage | Repair Way |
|---|---|
| Engine Oil Leak | Repair |

Engine

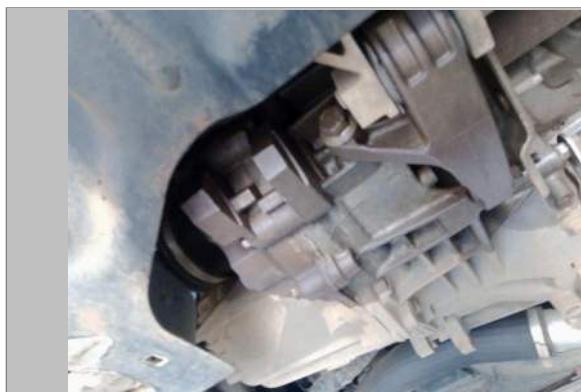
| Damage | Repair Way |
|---|---|
| Gearbox Oil Sweat | Repair |

Gearbox

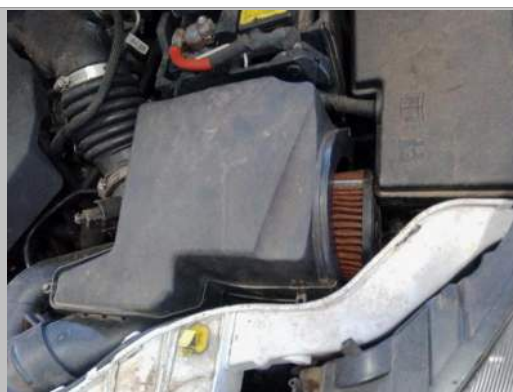
| Damage | Repair Way |
|---|---|
| Air cleaner Defective | Repair |

Air cleaner
