MFC Auction House  
M57 Pretoria Rd, Glenmarais, KEMPTON PARK  
Gauteng

DEKRA MFC  
M57 Pretoria Rd - 1619  
KEMPTON PARK - GT  
08610 33572

Report No: 2016347139

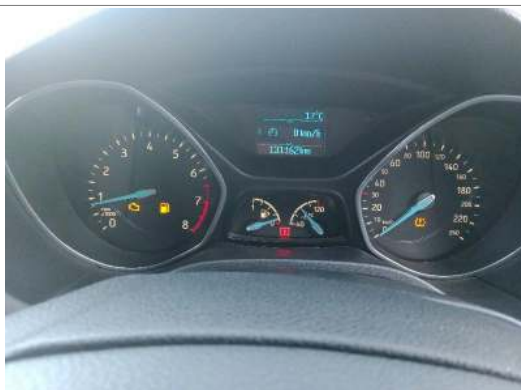
| Damage | Repair Way |
|---|---|
| Warning lights illuminated. | Repair. |

Warning lights illuminated

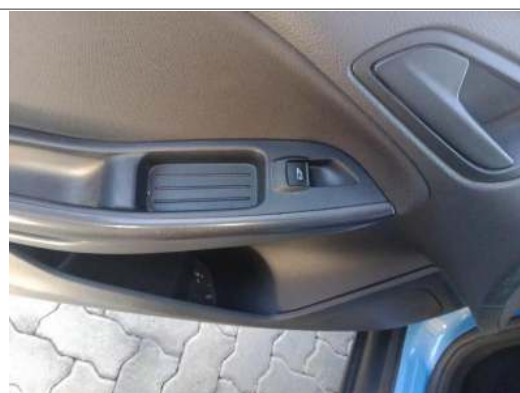
| Damage | Repair Way |
|---|---|
| Switch Electrical Window Winder front left Defective | Repair |

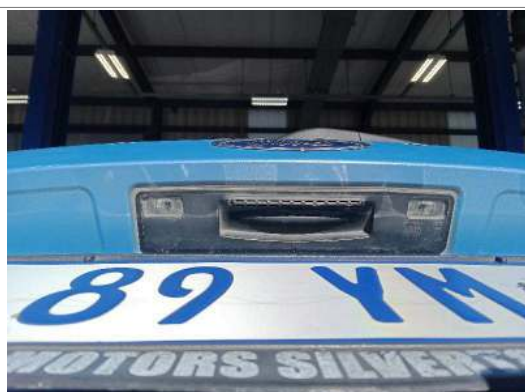
| Damage | Repair Way |
|---|---|
| Door Lock Boot Lid Defective | Replace |

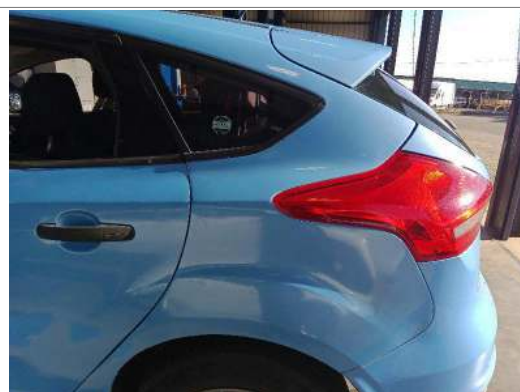
| Damage | Repair Way |
|---|---|
| Rear Fender Left Residual Traces of Repair | Repair |

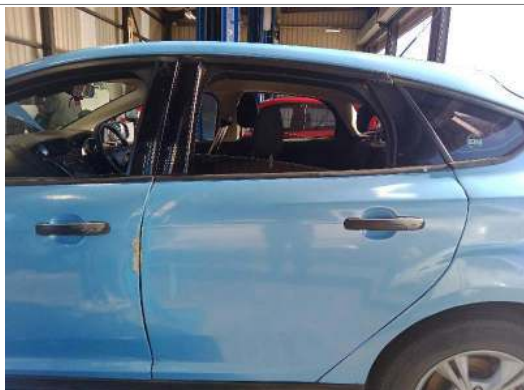
| Damage | Repair Way |
|---|---|
| Door Rear Left Residual Traces of Repair | Repair |

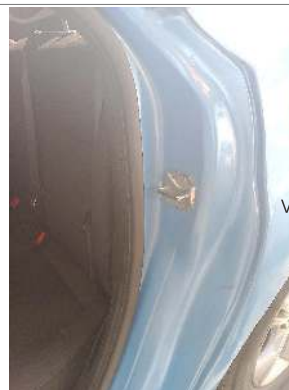
| Damage | Repair Way |
|---|---|
| C • Pillar Left Residual Traces of Repair | Repair |

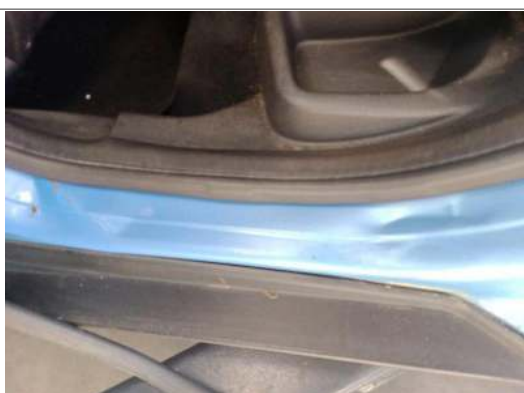
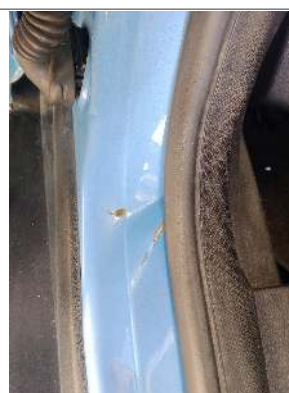
| Damage | Repair Way |
|---|---|
| Sill Panel Left Residual Traces of Repair | Repair |

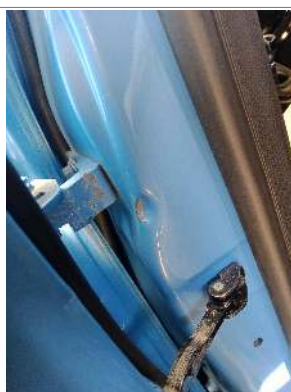
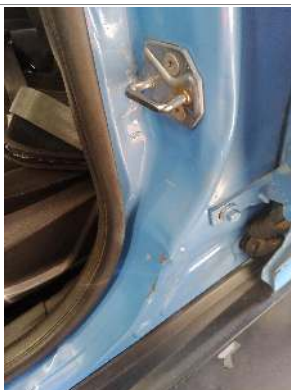
| Damage | Repair Way |
|---|---|
| B • Pillar Left Dented | Repair |

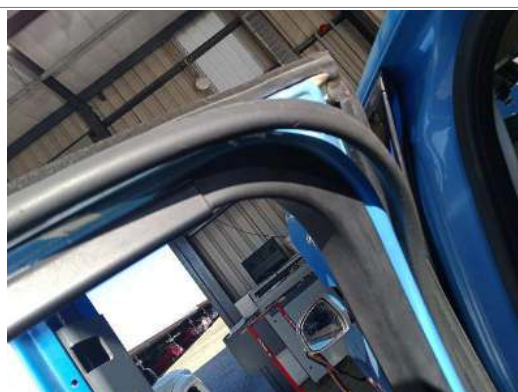
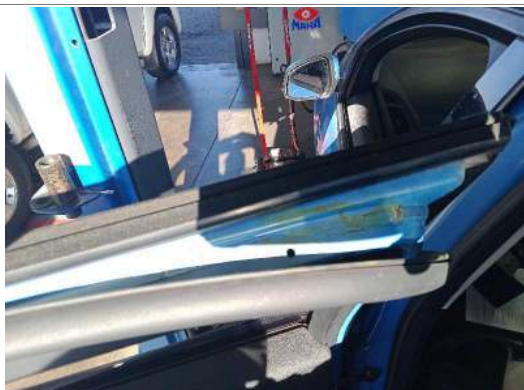
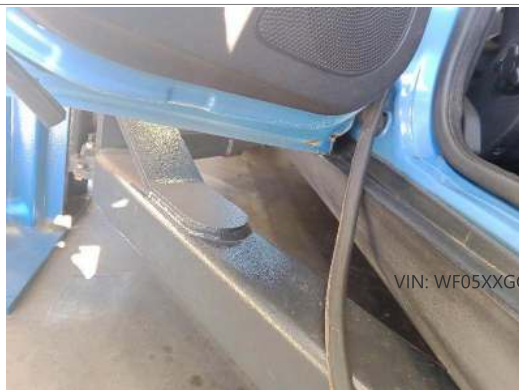
| Damage | Repair Way |
|---|---|
| Door Sealing Rubber Rear Left Torn / Cut | Replace |

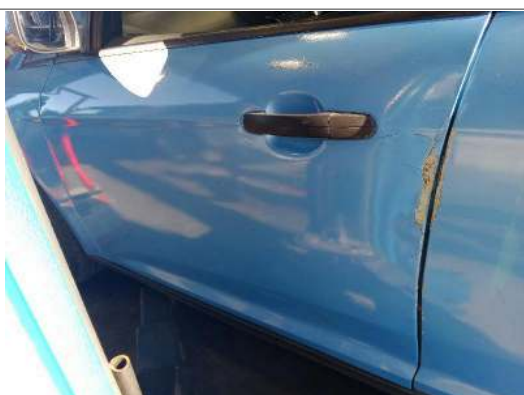
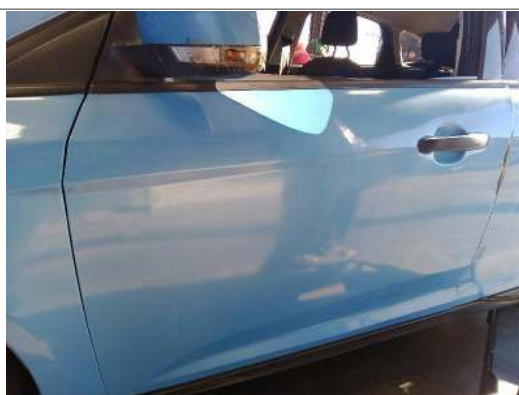
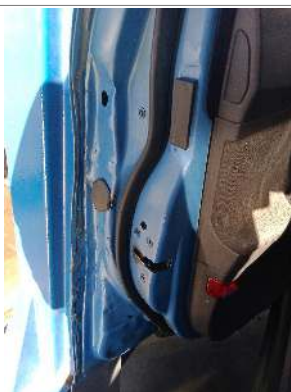
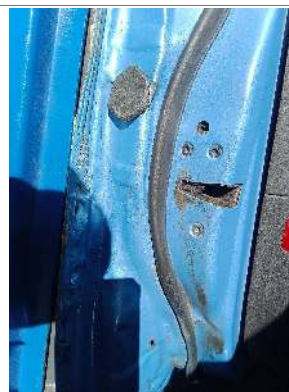
| Damage | Repair Way |
|---|---|
| Door Front Left Residual Traces of Repair | Repair |

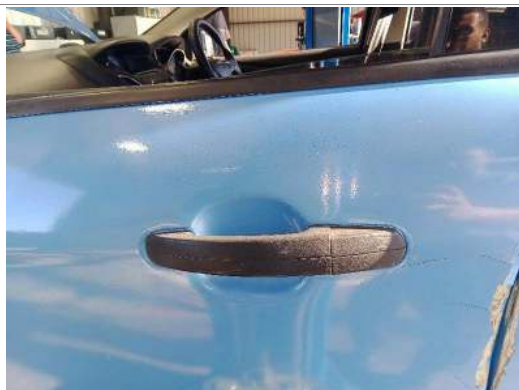
| Damage | Repair Way |
|---|---|
| Door Handle Front Left Damaged | Replace |

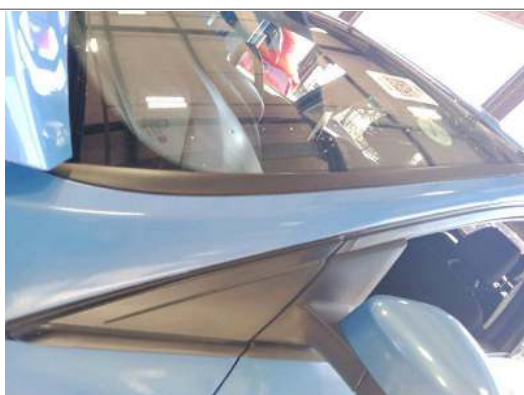
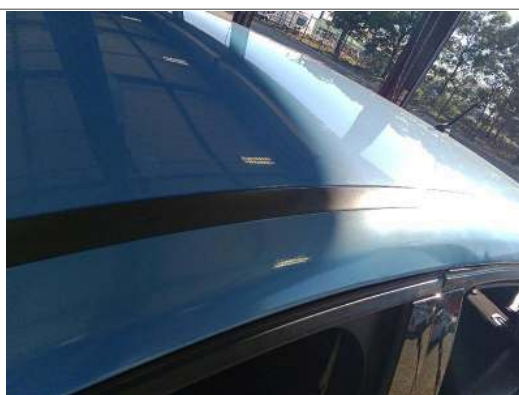
| Damage | Repair Way |
|---|---|
| A • Pillar Left Residual Traces of Repair | Repair |

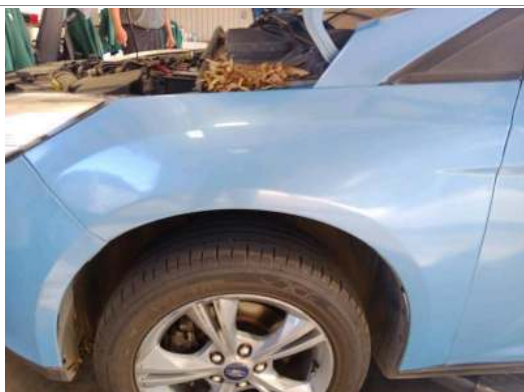
| Damage | Repair Way |
|---|---|
| Front Fender Left Residual Traces of Repair | Repair |

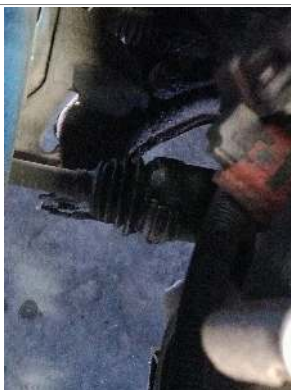
| Damage | Repair Way |
|---|---|
| CV Joint(s) Front Right (inner/outer) Damaged | Replace |

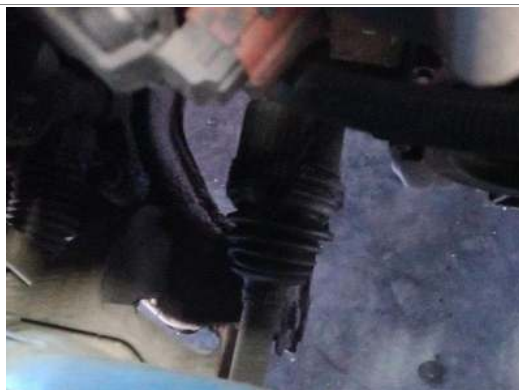
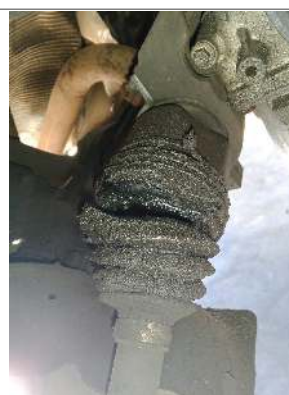
| Damage | Repair Way |
|---|---|
| CV Joint(s) Boot(s) Front Right (inner/outer) Damaged | Replace |

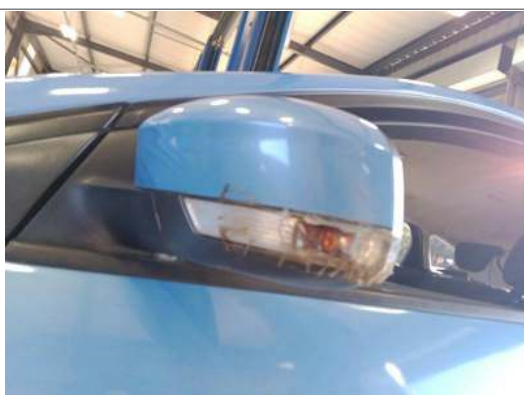
| Damage | Repair Way |
|---|---|
| Indicator Light Front Left Damaged | Replace |

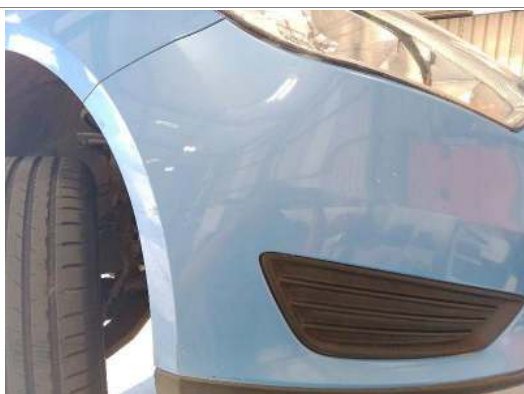
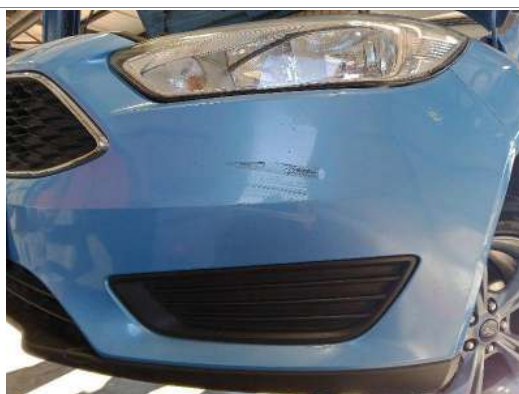
| Damage | Repair Way |
|---|---|
| Front Bumper Paintwork • Scratched | Repair |

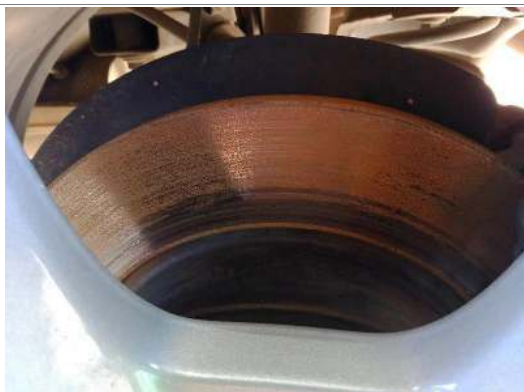
| Damage | Repair Way |
|---|---|
| Brake disc 2. Axle right Corrosion | Replace |

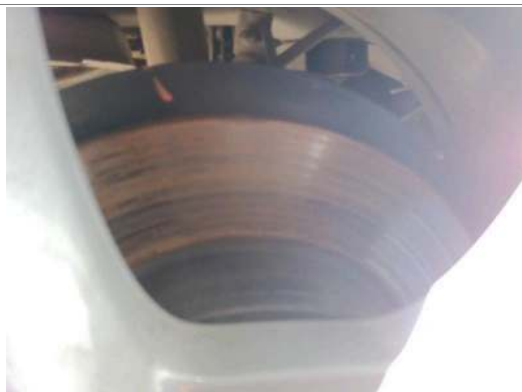
| Damage | Repair Way |
|---|---|
| Brake disc 2. Axle left Corrosion | Replace |

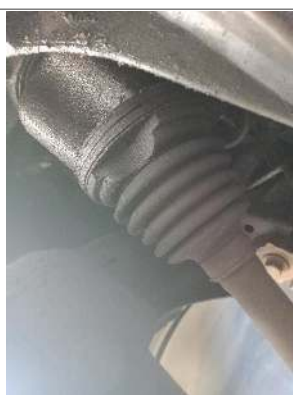
| Damage | Repair Way |
|---|---|
| CV Joint(s) Boot(s) Front Left (inner/outer) Damaged | Replace |

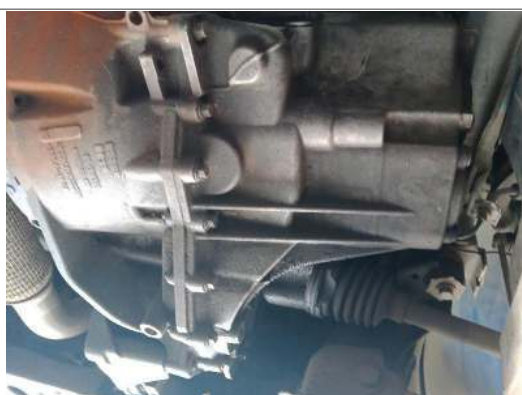
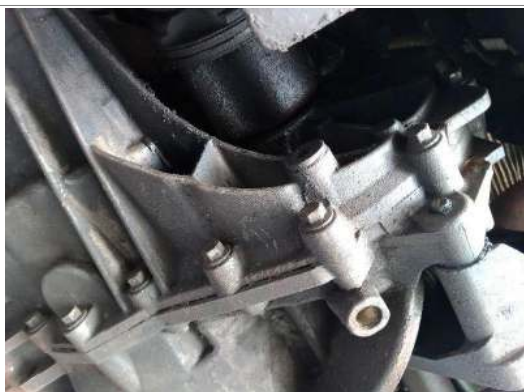
| Damage | Repair Way |
|---|---|
| Gearbox Oil Leak | Repair |

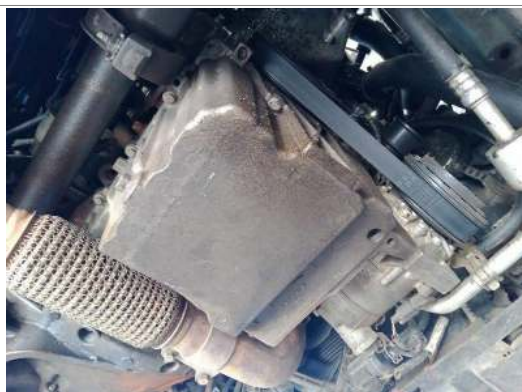
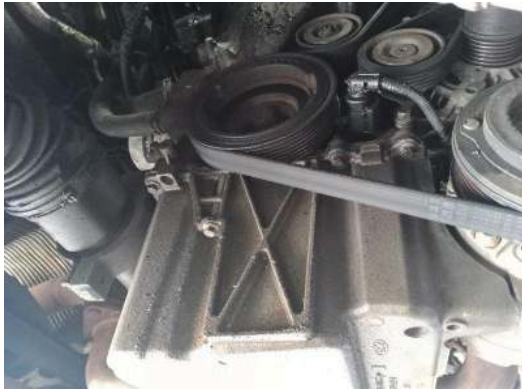
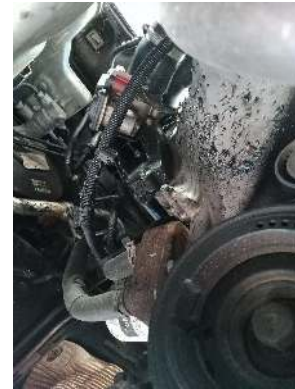
| Damage | Repair Way |
|---|---|
| Engine Oil Leak | Repair |

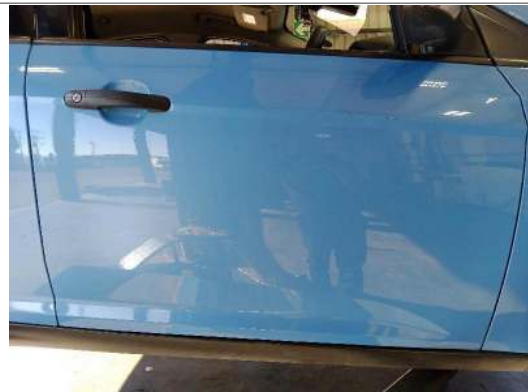
| Damage | Repair Way |
|---|---|
| Door Front Right Paintwork • Scratched | Repair |

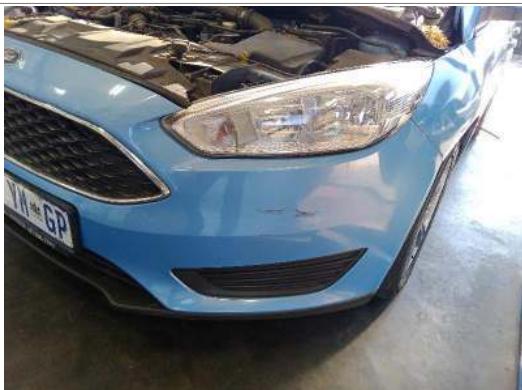
| Damage | Repair Way |
|---|---|
| Park Light Front Left Defective | Repair |

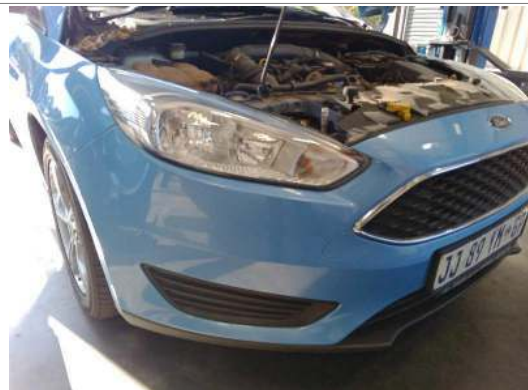
| Damage | Repair Way |
|---|---|
| Park Light Front Right Defective | Replace |

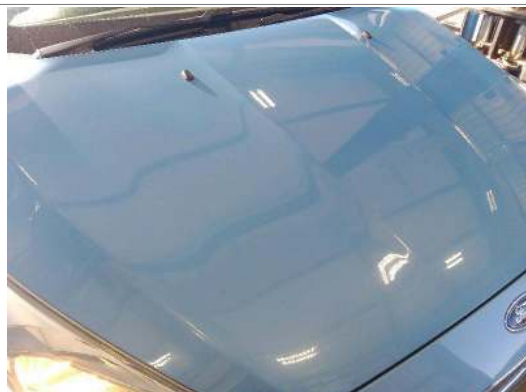
| Damage | Repair Way |
|---|---|
| Bonnet Paintwork • Chipmarks | Repair |
