Client	MFC Auction House	Inspection Location	MFC M57 Pretoria Road - 1619 Kempton Park - GT
Requested Date	26/01/2024		
Inspection Date	26/01/2024

Vehicle Type	PASSENGER VEHICLE	Registered Owner	MFC AUCTION HOUSE
Manufacturer	MINI	Registration Number	HZ62SVP
Model	JOHN COOPER WALKS	Register Number	
VIN	WMWXM920902F19959	Date Of First Licensing	
Engine Number		Last COR	
Doors	3	License Expiry Date	31/08/2024
Color	RED	Power / Displacement	
Year Model		Paint Finish	TWO COAT METALLIC
Km Reading	236,883 KM	Fuel	PETROL
Cab / Body Type	HATCHBACK	Transmission	AUTOMATIC

CONDITION REPORT

Report No: 2016244402

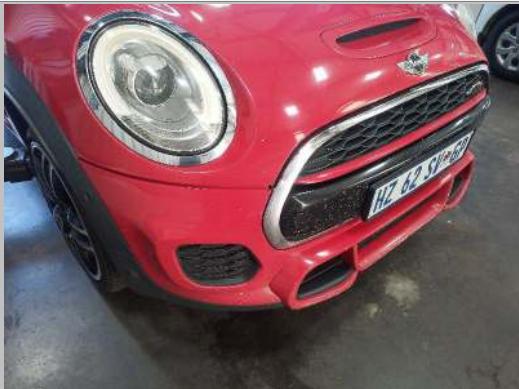
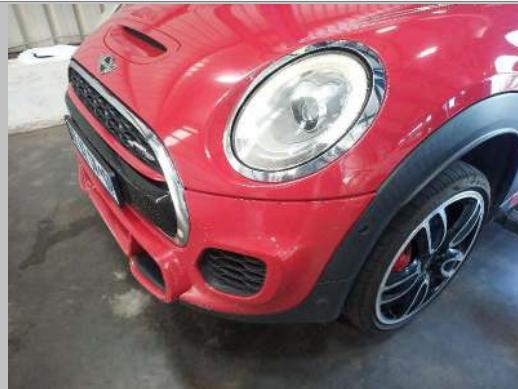
Damage	Repair Way
Engine Oil Sweat	Repair
Center Console / Cubbyhole + Lid Damaged	Repair
Windscreen Wiper Damaged	Replace
Seat Front Right Worn	Repair
Front Bumper Damaged	Repair
Bonnet Damaged	Repair
Front Fender Left Damaged	Repair
Front Fender Right Damaged	Repair
Rear Fender Right Damaged	Repair
Door Front Left Damaged	Repair
Door Front Right Damaged	Repair
Boot Lid / Hatch door Damaged	Repair
Rear bumper Damaged	Repair
Windscreen Damaged	Replace
Parking Brake Performance Left / Right Difference out of legal range	Repair
