CONDITION REPORT

Report No:  
2017297776  
DATE  
11/09/2026

MFC Auction House  
M57 Pretoria Rd, Glenmarais, KEMPTON PARK  
Gauteng

| Manufacturer | VOLKSWAGEN | Registration Number | LX15HYGP |

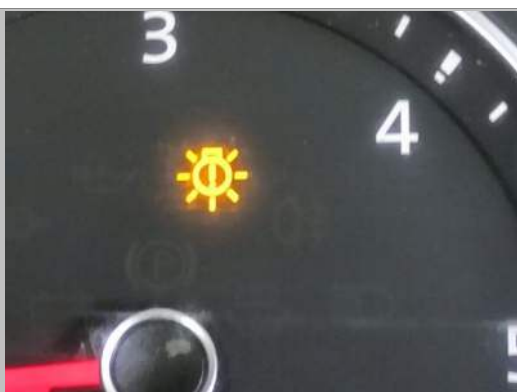
Warning lights illuminated

| Warning lights illuminated | Repair |

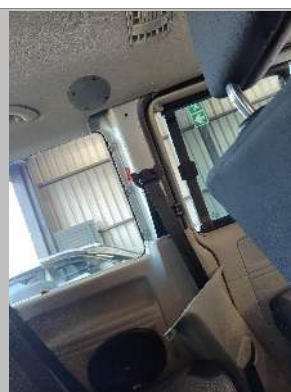
L/R interior panel loose

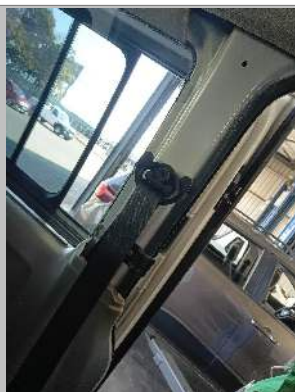
R/R interior panel loose

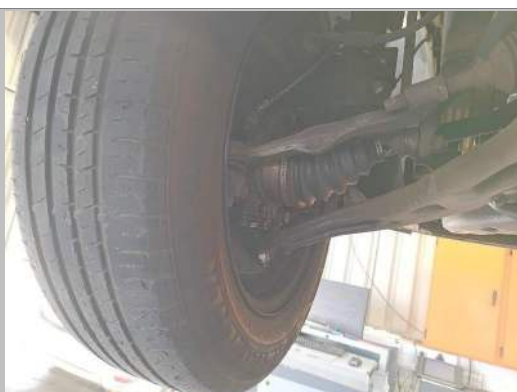
LF TYRE TREAD

| | Size | Load/Speed Index | Manufacture | Model | Type* | Production Date | Tread Depth (mm) |
|---|---|---|---|---|---|---|---|
| Front Left | 205/65R16 | 95H | Royal black | Mile | V | 4923 | 1 mm |

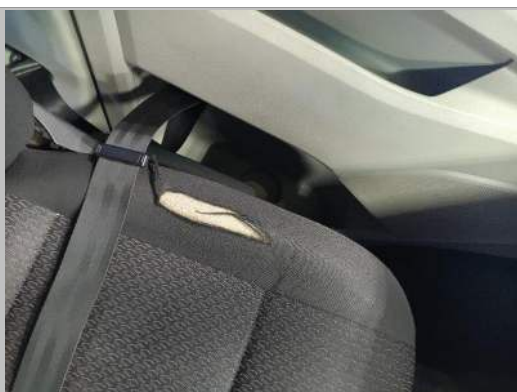
| Seat Front Left Torn / Cut | Repair |

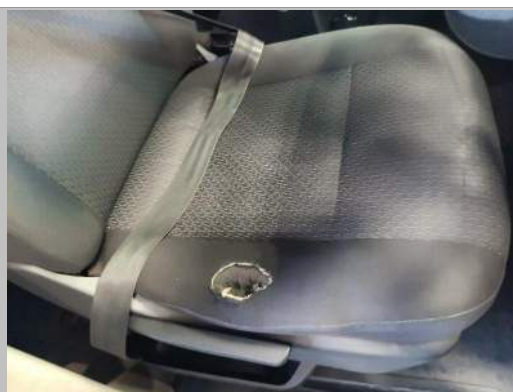
| Seat Front Right Torn / Cut | Replace |

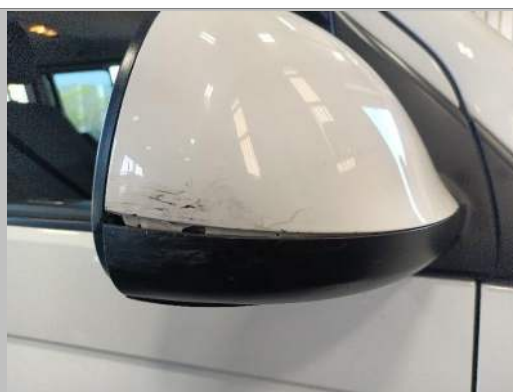
| Side Mirror Right Damaged | Repair |

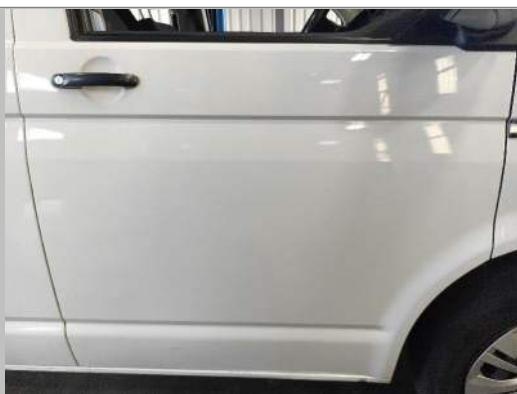
| Door Front Right Residual Traces of Repair | Repair |

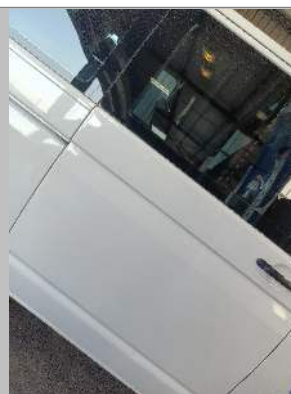
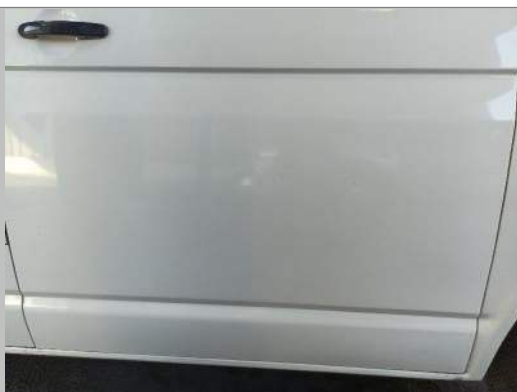
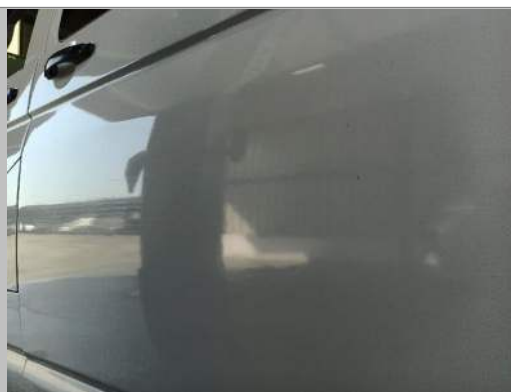
| Sliding Door Residual Traces of Repair | Repair |
| Left sliding door struggling to open. | Repair |

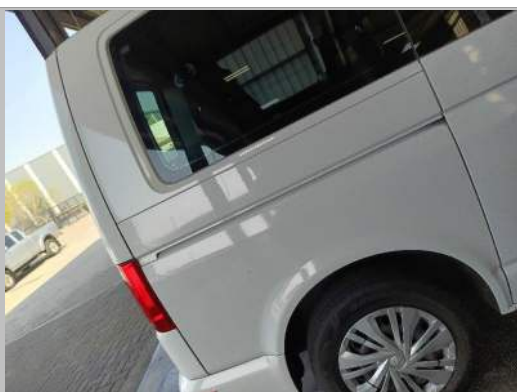
| Rear Fender Right Residual Traces of Repair | Repair |

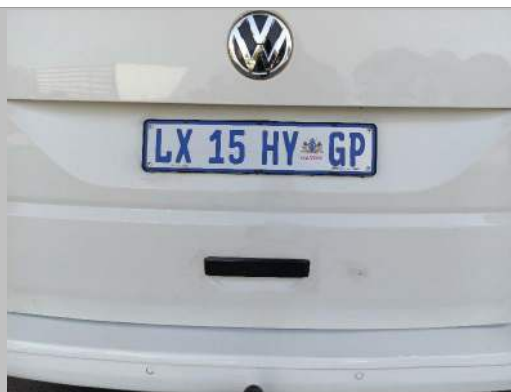
| Boot Lid / Hatch door Paintwork • Scratched | Repair |

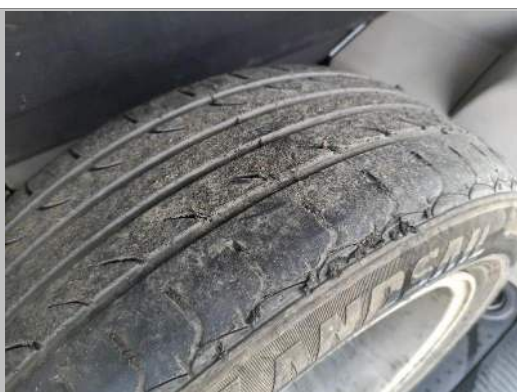
| Spare Tyre Smooth | Replace |

| | Size | Load/Speed Index | Manufacture | Model | Type* | Production Date | Tread Depth (mm) |
|---|---|---|---|---|---|---|---|
| Spare | 205/60R16 | 92H | Landsail | LS | V | 0000 | 0 mm |

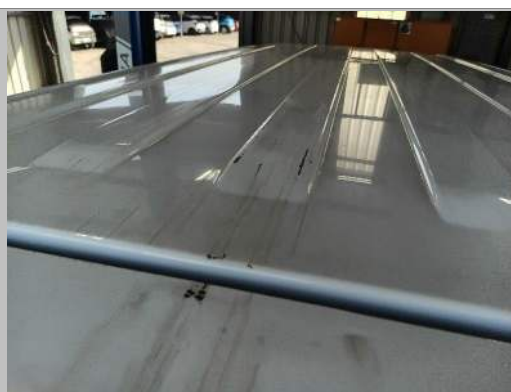
| Roof Paintwork • Scratched | Repair |

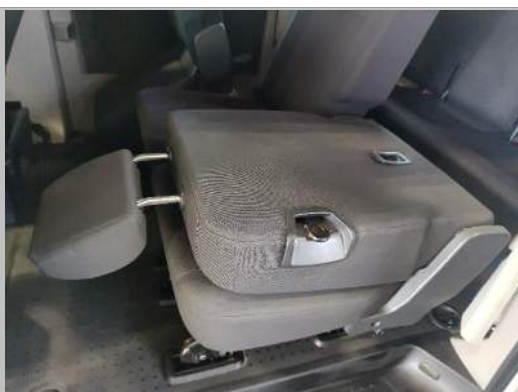
| Seat Rear Damaged | Repair |

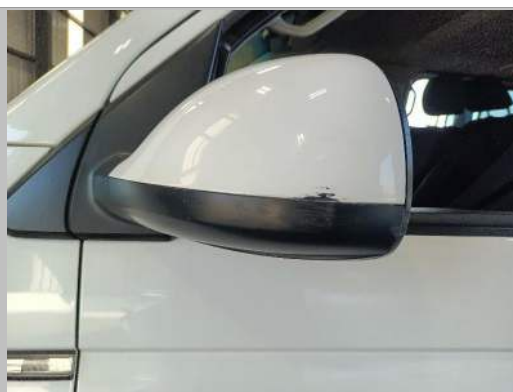
| Side Mirror Left Paintwork • Scratched | Repair |

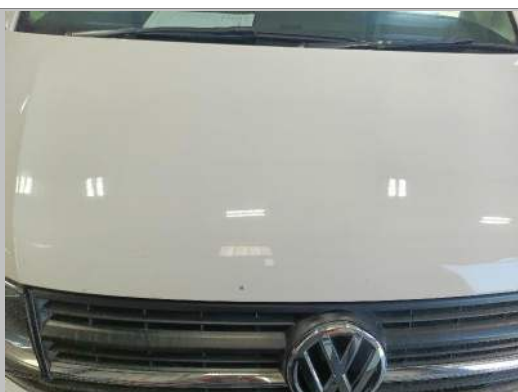
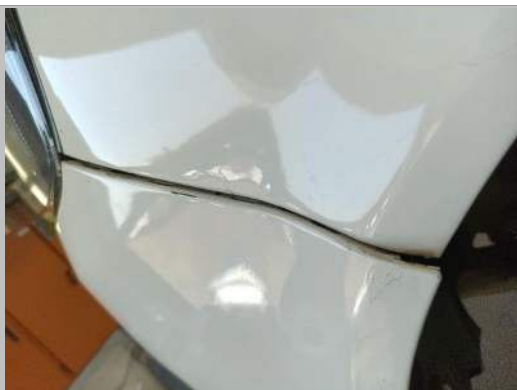
| Bonnet Paintwork • Chipmarks | Repair |

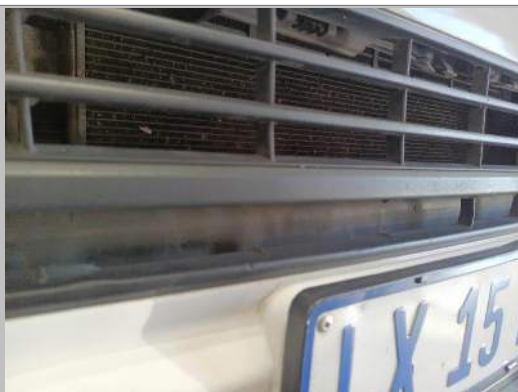
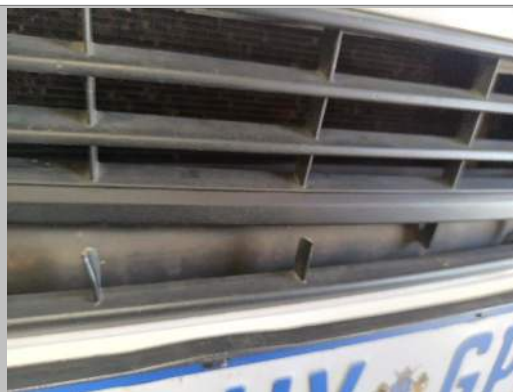
| Grill Damaged | Replace |

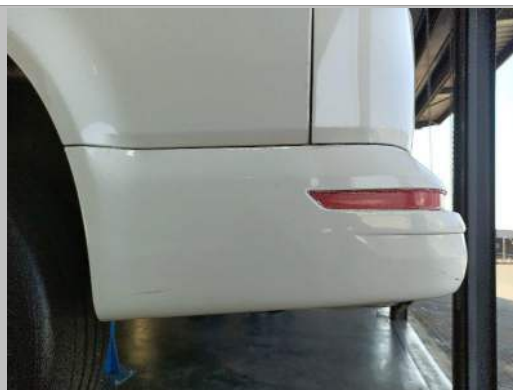
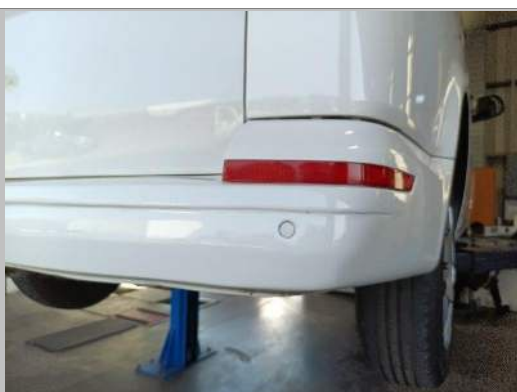
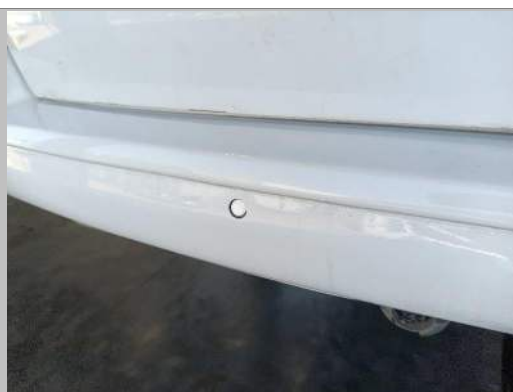
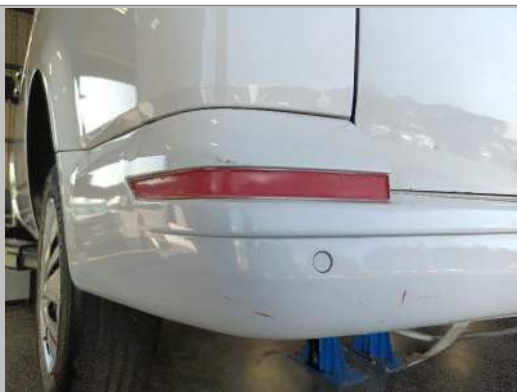
| Rear bumper Residual Traces of Repair | Replace |

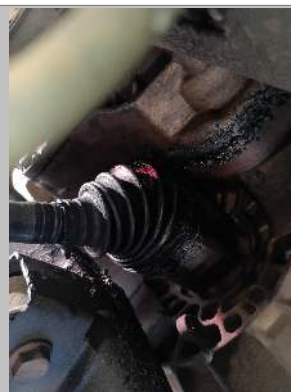
| CV Joint(s) Boot(s) Front Left (inner/outer) Damaged | Replace |

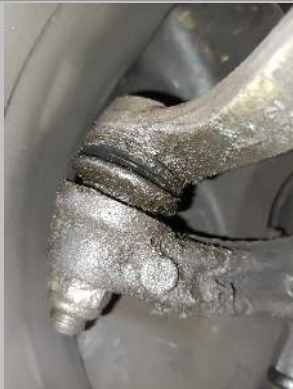
| Ball Joint(s) Front Axle Left Damaged | Replace |

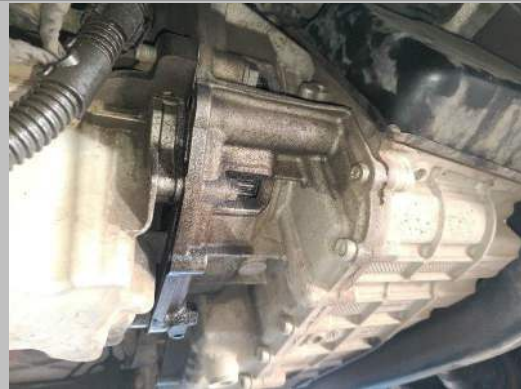
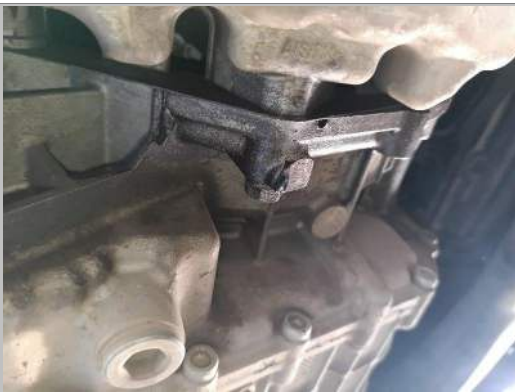
| Gearbox Oil Sweat | Repair |

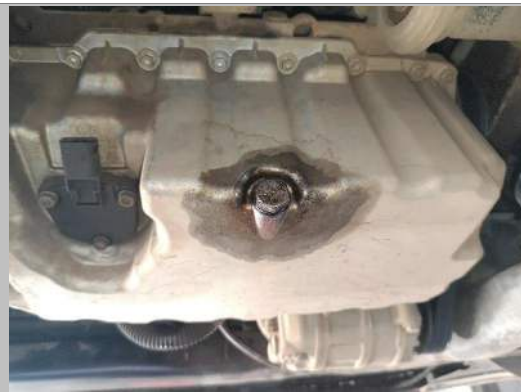
| Engine Oil Sweat | Repair |

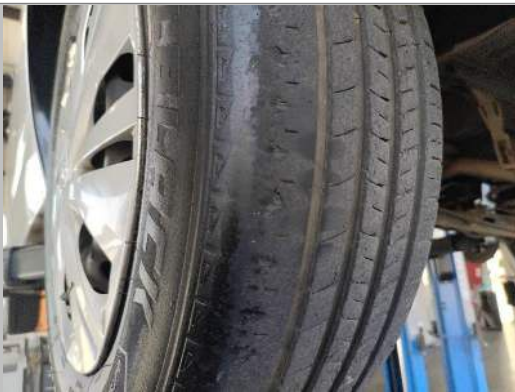
| Tyre Rear Left Smooth | Replace |

| | Size | Load/Speed Index | Manufacture | Model | Type* | Production Date | Tread Depth (mm) |
|---|---|---|---|---|---|---|---|
| Rear Left | 205/65R16 | 95H | Royal black | Mile | V | 4923 | 0 mm |

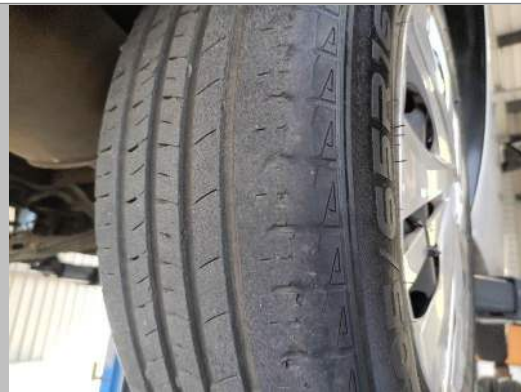
| Tyre Rear Right Smooth | Replace |

| | Size | Load/Speed Index | Manufacture | Model | Type* | Production Date | Tread Depth (mm) |
|---|---|---|---|---|---|---|---|
| Rear Right | 205/65R16 | 95H | Royal black | Mile | V | 4923 | 0 mm |

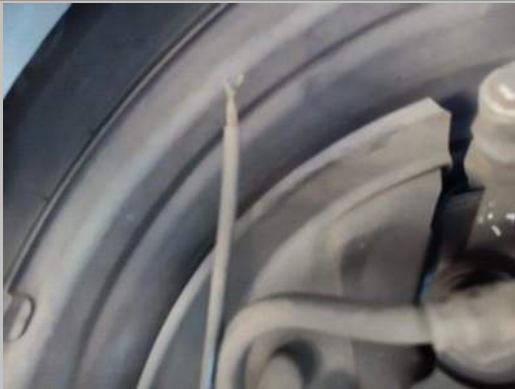
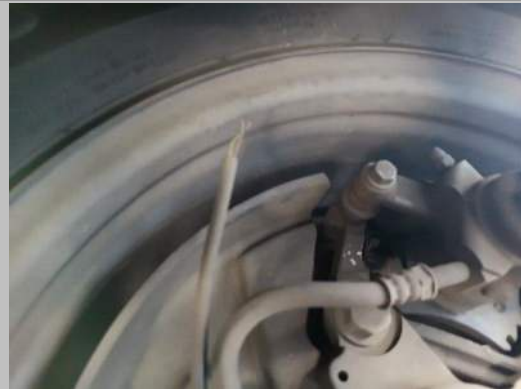
| Brake Piping Torn / Cut | Replace |

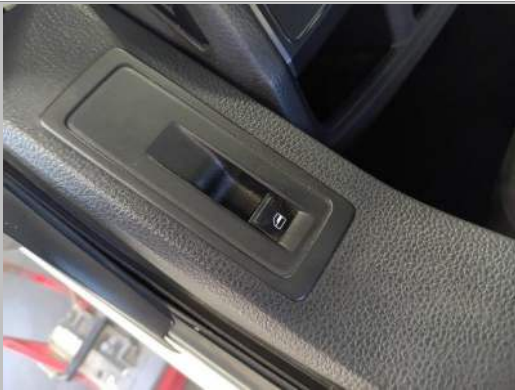
| Switch Electrical Window Winder front left Defective | Repair |
