## CONDITION REPORT

Report No:  
2017300402  
DATE  
17/09/2026

MFC Auction House  
M57 Pretoria Rd, Glenmarais, KEMPTON PARK  
Gauteng

| Model | TIGUAN 2.0 TDI SPORT&STYLE DSL 4MOTION DSG [2011-2015] | Register Number | |

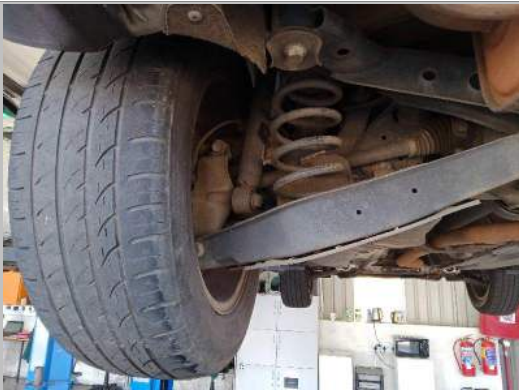
LR TYRE TREAD

| | Size | Load/Speed Index | Manufacture | Model | Type* | Production Date | Tread Depth (mm) |
|---|---|---|---|---|---|---|---|
| Rear Left | 235/55Z R17 | 103W | Rapid | P609 | V | 0121 | 1 mm |

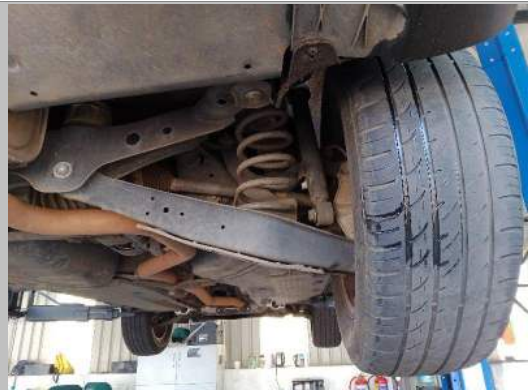
RR TYRE TREAD

| | Size | Load/Speed Index | Manufacture | Model | Type* | Production Date | Tread Depth (mm) |
|---|---|---|---|---|---|---|---|
| Rear Right | 235/55Z R17 | 103W | Rapid | P609 | V | 1521 | 1 mm |

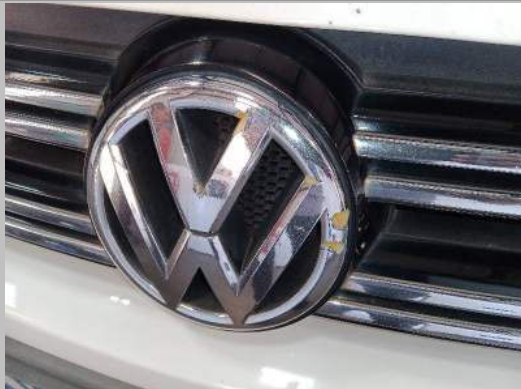
| Damage | Repair Way |
|---|---|
| Front emblem cracked | Replace |

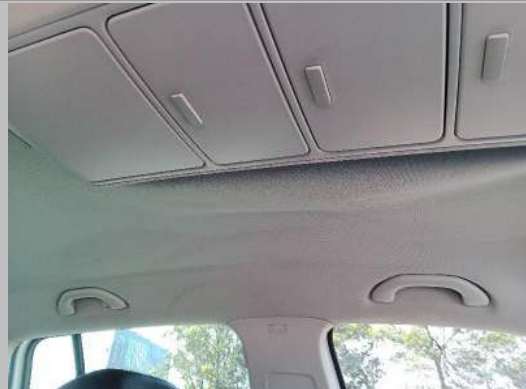
| Damage | Repair Way |
|---|---|
| Hood Lining Damaged | Repair |

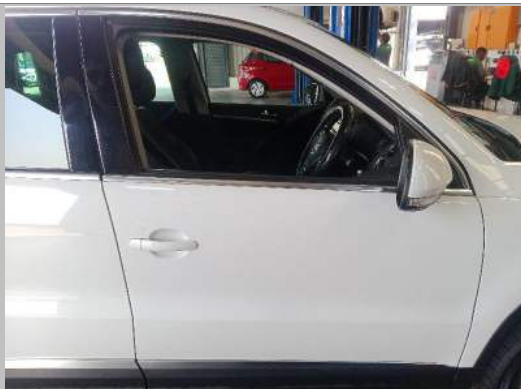
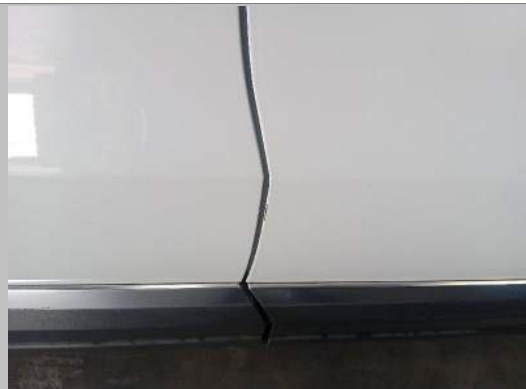
| Damage | Repair Way |
|---|---|
| Door Front Right Paintwork • Scratched | Repair |

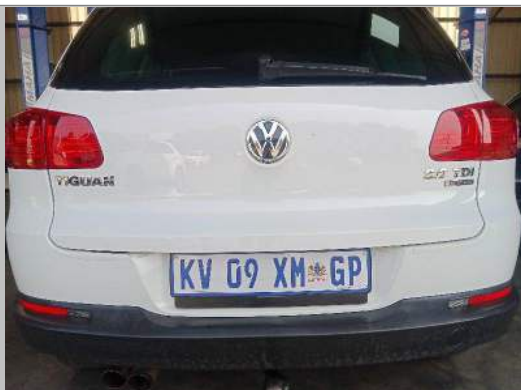
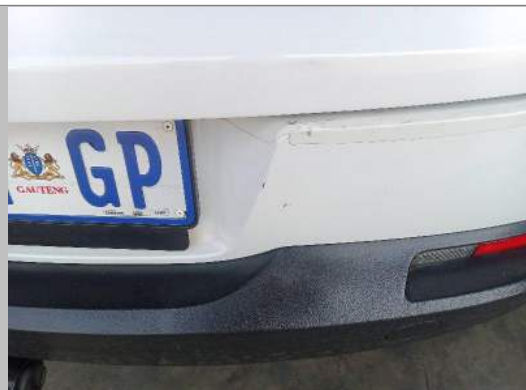
| Damage | Repair Way |
|---|---|
| Rear bumper Paintwork • Scratched | Repair |

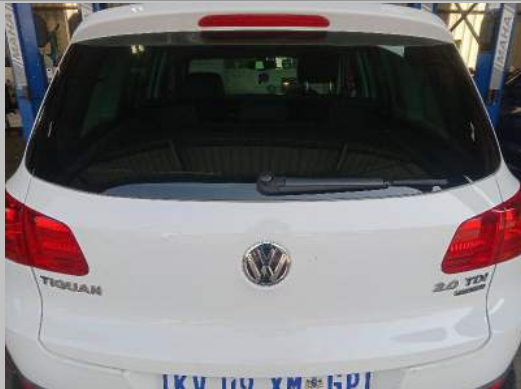
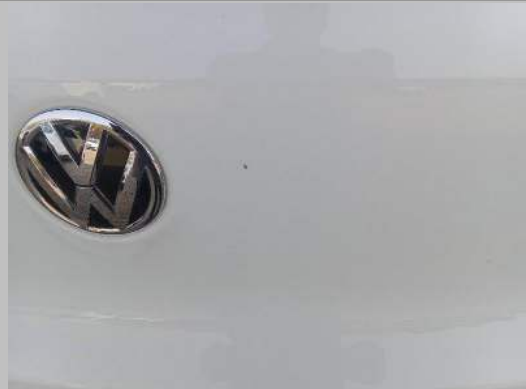
| Damage | Repair Way |
|---|---|
| Boot Lid / Hatch door Paintwork • Chipmarks | Repair |

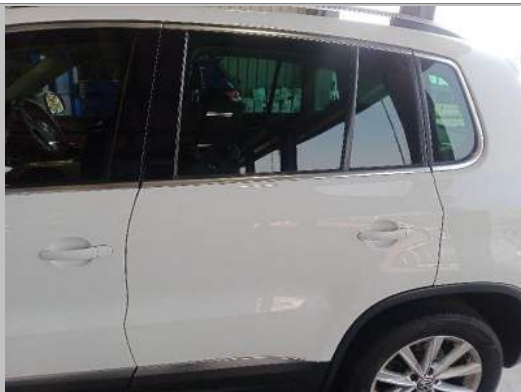
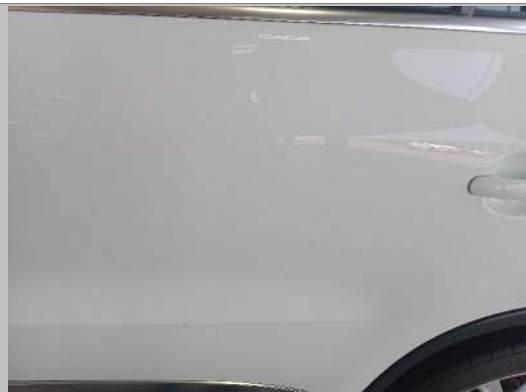
| Damage | Repair Way |
|---|---|
| Door Rear Left Paintwork • Chipmarks | Repair |

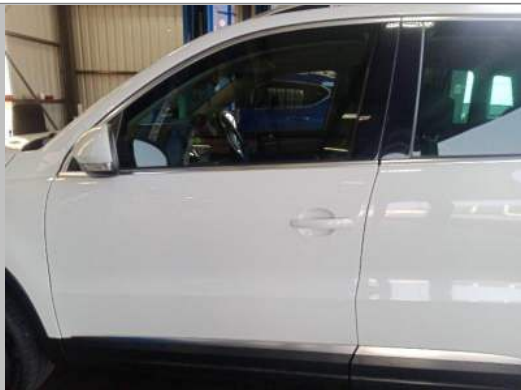
| Damage | Repair Way |
|---|---|
| Door Front Left Dented | Replace |

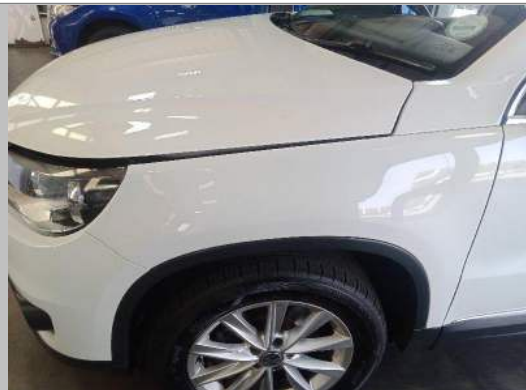
| Damage | Repair Way |
|---|---|
| Front Fender Left Residual Traces of Repair | Repair |

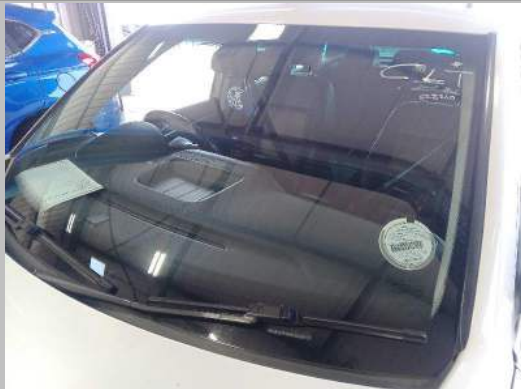
| Damage | Repair Way |
|---|---|
| Windscreen Chipped | Repair |

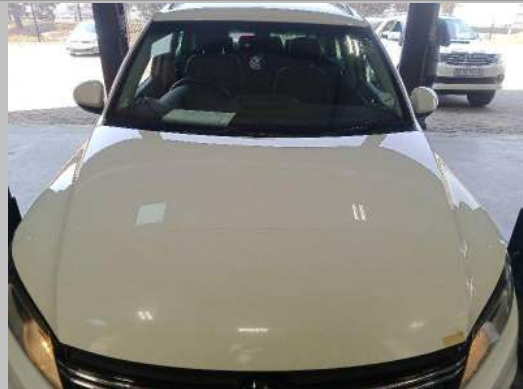
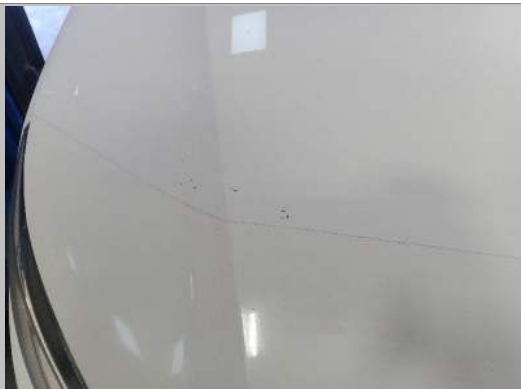
| Damage | Repair Way |
|---|---|
| Bonnet Paintwork • Chipmarks | Repair |

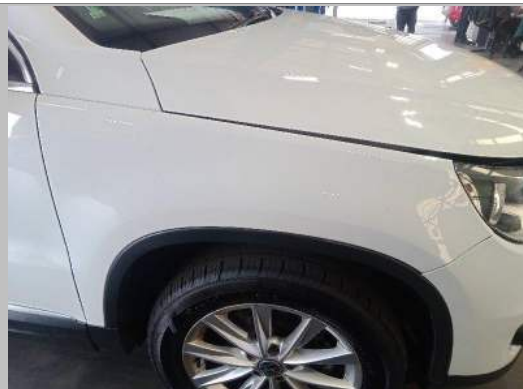
| Damage | Repair Way |
|---|---|
| Front Fender Right Residual Traces of Repair | Repair |

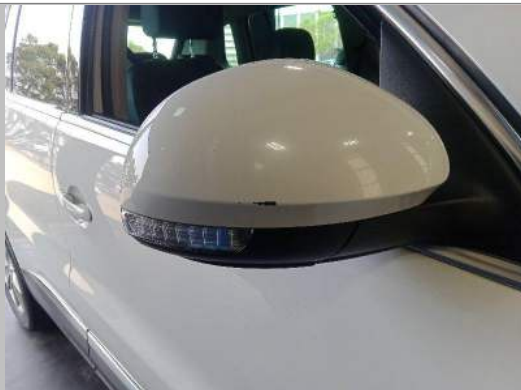
| Damage | Repair Way |
|---|---|
| Side Mirror Right Paintwork • Scratched | Repair |

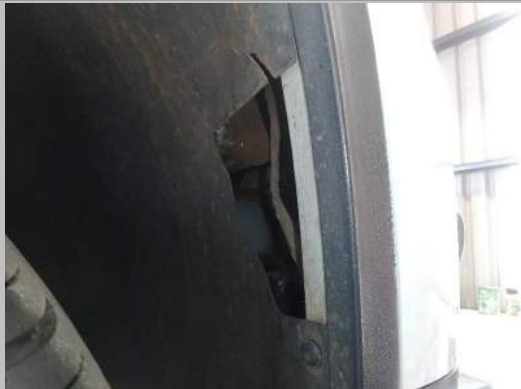
| Damage | Repair Way |
|---|---|
| Front Fender Right / Inner Tray Damaged | Replace |

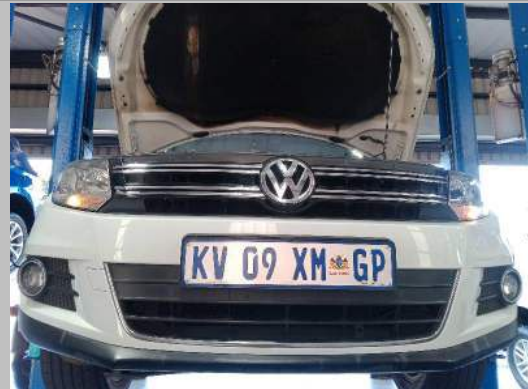
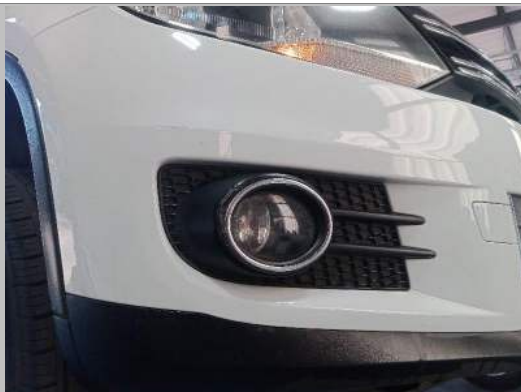
| Damage | Repair Way |
|---|---|
| Front Bumper Paintwork • Scratched | Repair |

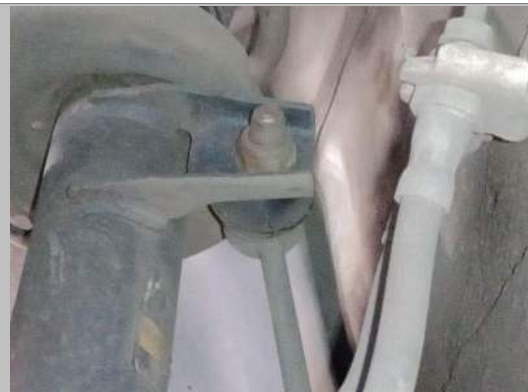
| Damage | Repair Way |
|---|---|
| Stabilizer Mounting Front Left Damaged | Replace |

Axle and Suspension: Front suspension faulty

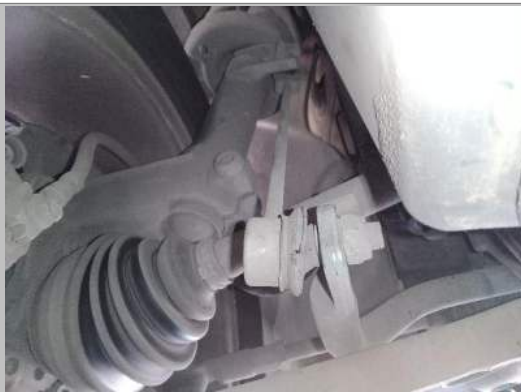
| Damage | Repair Way |
|---|---|
| Stabilizer Mounting Front Right Damaged | Replace |

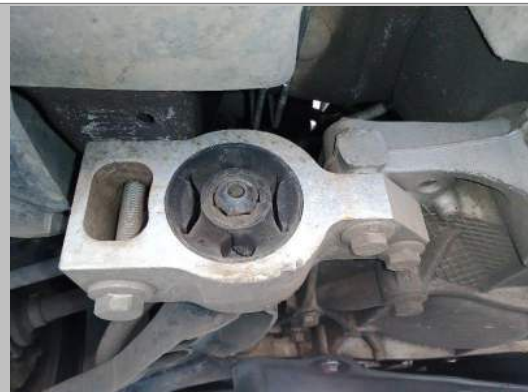
| Damage | Repair Way |
|---|---|
| Control Arm Bush(es) Front Axle Left Cracked | Replace |

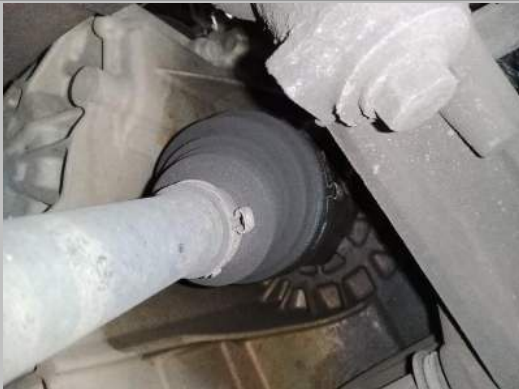
| Damage | Repair Way |
|---|---|
| CV Joint(s) Boot(s) Front Left (inner/outer) Defective | Replace |

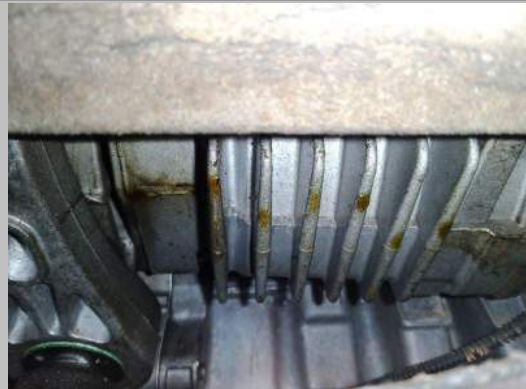
| Damage | Repair Way |
|---|---|
| Gearbox Oil Leak | Repair |

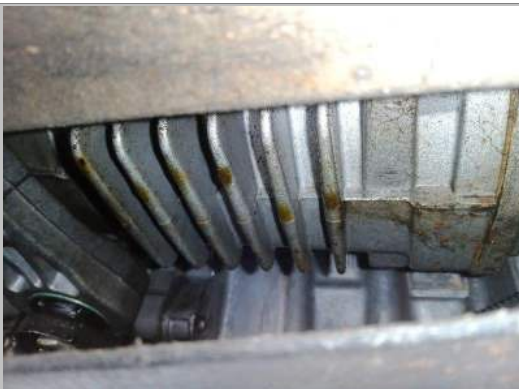
| Damage | Repair Way |
|---|---|
| Differential Oil Leak | Repair |

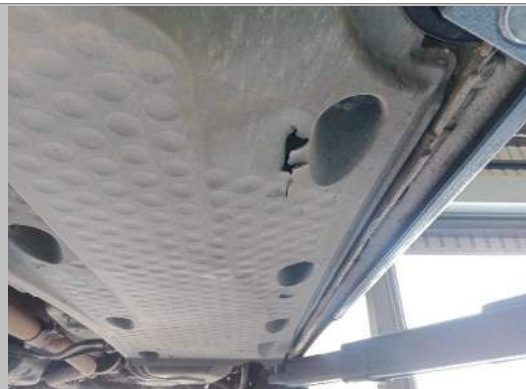
| Damage | Repair Way |
|---|---|
| Belly plates Damaged | Repair |
