## CONDITION REPORT

Report No:  
2017295899  
DATE  
08/09/2026

| Manufacturer | VOLKSWAGEN | Registration Number | MN06MNGP |
| Model | GOLF 7 2.0 TSI GTI 5-DR DSG [2013-2016] | Register Number | |

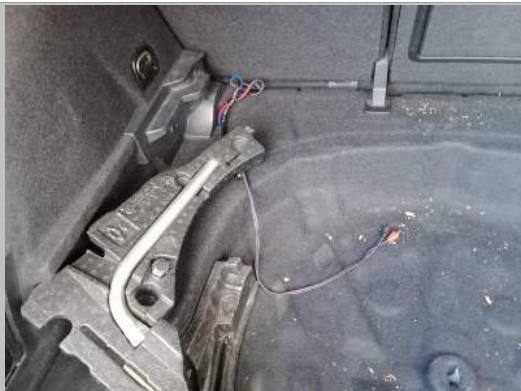
| Loose sound wiring inside boot of vehicle | Replace |

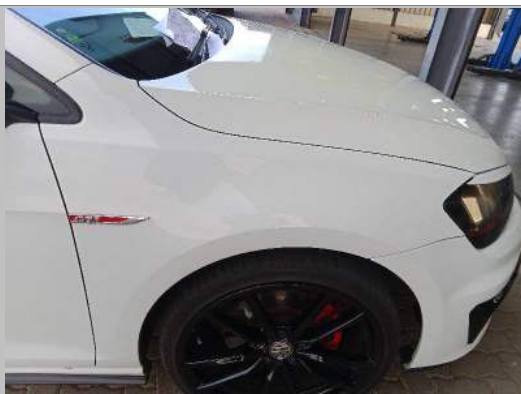
| Front Fender Right Residual Traces of Repair | Repair |

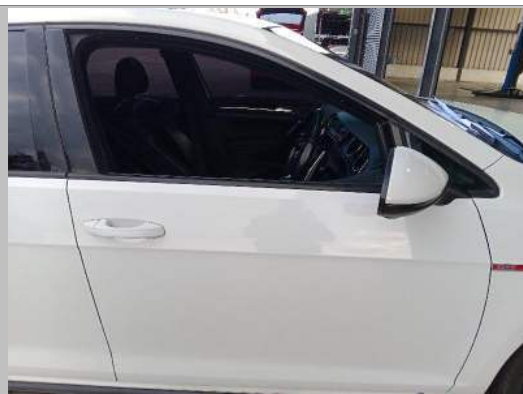
| Door Front Right Residual Traces of Repair | Repair |

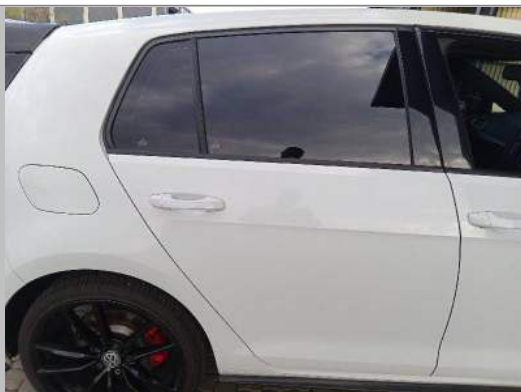
| Door Rear Right Residual Traces of Repair | Repair |

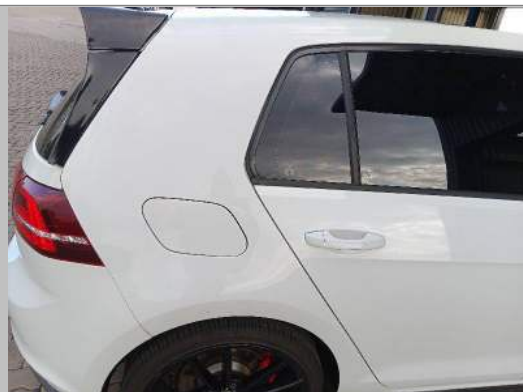
| Rear Fender Right Residual Traces of Repair | Repair |

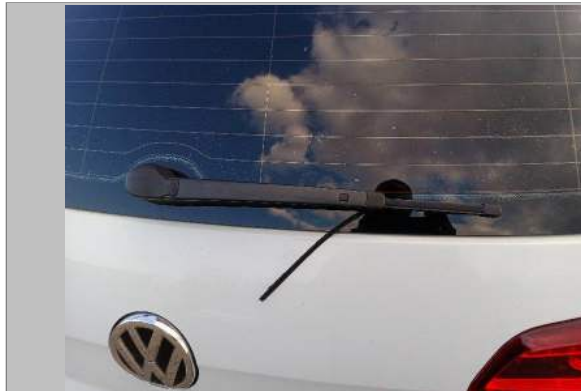
| Windscreen Wiper Damaged | Replace |

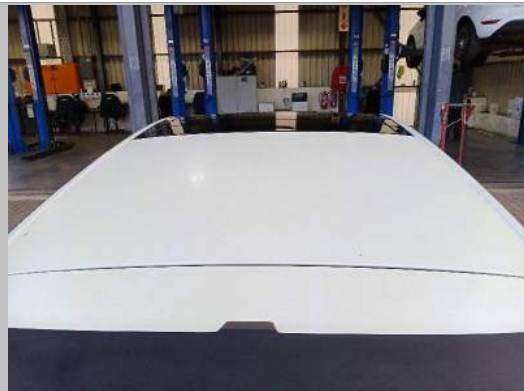
| Roof Residual Traces of Repair | Repair |

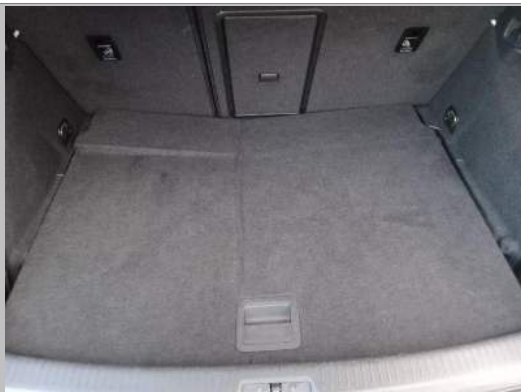
| Boot Carpet Damaged | Repair |

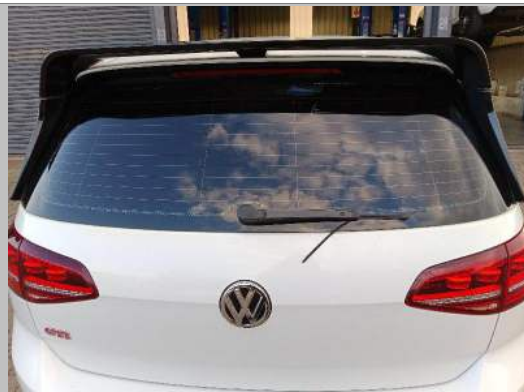
| Boot Lid / Hatch door Residual Traces of Repair | Repair |

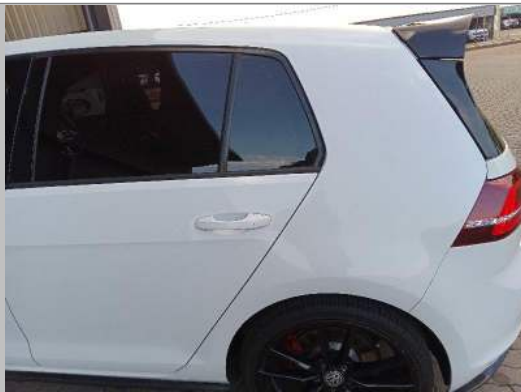
| Rear Fender Left Residual Traces of Repair | Repair |

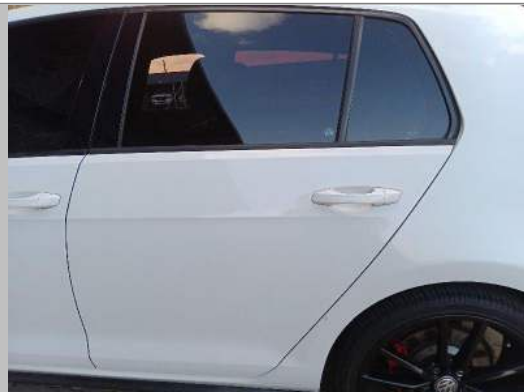
| Door Rear Left Residual Traces of Repair | Repair |

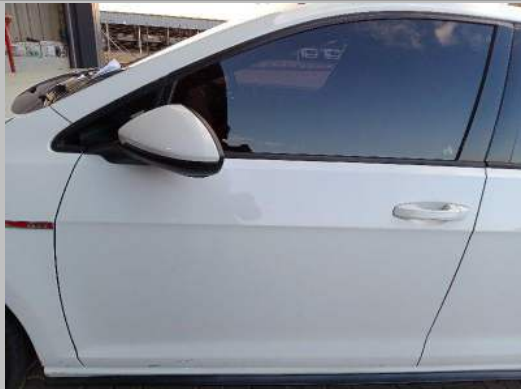
| Door Front Left Residual Traces of Repair | Repair |

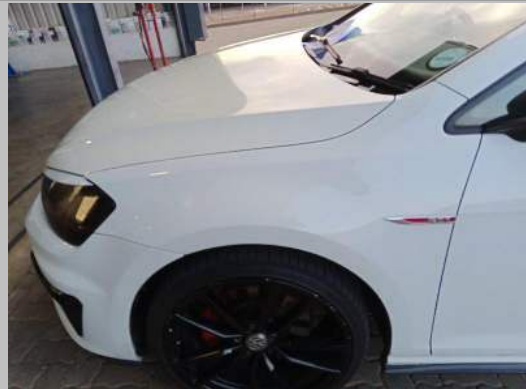
| Front Fender Left Residual Traces of Repair | Repair |

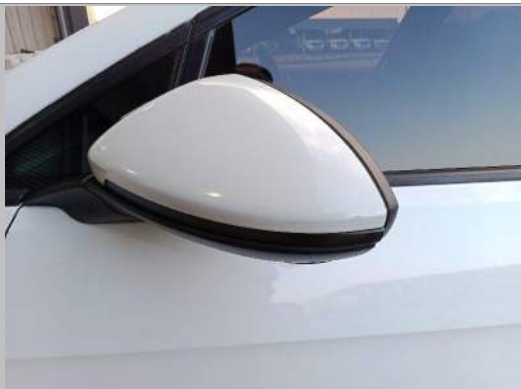
| Side Mirror Left Paintwork • Scratched | Repair |

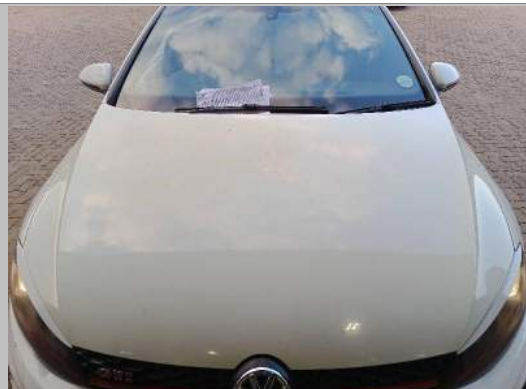
| Bonnet Residual Traces of Repair | Repair |

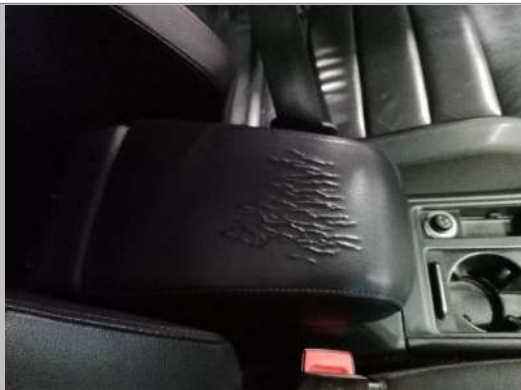
| Center Console / Cubbyhole + Lid Damaged | Repair |

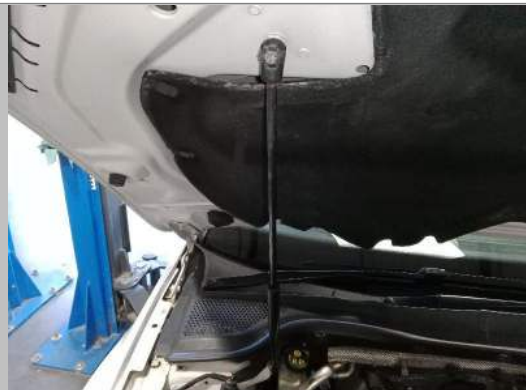
| Bonnet stay and shocks Damaged | Replace |

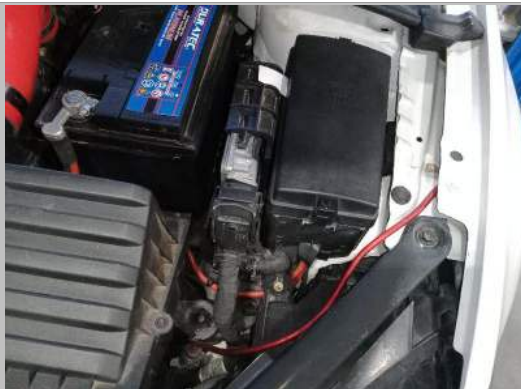
| Engine Wiring Defective | Repair |

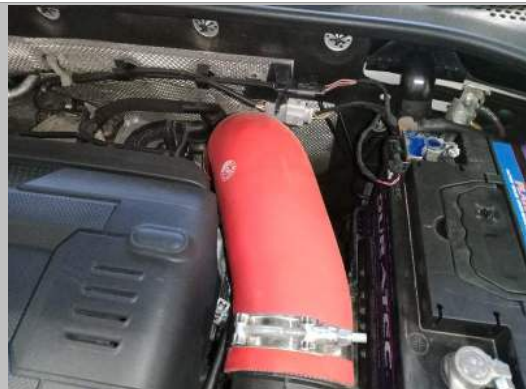
| Hoses Defective | Repair |

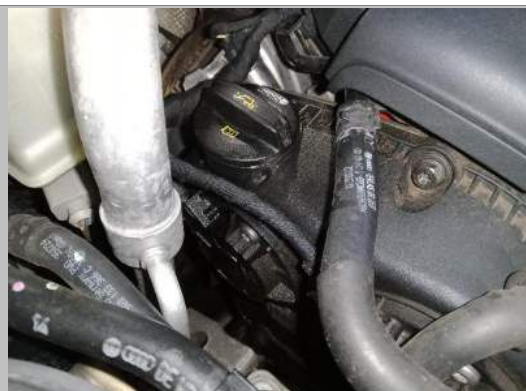
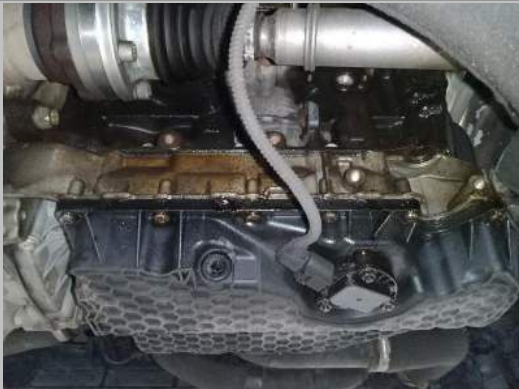
| Engine Oil Leak | Repair |
| Engine Noise Excessive | Repair |

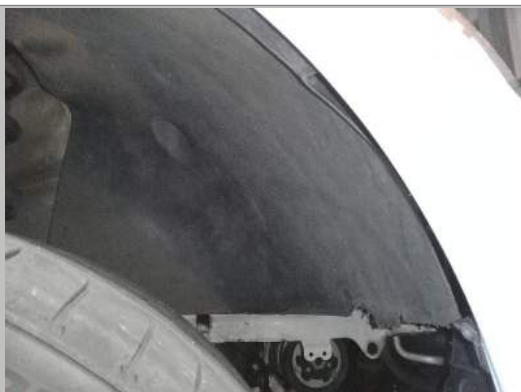
| Front Fender Right / Inner Tray Damaged | Replace |

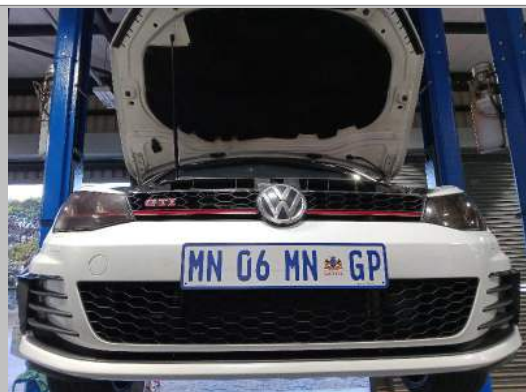
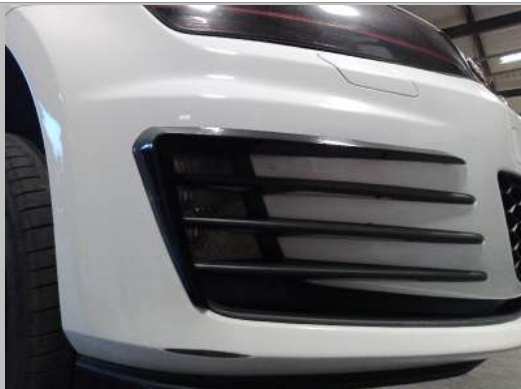
| Front Bumper Paintwork • Scratched | Repair |

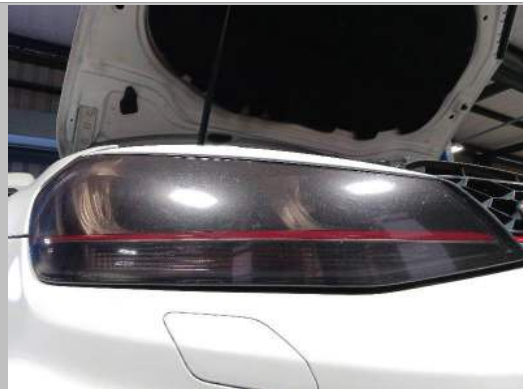
| Headlight Right Defective | Replace |

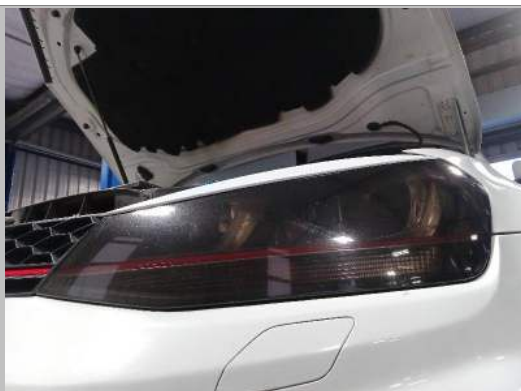
| Headlight Left Defective | Replace |

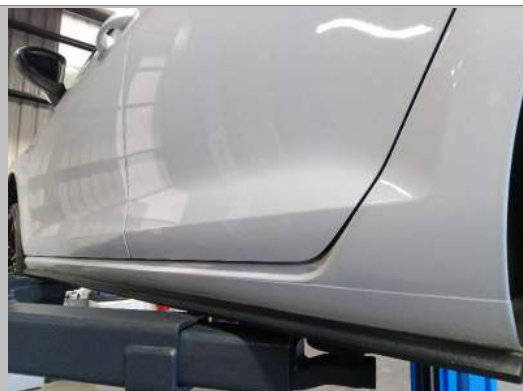
| Sill Panel Left Residual Traces of Repair | Repair |

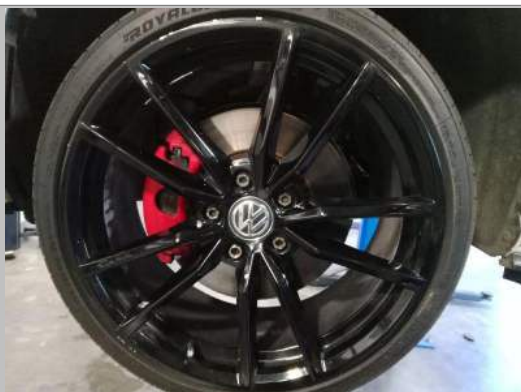
| Rim Front Left Scratched | Repair |

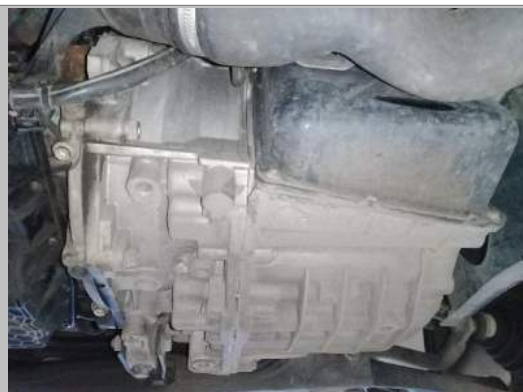
| Gearbox Oil Sweat | Repair |

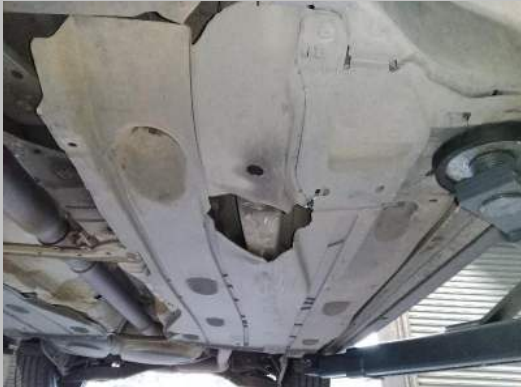
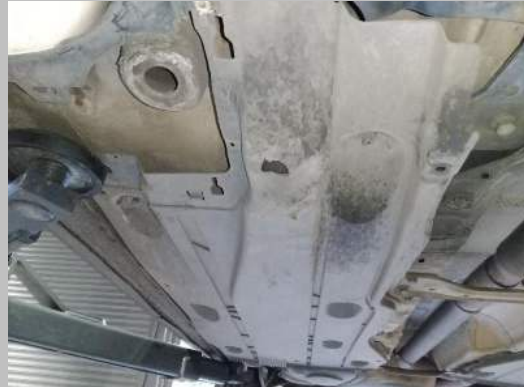
| Belly plates Damaged | Replace |

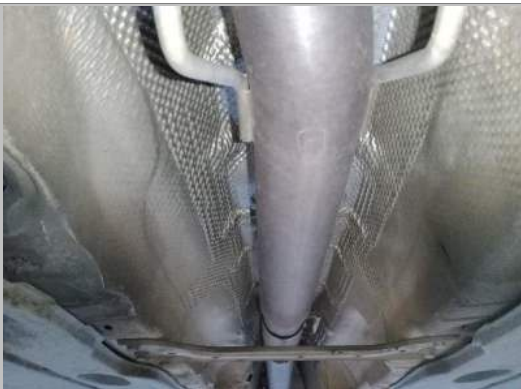
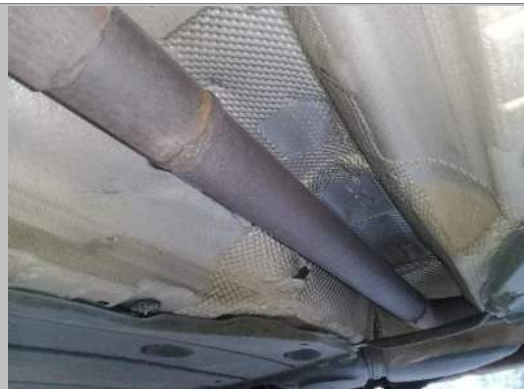
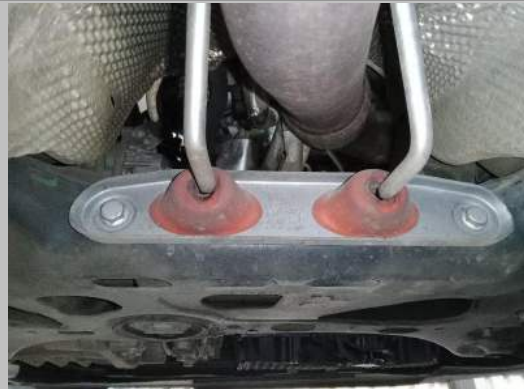
| Engine to silencer pipe Defective | Replace |

Undercarriage: Non standard exhaust fitted to vehicle.

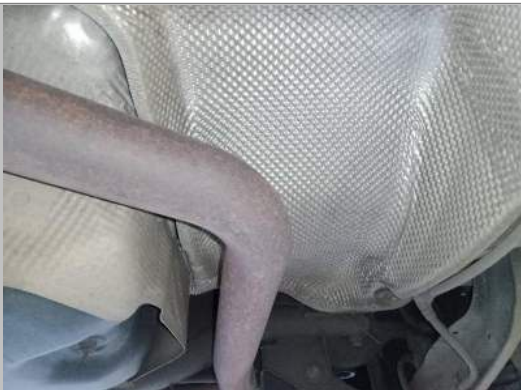
| Silencer Missing | Replace |

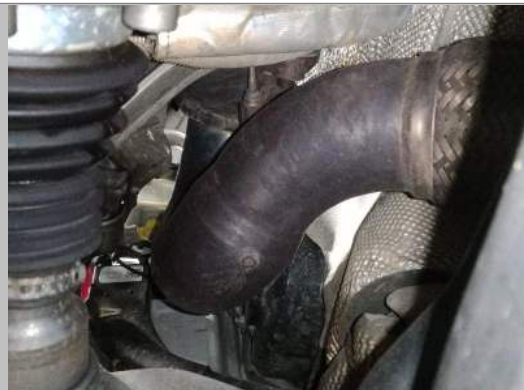
| Catalytic converter Missing | Replace |

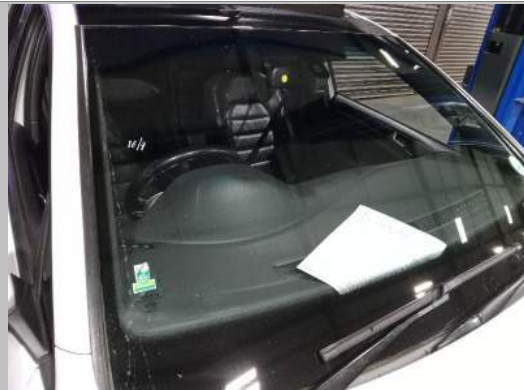
| Windscreen Chipped | Repair |
