## CONDITION REPORT

Report No:  
2017213531  
DATE  
09/04/2026

MFC Auction House  
M57 Pretoria Rd, Glenmarais, KEMPTON PARK  
Gauteng

| Model | GOLF 7 R 2.0 TSI 206KW 4MOTION 5-DR DSG [2015-2017] | Register Number | |

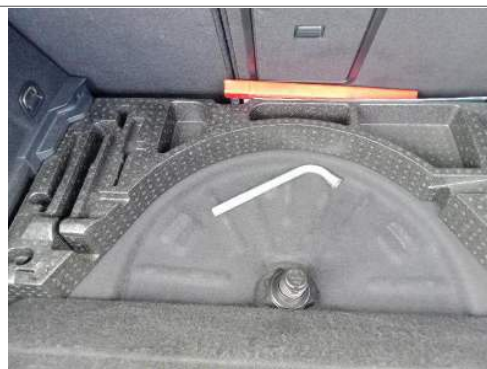
Spare wheel Accessories

| | Damage | Repair Way |
|---|---|---|
| | Tyres and rims | Spare wheel missing |

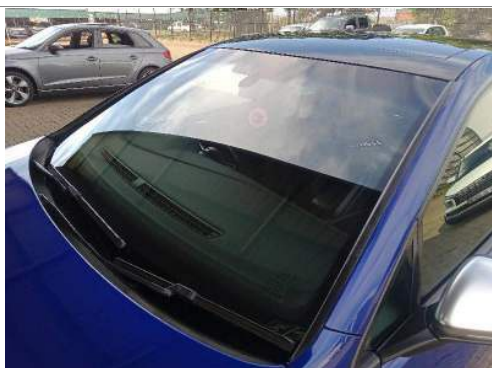
No license disc

| | Damage | Repair Way |
|---|---|---|
| | Vehicle license disk missing | Replace |

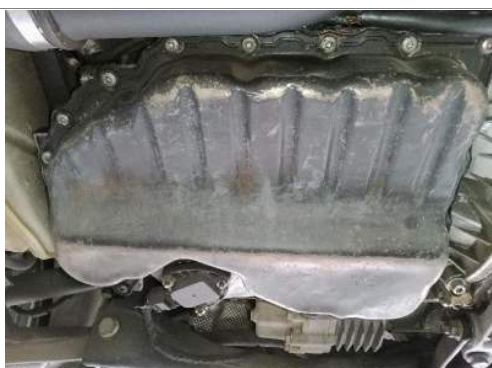
| | Damage | Repair Way |
|---|---|---|
| | Engine | Engine oil sump damaged |

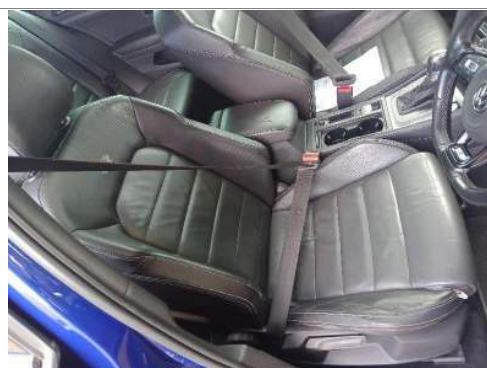
| | Damage | Repair Way |
|---|---|---|
| | Seat Front Right Damaged | Repair |

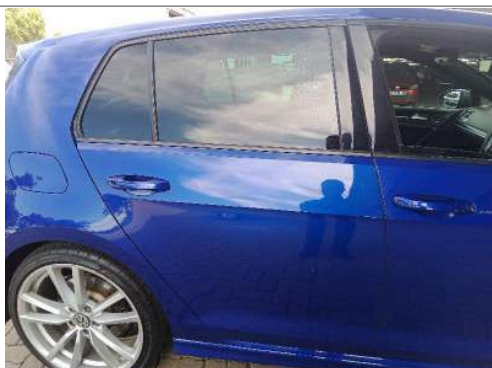
| | Damage | Repair Way |
|---|---|---|
| | Door Rear Right Residual Traces of Repair | Repair |

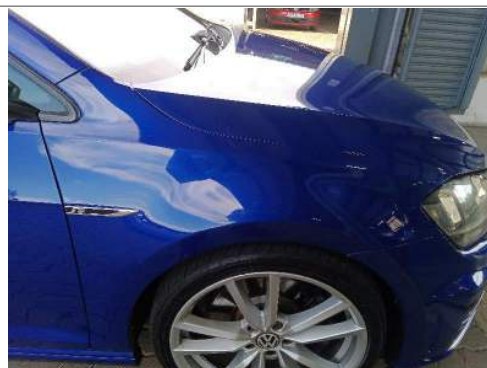
| | Damage | Repair Way |
|---|---|---|
| | Front Fender Right Residual Traces of Repair | Repair |

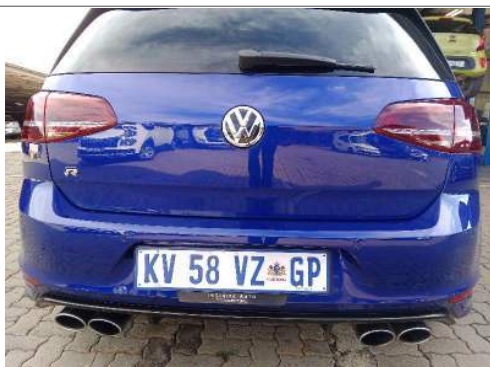
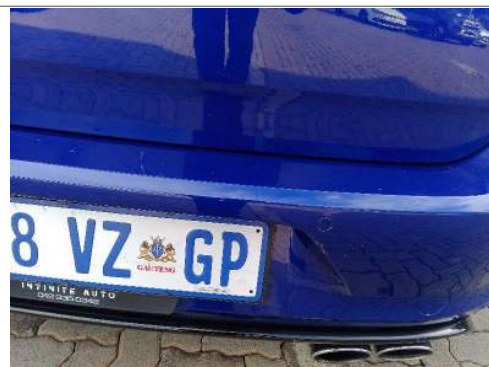
| | Damage | Repair Way |
|---|---|---|
| | Rear bumper Paintwork • Scratched | Repair |

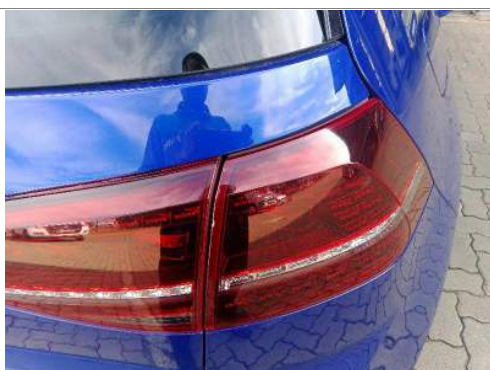
| | Damage | Repair Way |
|---|---|---|
| | Tail Light Right Chipped | Replace |

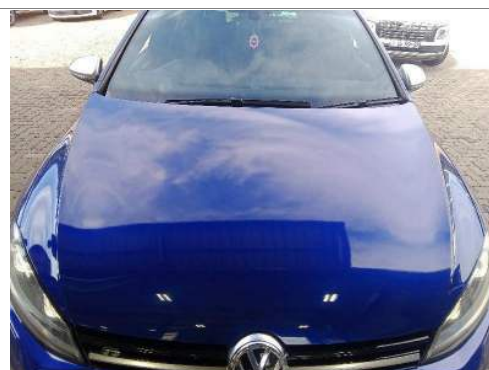
| | Damage | Repair Way |
|---|---|---|
| | Bonnet Residual Traces of Repair | Repair |

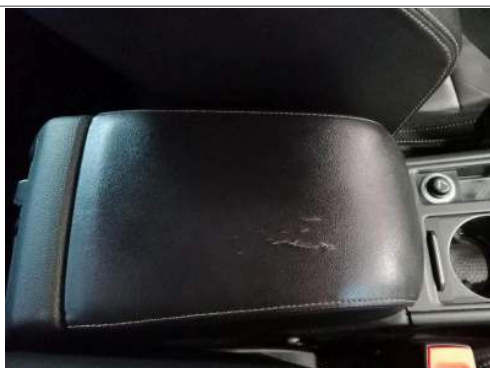
| | Damage | Repair Way |
|---|---|---|
| | Center Console / Cubbyhole + Lid Damaged | Repair |

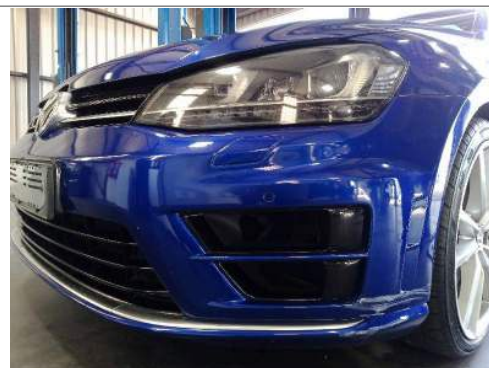
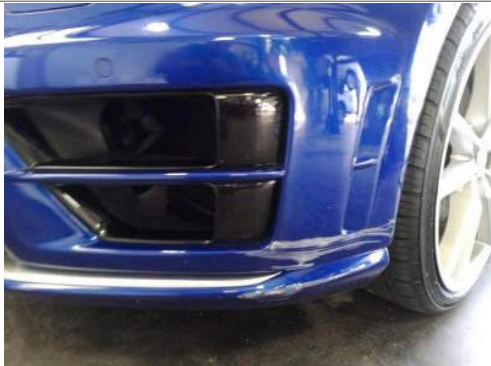
| | Damage | Repair Way |
|---|---|---|
| | Front Bumper Damaged | Repair |

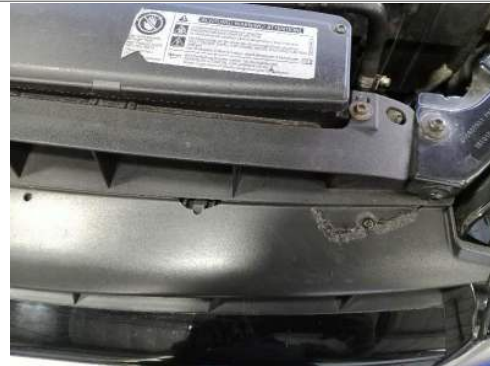
| | Damage | Repair Way |
|---|---|---|
| | Grill Damaged | Replace |

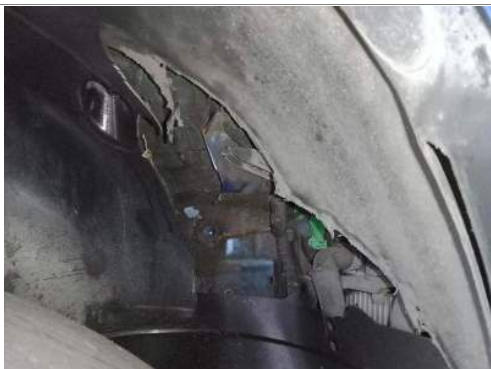
| | Damage | Repair Way |
|---|---|---|
| | Front Fender Right / Inner Tray Damaged | Replace |

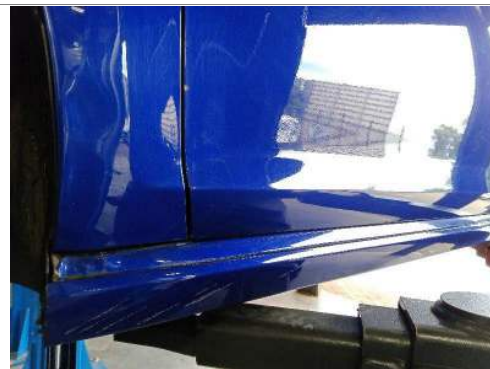
| | Damage | Repair Way |
|---|---|---|
| | Sill Panel Left Damaged | Repair |

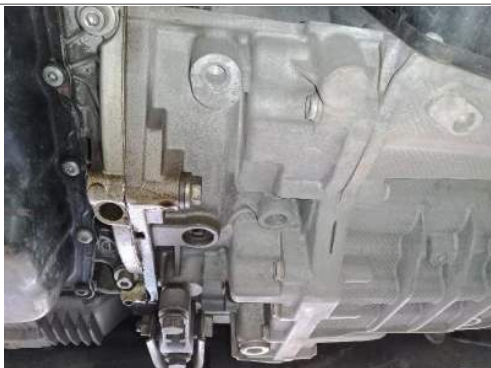
| | Damage | Repair Way |
|---|---|---|
| | Gearbox Oil Leak | Repair |

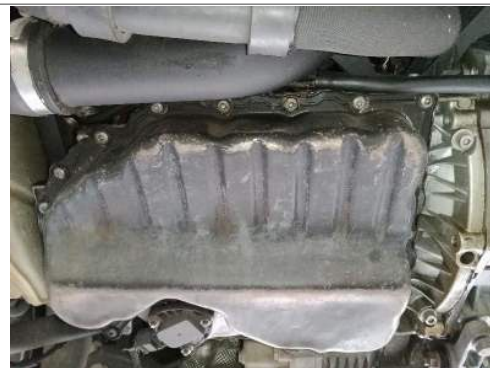
| | Damage | Repair Way |
|---|---|---|
| | Engine Oil Leak | Repair |

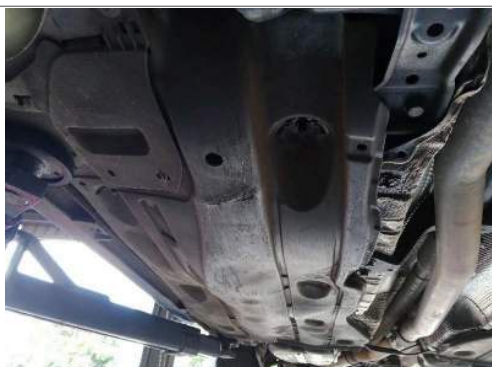
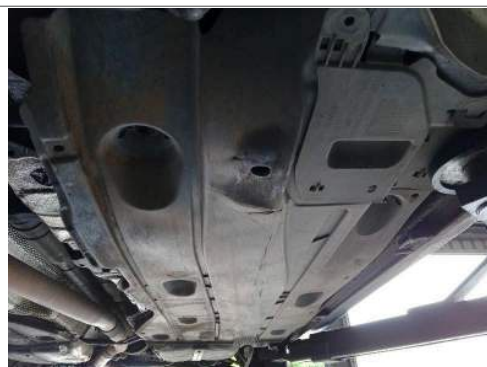
| | Damage | Repair Way |
|---|---|---|
| | Belly plates Damaged | Repair |

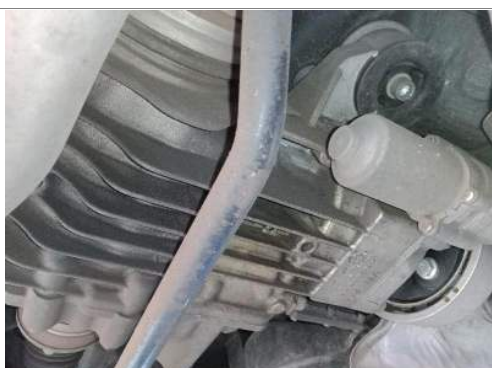
| | Damage | Repair Way |
|---|---|---|
| | Differential Oil Sweat | Repair |

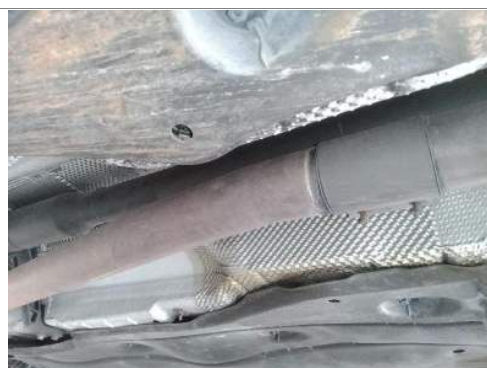
| | Damage | Repair Way |
|---|---|---|
| | Silencer Missing | Replace |

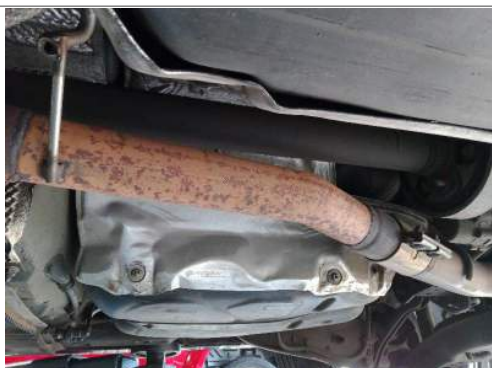
| | Damage | Repair Way |
|---|---|---|
| | Engine to silencer pipe Welded | Replace |
