## CONDITION REPORT

2017297678

| Manufacturer | DODGE | Registration Number | DV62LWGP |
| Model | JOURNEY 3.6 RT AT [2012-2017] | Register Number | |

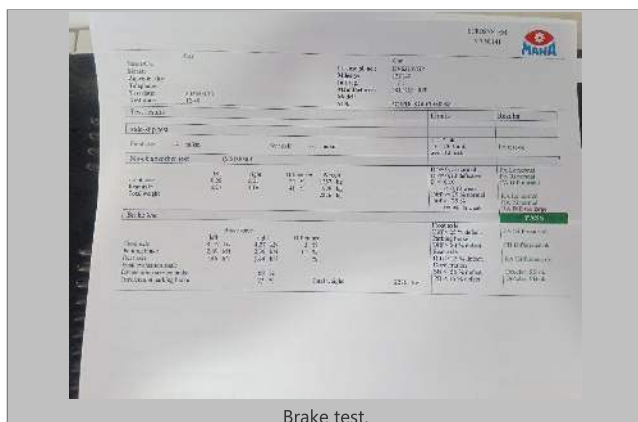
Brake test.

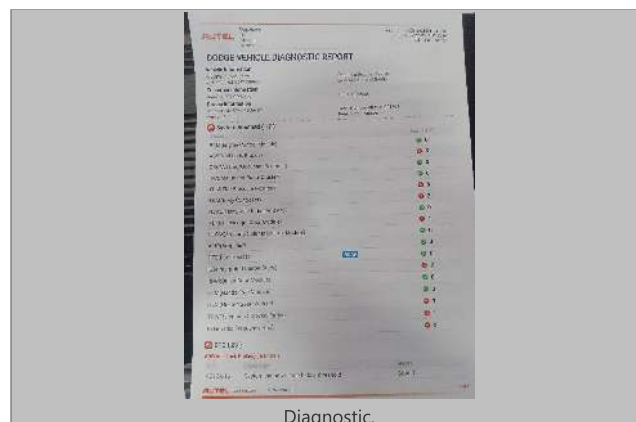
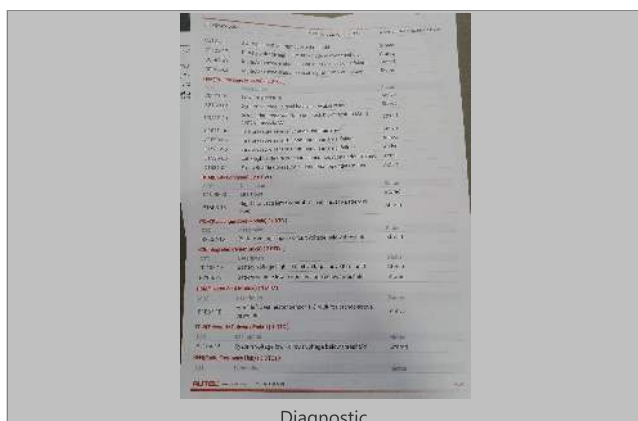
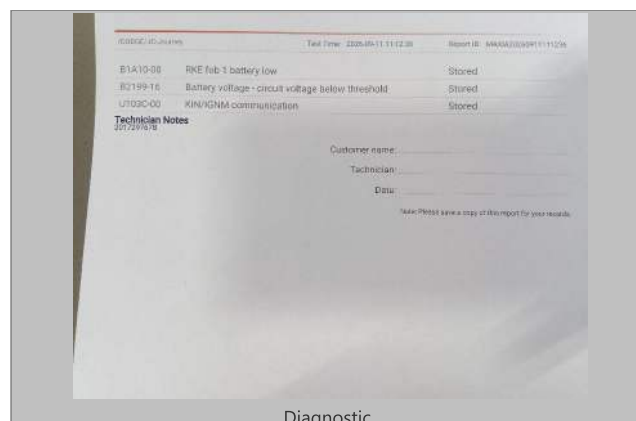
| No | System | Code | Description | Status |
|---|---|---|---|---|
| 1 | ABS | C212A-16 | SYSTEM CIRCUIT VOLTAGE BELOW THRESHOLD | |

Diagnostic.

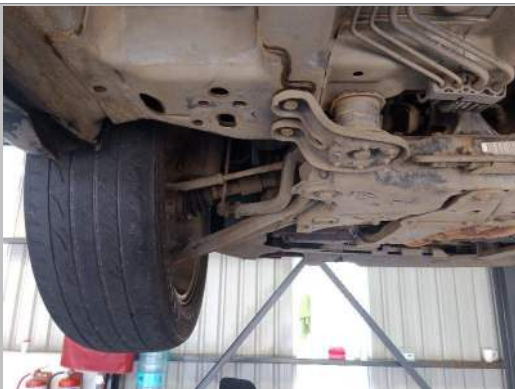
| | Size | Load/Speed Index | Manufacture | Model | Type* | Production Date | Tread Depth (mm) |
|---|---|---|---|---|---|---|---|
| Front Left | 235/55R19 | 105W | Landsail | Radial | V | 0116 | 0 mm |

LF TYRE TREAD

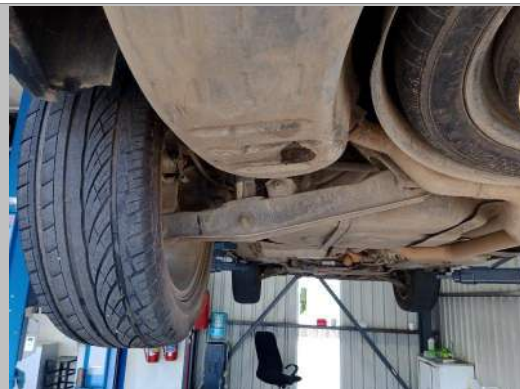
| | Size | Load/Speed Index | Manufacture | Model | Type* | Production Date | Tread Depth (mm) |
|---|---|---|---|---|---|---|---|
| Rear Left | 235/55R19 | 105V | Hifly | Radial | V | 2321 | 2 mm |

LR TYRE TREAD

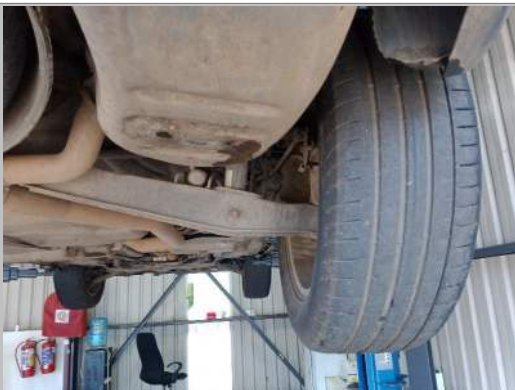
| | Size | Load/Speed Index | Manufacture | Model | Type* | Production Date | Tread Depth (mm) |
|---|---|---|---|---|---|---|---|
| Rear Right | 235/55R19 | 101Y | Goodyear | Eagle | V | 3718 | 2 mm |

RR TYRE TREAD

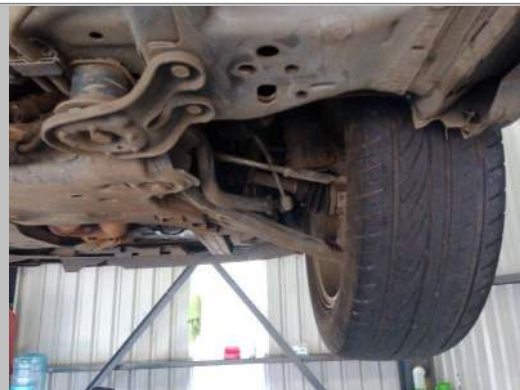
| | Size | Load/Speed Index | Manufacture | Model | Type* | Production Date | Tread Depth (mm) |
|---|---|---|---|---|---|---|---|
| Front Right | 235/55R19 | 105V | Hifly | Radial | V | 0121 | 0 mm |

RF TYRE TREAD

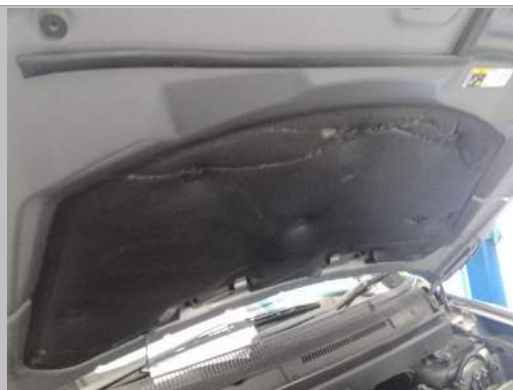
Engine Oil Leak  
Under bonnet insulation cover Damaged  
Radio/CD/USB Defective  
Headlight Right Damaged  
Seat Front Right Damaged  
Front Bumper Damaged  
Bonnet Damaged  
Front Fender Left Damaged  
Front Fender Right Damaged  
Rear Fender Left Damaged  
Rear Fender Right Damaged  
Door Front Left Damaged  
Door Front Right Damaged  
Door Rear Left Damaged  
Door Rear Right Damaged  
Rear bumper Damaged  
Roof Damaged  
Shock Absorber Front Right Damaged  
Stabilizer Mounting Front Right Damaged  
Control Arm(s) Front Rear Left Worn  
Control Arm(s) Front Rear Right Worn  
Control Arm Bush(es) Front Axle Left Worn  
Control Arm Bush(es) Front Axle Right Worn  
Tyre Front Left Worn  
Tyre Front Right Worn  
Gearbox Oil Leak

Repair  
Replace  
Repair  
Replace  
Replace  
Repair  
Repair  
Repair  
Repair  
Repair  
Repair  
Repair  
Repair  
Repair  
Replace  
Replace  
Replace  
Replace  
Replace  
Replace  
Replace  
Replace  
Replace  
Replace  
Replace  
Repair
