CONDITION REPORT

Report No:  
2017095089  
DATE  
08/12/2025

Vehicle Type	PASSENGER VEHICLE	Registered Owner	MFC
Manufacturer	VOLKSWAGEN	Registration Number	KYR291MP
Model	POLO VIVO 1.4 55KW TRENDLINE 5-DR [2023-2024]	Register Number	
VIN	AAVZZZ6RZPU024783	Date Of First Licensing	
Engine Number		Last COR	
Doors	5	License Expiry Date	28/02/2026
Color	SILVER	Power / Displacement	
Year Model	2023	Paint Finish	TWO COAT UNI
Km Reading	45,473 KM	Fuel	PETROL
Cab / Body Type	HATCHBACK	Transmission	MANUAL

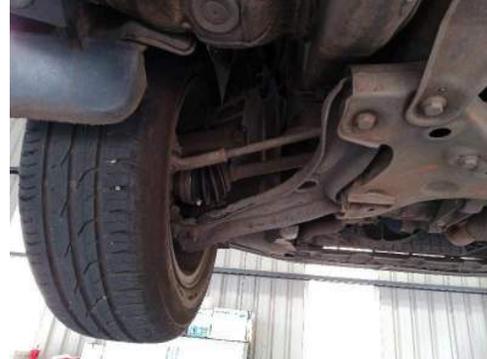
LF TYRE TREAD

Size	Load/Speed Index	Manufacture	Model	Type*	Production Date	Tread Depth (mm)
Front Left	185/60 R15	84H	Continental	Contipremuim	V	3524	4 mm
Front Right	185/60 R15	84H	Continental	Contipremuim	V	3023	2 mm
Rear Left	185/60 R15	84H	Continental	Contipremuim	V	2123	4 mm
Rear Right	185/60 R15	84H	Continental	Contipremuim	V	0325	6 mm
Spare	185/60 R14	82H	Goodyear	Efficient	V	2623	5 mm

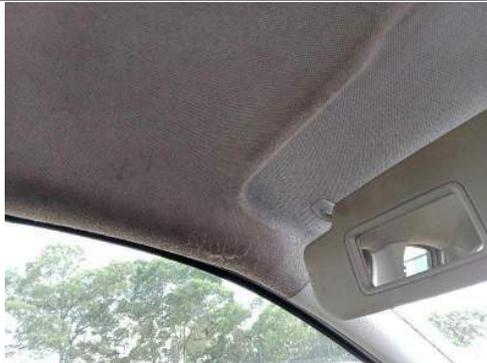
Damage	Repair Way
Engine Oil Sweat	Repair
Tail Light Left Damaged	Replace
Hood Lining Damaged	Repair
Parcel Tray Damaged	Repair
Steering Wheel Trim Excessive Wear & Tear	Repair
Side Mirror Right Paintwork • Scratched	Repair
Front Bumper Paintwork • Scratched	Repair
Front Fender Right Paintwork • Scratched	Repair
Rear Fender Left Damaged	Repair
Rear Fender Right Paintwork • Scratched	Repair
Door Rear Left Damaged	Repair
Door Rear Right Dented	Repair
Boot Lid / Hatch door Dented	Repair
Rear bumper Paintwork • Scratched	Repair
Sill Panel Right Damaged	Repair
Tyre Rear Left Damaged	Replace
Belly plates Damaged	Replace
CV Joint(s) Front Right (inner/outer) Defective	Repair
Radiator Cradle Damaged	Repair

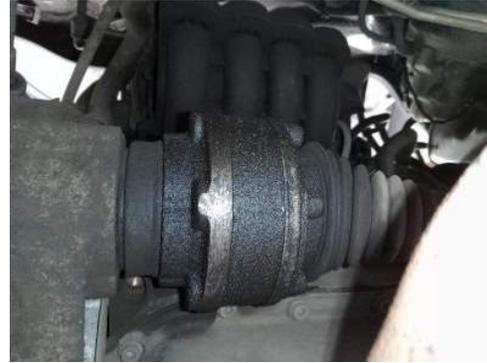
CV Joint(s) Front Right (inner/outer)

General Comments: ACCORDING TO THE AGE AND MILEAGE OF THE VEHICLE, NORMAL WEAR AND TEAR MARKS ARE VISIBLE ON THE INTERIOR, EXTERIOR, ELECTRICAL AND MECHANICAL PARTS. Interior: Vehicle interior dirty and some panels scratched  
Body • Exterior: Dents and scratches on some body panels  
Undercarriage: Oil sweat on front right inner CV joint. Vehicle undercarriage dirty
