CONDITION REPORT

Report No:
2017067165
DATE
10/11/2025

Vehicle Type	PASSENGER VEHICLE	Registered Owner	MFC
Manufacturer	VOLKSWAGEN	Registration Number	KTL916MP
Model	POLO 1.0 TSI 70KW 5-DR [2022-2024]	Register Number	
VIN	AAVZZZAWZPU038403	Date Of First Licensing	
Engine Number		Last COR	
Doors	5	License Expiry Date	31/01/2026
Color	WHITE	Power / Displacement	
Year Model	2023	Paint Finish	TWO COAT UNI
Km Reading	73,036 KM	Fuel	PETROL
Cab / Body Type	HATCHBACK	Transmission	MANUAL

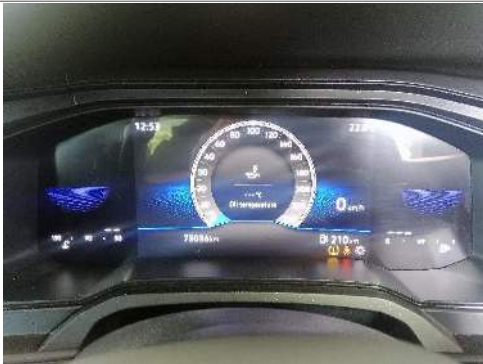
DASHBOARD (W/ ENGINE RUNNING)

No	System	Code	Description	Status
1	AGENT CONTROL MODULE 1	P06EF00	ENGINE RESTART PERFORMANCE

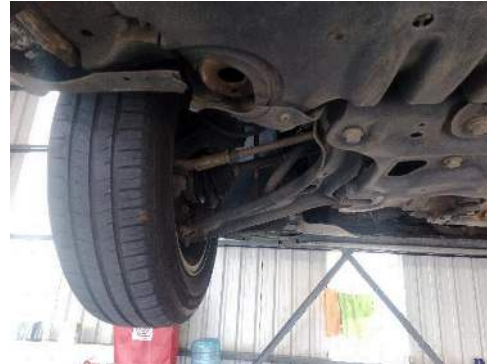
LF TYRE TREAD

Size	Load/Speed Index	Manufacture	Model	Type*	Production Date	Tread Depth (mm)
Front Left	185/65R15	88H	Xcent	Radial	V	3824	2 mm
Front Right	185/65R15	88H	Xcent	Radial	V	3824	2 mm
Rear Left	185/65R15	88H	Goodyear	Efficient	V	4122	0 mm
Rear Right	185/65R15	88H	Goodyear	Efficient	V	4122	1 mm

Seat Front Right Damaged	Repair
Front Bumper Damaged	Repair
Bonnet Damaged	Repair
Front Fender Left Damaged	Repair
Front Fender Right Damaged	Repair
Rear Fender Left Damaged	Repair
Rear Fender Right Damaged	Repair
Door Front Left Damaged	Repair
Door Front Right Damaged	Repair
Door Rear Left Damaged	Repair
Door Rear Right Damaged	Repair
Boot Lid / Hatch door Damaged	Repair
Rear bumper Damaged	Repair
Window Rear Door Right Damaged	Replace
Service Brake Performance Rear Axle Left / Right	Repair
Difference out of legal range	
Parking Brake Performance Left / Right Difference out of legal range	Repair
Tyre Rear Left Worn	Replace

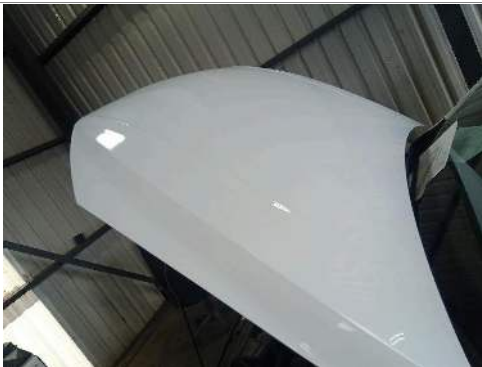
Bonnet

General Comments: ACCORDING TO THE AGE AND MILEAGE OF THE VEHICLE, NORMAL WEAR AND TEAR MARKS ARE VISIBLE ON THE INTERIOR, EXTERIOR, ELECTRICAL AND MECHANICAL PARTS. 11 DTC'S AT TIME OF TESTING SEE DTC REPORT. Body • Exterior: bonnet slam plate plastic cover damaged. Minor dents and scratches and stone chips to some body panels. Signs of repair work done to somebody panels. Poor alignment to somebody panels. Vehicle body in poor condition.
