## CONDITION REPORT

Report No:  
2017294644  
DATE  
04/09/2026

| Manufacturer | ISUZU | Registration Number | KPF527MP |
| Model | D-MAX 3.0 DDI HR LSE D-CAB DSL PU AT [2022-2023] | Register Number | |

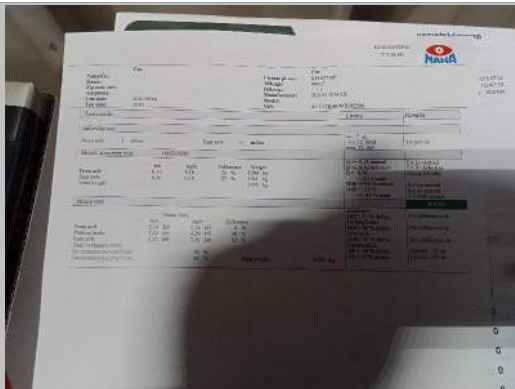
Brake test.

## Brake Test Results

| | Left | Right | | |
|---|---|---|---|---|
| Front | 5.14 | 5.16 | - | |
| Rear | 3.23 | 3.7 | - | |
| Emergency / Parking | 3 | 4.29 | - | |

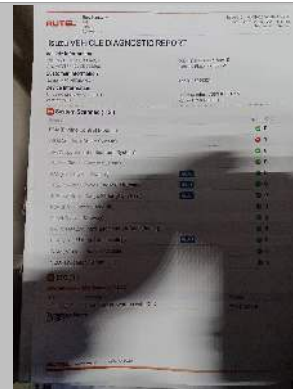
Diagnostic.

During the diagnostic the following error messages were detected: (See also attached Diagnostic Report. For more information regarding the Fault Codes (DTC) and the recommended rectifications please contact the workshops of the vehicle manufacture).

| No | System | Code | Description | Status |
|---|---|---|---|---|
| 1 | ABS | U0136_87 | LOSS COMMUNICATION WITH DLC | |

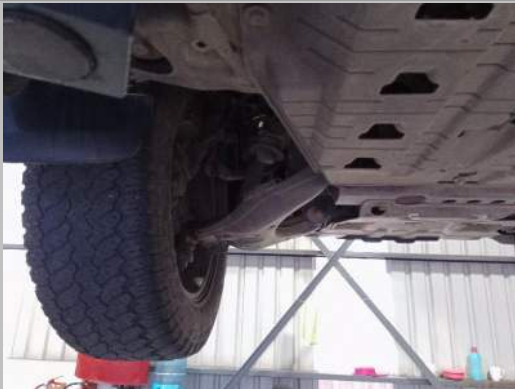
LF TYRE TREAD

| | Size | Load/Speed Index | Manufacture | Model | Type* | Production Date | Tread Depth (mm) |
|---|---|---|---|---|---|---|---|
| Front Left | 265/60R18 | 110H | General | Radial | V | 0722 | 2 mm |

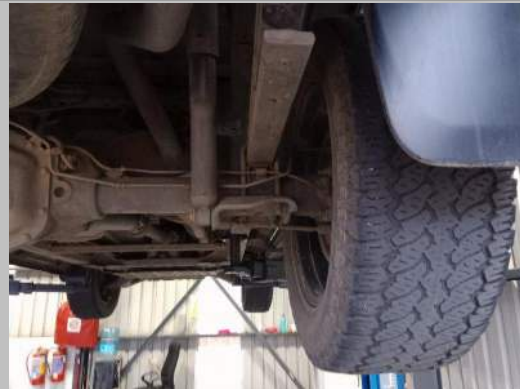
RR TYRE TREAD

| | Size | Load/Speed Index | Manufacture | Model | Type* | Production Date | Tread Depth (mm) |
|---|---|---|---|---|---|---|---|
| Rear Right | 265/60R18 | 110H | General | Radial | V | 0722 | 2 mm |

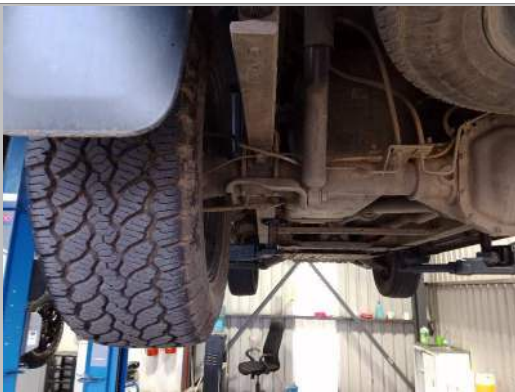
LR TYRE TREAD

| | Size | Load/Speed Index | Manufacture | Model | Type* | Production Date | Tread Depth (mm) |
|---|---|---|---|---|---|---|---|
| Rear Left | 265/60R18 | 110H | General | Radial | V | 3023 | 3 mm |

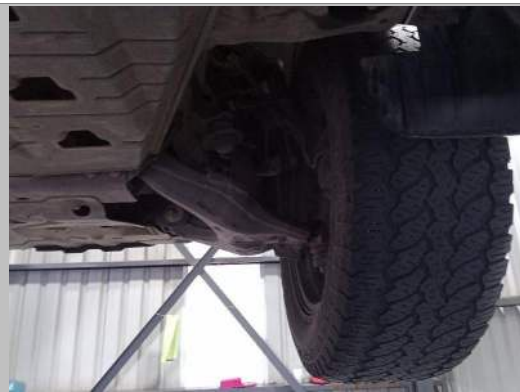
RF TYRE TREAD

| | Size | Load/Speed Index | Manufacture | Model | Type* | Production Date | Tread Depth (mm) |
|---|---|---|---|---|---|---|---|
| Front Right | 265/60R18 | 110H | General | Radial | V | 0722 | 2 mm |

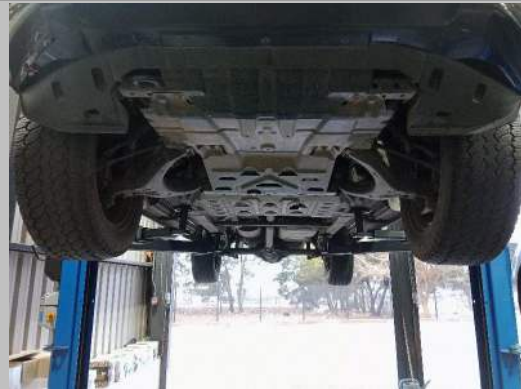
Undercarriage front.

General Comments: ACCORDING TO THE AGE AND MILEAGE OF THE VEHICLE, NORMAL WEAR AND TEAR MARKS ARE VISIBLE ON THE INTERIOR, EXTERIOR, ELECTRICAL AND MECHANICAL PARTS. Undercarriage: bottom of engine and gearbox fully covered.
