## CONDITION REPORT

Report No:  
2017296439  
DATE  
09/09/2026

| Manufacturer | NISSAN | Registration Number | MR98VSGP |
| Model | NP300 HARDBODY 2.5TDI HI-RIDER D-CAB<br>DSL PU [2013-2022] | Register Number | |

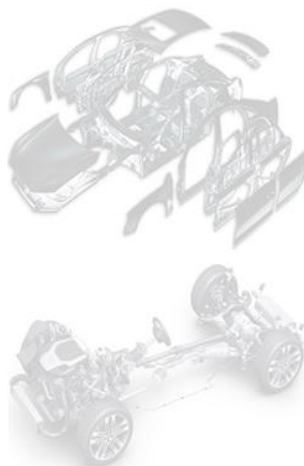
Tail Light Left Cracked  
 Tail Light Right Damaged  
 Front Bumper Paintwork • Scratched  
 Bonnet Paintwork • Chipmarks  
 Rear Fender Left Dented  
 Rear Fender Right Dented  
 Door Front Right Paintwork • Scratched  
 ABS light on

Replace  
 Replace  
 Repair  
 Repair  
 Repair  
 Repair  
 Repair  
 Repair

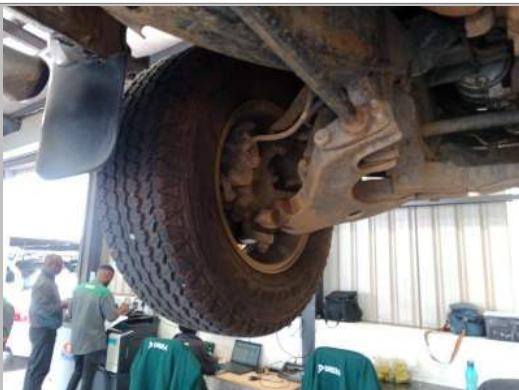
LF TYRE TREAD

| | Size | Load/Speed Index | Manufacture | Model | Type* | Production Date | Tread Depth (mm) |
|---|---|---|---|---|---|---|---|
| Front Left | 245/70R16 | 111/109T | Goodyear | Wrangler | V | 2321 | 5 mm |

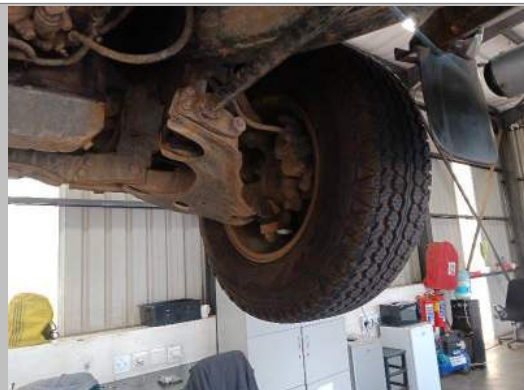
RF TYRE TREAD

| | Size | Load/Speed Index | Manufacture | Model | Type* | Production Date | Tread Depth (mm) |
|---|---|---|---|---|---|---|---|
| Front Right | 245/70R16 | 111/109T | Goodyear | Wrangler | V | 2520 | 5 mm |

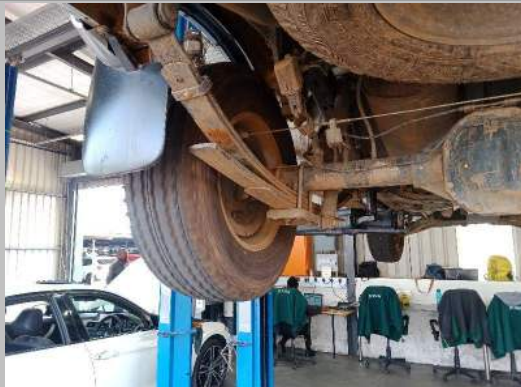
LR TYRE TREAD

| | Size | Load/Speed Index | Manufacture | Model | Type* | Production Date | Tread Depth (mm) |
|---|---|---|---|---|---|---|---|
| Rear Left | 245/70R16 | 111/109T | Goodyear | Wrangler | V | 0722 | 4 mm |

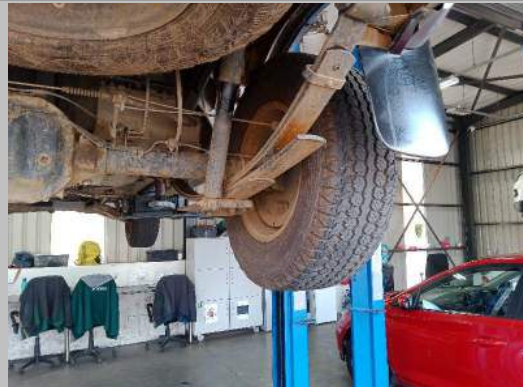
RR TYRE TREAD

| | Size | Load/Speed Index | Manufacture | Model | Type* | Production Date | Tread Depth (mm) |
|---|---|---|---|---|---|---|---|
| Rear Right | 245/70R16 | 111/109T | Goodyear | Wrangler | V | 4921 | 5 mm |

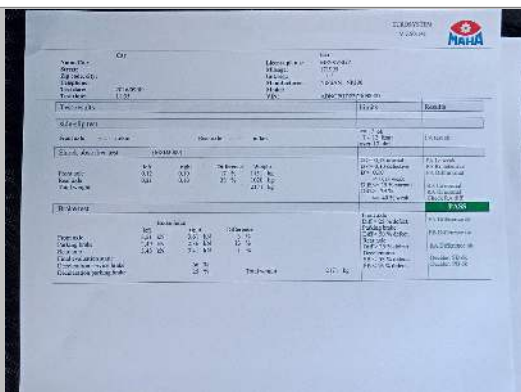
SHOCK AND BRAKE TEST REPORT

| | Left | Right | | |
|---|---|---|---|---|
| Front | 3.51 | 3.61 | - | |
| Rear | 3.43 | 3.41 | - | |
| Emergency / Parking | 2.49 | 2.86 | - | |

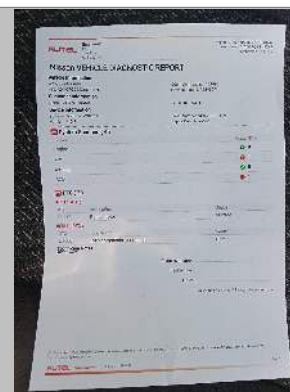
DIAGNOSTIC REPORT

During the diagnostic the following error messages were detected: (See also attached Diagnostic Report. For more information regarding the Fault Codes (DTC) and the recommended rectifications please contact the workshops of the vehicle manufacture).

| No | System | Code | Description | Status |
|---|---|---|---|---|
| 1 | ABS | C111 | PUMP MOTOR | CURRENT |
