## CONDITION REPORT

Report No: 2016736278

Vehicle Type	PASSENGER VEHICLE	Registered Owner	
Manufacturer	TOYOTA	Registration Number	KB43JLGP
Model	COROLLA QUEST 1.6 PLUS [2016-2021]	Register Number	
VIN	AHTLB52E603124448	Date Of First Licensing	
Engine Number		Last COR	
Doors	4	License Expiry Date	31/05/2024
Color	WHITE	Power / Displacement	
Year Model	2017	Paint Finish	C - COMMON
Km Reading	154,838 KM	Fuel	PETROL
Cab / Body Type	SEDAN	Transmission	MANUAL

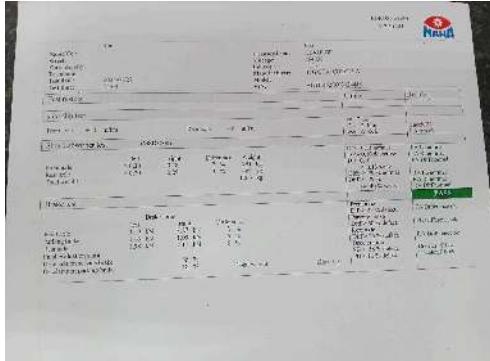
Shock and brake report

Left	Right	Axle Weight [KG]	Deceleration [m/s <sup>2</sup> ]
	Braking Force [KN]	Braking Force [KN]		
Front	3.1	3.2	-	-
Rear	1.9	2.1	-	-
Emergency / Parking	1.1	1	-	-

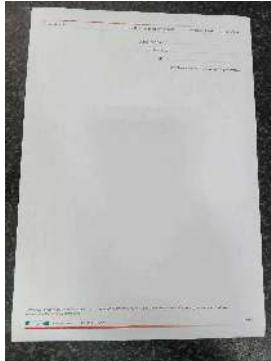
Diagnostic report

No	System	Code	Description	Status
1	CURRENT	C1241	LOW OR HIGH POWER SUPPLY VOLTAGE

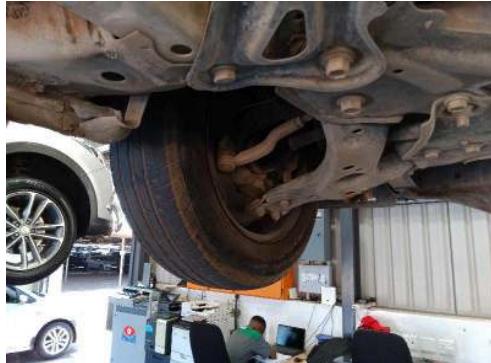
LF TYRE TREAD

Size	Load/Speed Index	Manufacture	Model	Type*	Production Date	Tread Depth (mm)
Front Left	195/65R15	91H	Continental	Contact	V	1418	2 mm
Front Right	185/65R15	91V	Dunlop	Sp sport	V	3219	1 mm
Rear Left	195/65R15	91V	Dunlop	Sp sport	V	3219	1 mm
Rear Right	195/65R15	91V	Dunlop	Sp sport	V	4019	2 mm
Spare	195/65R15	91H	Yokohama	Bluearth	V	3119	1 mm

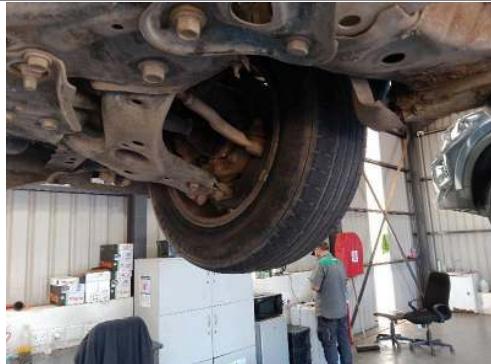
RF TYRE TREAD

Damage	Repair Way
Gear Lever Dust Boot Defective	Repair
Front Bumper Paintwork • Scratched	Repair
Bonnet Paintwork • Chipmarks	Repair
Front Fender Left Paintwork • Scratched	Repair
Front Fender Right Dented	Repair
Door Front Left Paintwork • Scratched	Repair
Door Front Right Dented	Repair
Door Rear Left Dented	Repair
Door Rear Right Dented	Repair
Boot Lid / Hatch door Residual Traces of Repair	Repair
Rear bumper Paintwork • Discoloured	Repair
Shock Absorber Rear Right Leak	Replace
Body exterior	Vehicle got minor scratches, stone chips and dents
Body exterior	Signs of spray work done on some body panels
Body exterior	Signs of repair work done on some body panels
Door light on	Repair
Front tyres size differs	Replace
