CONDITION REPORT

Report No: 2016217559

Vehicle Type	PASSENGER VEHICLE	Registered Owner	MFC
Manufacturer	TOYOTA	Registration Number	LG96ZXGP
Model	QUANTUM	Register Number	
VIN	AHTSS22P007150256	Date Of First Licensing	
Engine Number		Last COR	
Doors	4	License Expiry Date	31/07/2024
Color	WHITE	Power / Displacement	
Year Model		Paint Finish	C - COMMON
Km Reading	21,761 KM	Fuel	DIESEL
Cab / Body Type	OTHERS	Transmission	MANUAL

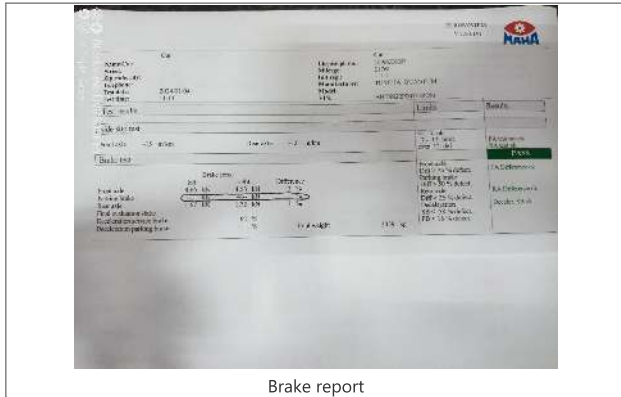
Brake report

Left	Right	Axle Weight [KG]	Deceleration [m/s ²]
	Braking Force [KN]	Braking Force [KN]		
Front	4.6	4.5	-	
Rear	1.6	1.7	-	
Emergency / Parking	0	0	-

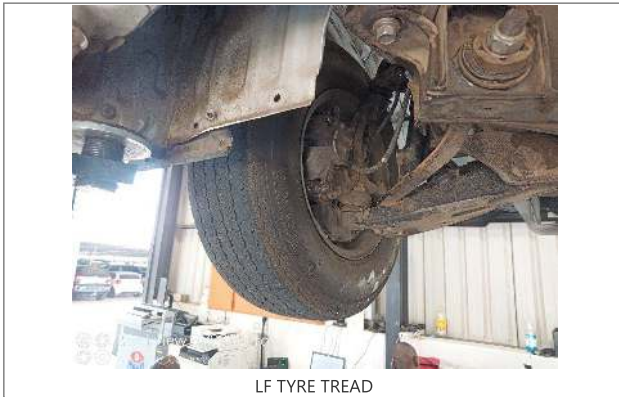
LF TYRE TREAD

Size	Load/Speed Index	Manufacture	Model	Type*	Production Date	Tread Depth (mm)
Front Left	205/75R14	109/107S	Yokohama	Radial	V	0122	3 mm
Front Right	205/75R14	109/107S	Yokohama	Radial	V	0222	0 mm
Rear Left	205/75R14	109/107S	Yokohama	Radial	V	3122	0 mm
Rear Right	205/75R14	109/107S	Yokohama	Radial	V	3122	0 mm

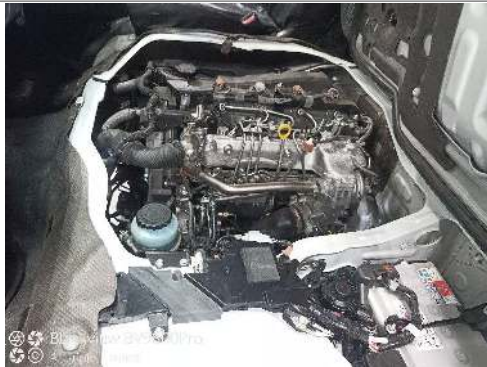
ENGINE 1

Damage	Repair Way
Engine Oil Leak	Repair
Hooter Defective	Repair
Tail Light Left Cracked	Repair
Tail Light Right Scratched	Repair
Boot Lid / Hatch door Dented	Repair
Windscreen Cracked	Replace
Caliper 1. Axle left Leak	Repair
Parking Brake Performance Left / Right Difference out of legal range	Repair
Steering box Leak	Repair
Steering Rack Boot Left Defective	Repair
Tyre Front Right Smooth	Replace
Tyre Rear Left Damaged	Replace
Tyre Rear Right Damaged	Replace
Silencer Welded	Repair
Airbag and traction control light	Repair

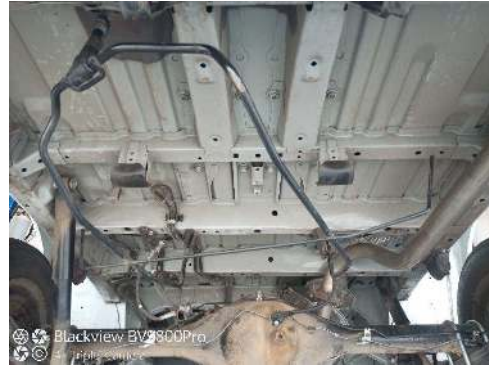
No spare wheel
