CONDITION REPORT

Report No:
2017096177
DATE
09/12/2025

Vehicle Type	PASSENGER VEHICLE	Registered Owner	MFC
Manufacturer	TOYOTA	Registration Number	LM52CWGP
Model	HI-ACE 2.5 SESFIKILE 16-S DSL MINIBUS [2021-2024]	Register Number	
VIN	AHTSS22P407154486	Date Of First Licensing	
Engine Number		Last COR	
Doors	4	License Expiry Date	30/11/2025
Color	WHITE	Power / Displacement	
Year Model	2023	Paint Finish	TWO COAT UNI
Km Reading	158,467 KM	Fuel	DIESEL
Cab / Body Type	STATION WAGON	Transmission	MANUAL

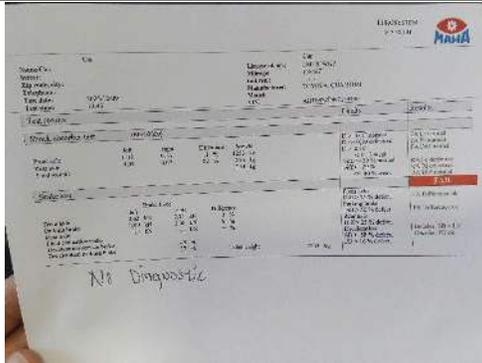
Brake test.

Left	Right		
	Braking Force [KN]	Braking Force [KN]	Axle Weight [KG]	Deceleration [m/s ²]
Front	2.63	2.71	-	
Rear	0.0	0.0	-	
Emergency / Parking	0.99	1.08	-

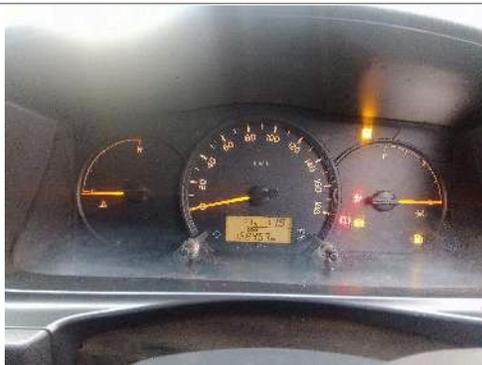
DASHBOARD (W/ ENGINE RUNNING)

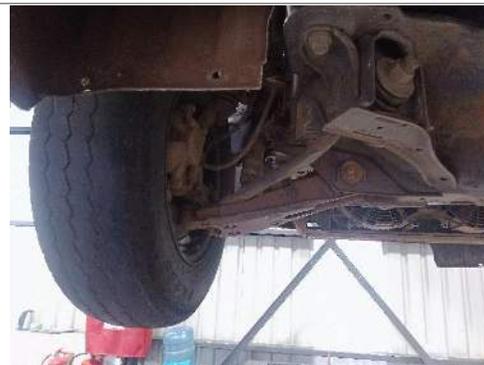
LF TYRE TREAD

Size	Load/Speed Index	Manufacture	Model	Type*	Production Date	Tread Depth (mm)
Front Left	195R15LT	104R	Double King	Radial	V	0824	0 mm
Front Right	195R15LT	104R	Double King	Radial	V	0824	0 mm
Rear Left	195R15C	104S	Toyo	Radial	V	1222	0 mm
Rear Right	195R15C	104R	Firemax	Radial	V	0424	0 mm

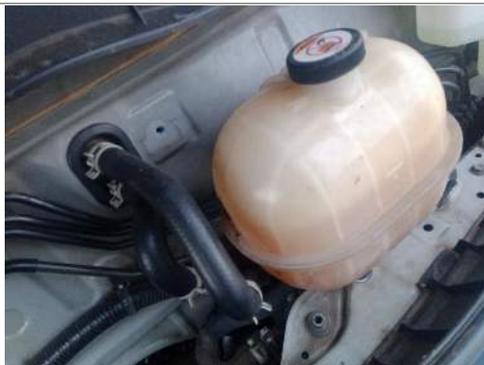
Damage	Repair Way
Engine Oil Leak	Replace
Expansion Bottle Damaged	Replace
Central Air Vent Damaged	Replace
Radio/CD/USB Missing	Replace
Engine Management Lights Set	Repair
Tail Light Left Damaged	Replace
Tail Light Right Damaged	Replace
Headlight Left Damaged	Replace
Headlight Right Damaged	Replace
Seat Front Left Damaged	Replace
Seat Front Right Damaged	Repair
Seat Rear Damaged	Repair
Seat Rear (2. Row) Damaged	Repair
Side Mirror Right Damaged	Replace
Front Bumper Damaged	Repair
Bonnet Damaged	Repair
Front Fender Left Damaged	Repair
Rear Fender Left Damaged	Replace
Rear Fender Right Damaged	Repair
Door Front Left Damaged	Repair
Door Front Right Damaged	Repair
Door Rear Left Damaged	Repair
Boot Lid / Hatch door Damaged	Repair
Windscreen Damaged	Replace
Wheel Cylinder / Caliper 2. Axle left Missing	Replace
Wheel Cylinder / Caliper 2. Axle right Missing	Replace
Brake Pad/Shoe 2. Axle left Damaged	Replace
Brake Pad/Shoe 2. Axle right Damaged	Replace

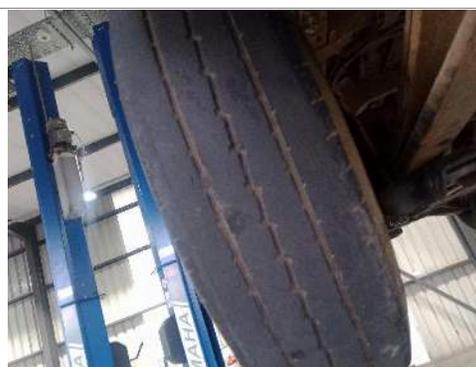
Brake Drum 2. Axle left Damaged	Replace
Brake Drum 2. Axle right Damaged	Replace
Brake Piping Damaged	Replace
Shock Absorber Rear Left Missing	Replace
Shock Absorber Rear Right Worn	Replace
Tyre Front Left Worn	Replace
Tyre Front Right Worn	Replace
Tyre Rear Left Worn	Replace
Tyre Rear Right Worn	Replace
Gearbox Oil Leak	Replace
Brakes Insufficient	Replace

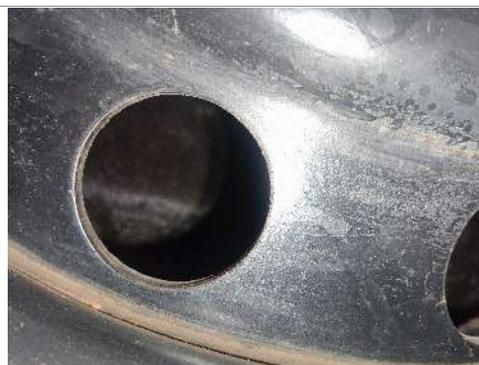
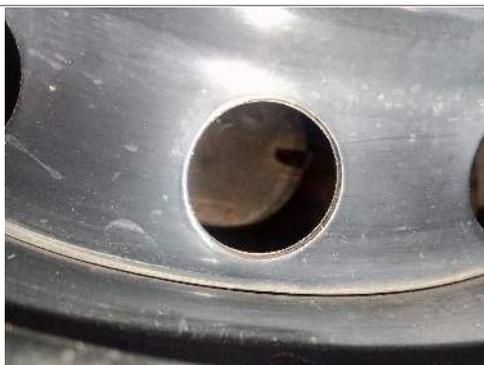
Brakes

General Comments: ACCORDING TO THE AGE AND MILEAGE OF THE VEHICLE, NORMAL WEAR AND TEAR MARKS ARE VISIBLE ON THE INTERIOR, EXTERIOR, ELECTRICAL AND MECHANICAL PARTS. Body • Exterior: Minor dents and scratches and stone chips to some body panels. Signs of repair work done to somebody panels. Poor alignment to somebody panels. Repair work done to vehicle below standard.
Road Test: vehicle has no handbrake. vehicle has no rear brakes.
