MFC Auction House  
M57 Pretoria Rd, Glenmarais, KEMPTON PARK  
Gauteng

Vehicle Type	MINI BUS	Registered Owner	MFC
Manufacturer	TOYOTA	Registration Number	JRF524EC
Model	QUANTUM	Register Number	
VIN	JTFPA9AP708002820	Date Of First Licensing	
Engine Number		Last COR	
Doors	4	License Expiry Date	31/07/2024
Color	WHITE	Power / Displacement	
Year Model		Paint Finish	C - COMMON
Km Reading	246,223 KM	Fuel	DIESEL
Cab / Body Type	OTHERS	Transmission	MANUAL

## CONDITION REPORT

Report No: 2016212361

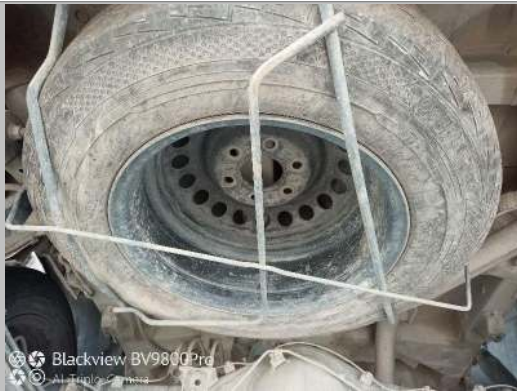
Spare wheel

Size	Load/Speed Index	Manufacture	Model	Type*	Production Date	Tread Depth (mm)
Front Left	205/75R16	110/108R	Continental	Contact	V	2822	0 mm
Front Right	205/75R16	110/108R	Continental	Contact	V	4722	0 mm
Rear Left	205/75R16	110/108R	Continental	Contact	V	0522	4 mm
Rear Right	205/75R16	110/108R	Continental	Contact	V	3322	0 mm
Spare	205/75R16	110/108R	Continental	Contact	V	0000	1 mm

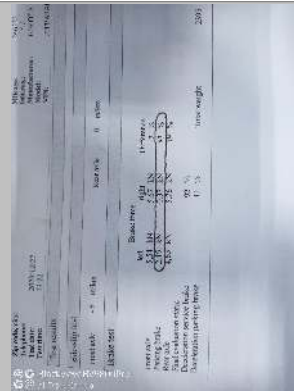
Parking Brake Performance

Left	Right	Axle Weight [KG]	Deceleration [m/s <sup>2</sup> ]
	Braking Force [KN]	Braking Force [KN]		
Front	5.5	5.6	-	
Rear	4.6	5.7	-	
Emergency / Parking	2.1	0.3	-

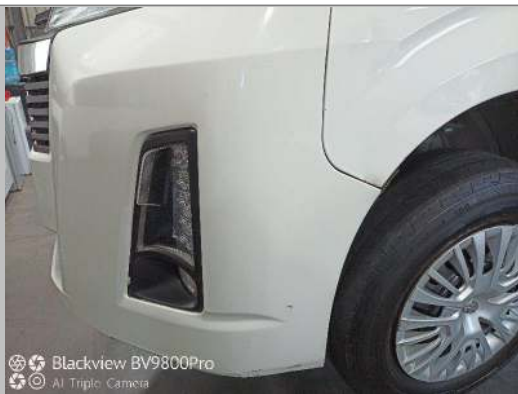
Damage	Repair Way
Tail Light Left Cracked	Repair
Tail Light Right Cracked	Repair
Front Bumper Paintwork • Scratched	Repair
Front Fender Left Dented	Repair
Rear Fender Left Paintwork • Scratched	Repair
Rear Fender Right Paintwork • Scratched	Repair
Door Front Left Dented	Repair
Rear bumper Paintwork • Scratched	Repair
Sill Panel Left Dented	Repair
Sliding Door Paintwork • Scratched	Repair
Windscreen Cracked	Replace
Parking Brake Performance Left / Right Difference out of legal range	Repair
Tyre Front Left Smooth	Replace
Tyre Front Right Smooth	Replace
Tyre Rear Right Smooth	Replace
Bolt(s) / Nut(s) Rear Wheel Left Missing	Replace
L/R hup cap missing	Replace
