CONDITION REPORT

Report No: 2016309246

DATE
18/03/2024

Vehicle Type	PASSENGER VEHICLE	Registered Owner	MFC AUCTION HOUSE
Manufacturer	KIA	Registration Number	FC47GZGP
Model	RIO	Register Number	
VIN	KNADN511LG6758805	Date Of First Licensing	
Engine Number		Last COR	
Doors	5	License Expiry Date	18/03/2024
Color	WHITE	Power / Displacement	
Year Model		Paint Finish	TWO COAT UNI
Km Reading	134,289 KM	Fuel	PETROL
Cab / Body Type	HATCHBACK	Transmission	MANUAL

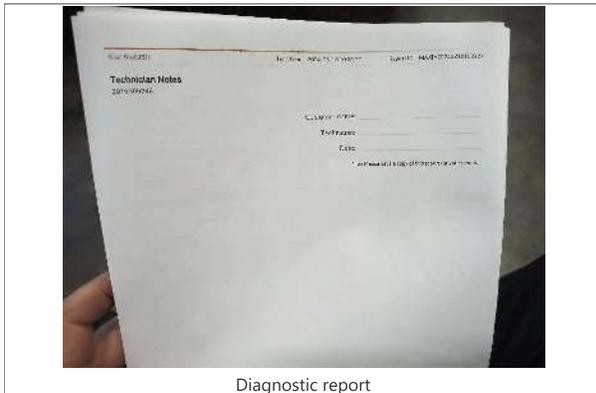
During the diagnostic no active error messages were detected. (See also attached Diagnostic Report. For more information regarding the Fault Codes (DTC) and the recommended rectifications please contact the workshops of the vehicle manufacture).

Diagnostic report

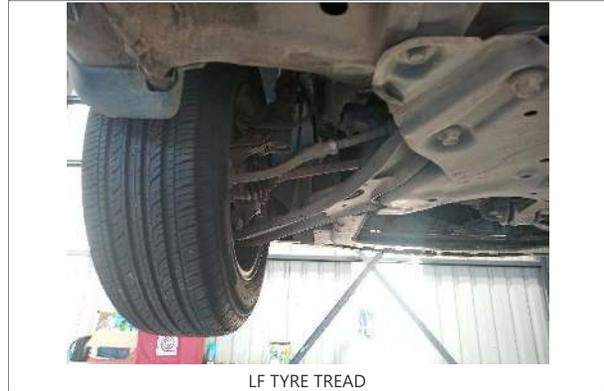
Size	Load/Speed Index	Manufacture	Model	Type*	Production Date	Tread Depth (mm)
Front Left	185/65R15	88H	Kapsen	Radial	V	1223	4 mm
Front Right	185/65R15	88H	Kapsen	Radial	V	1323	4 mm
Rear Left	185/65R15	88H	Kumho	Radial	V	3515	4 mm
Rear Right	185/65R15	88H	Rapid	Radial	V	0723	4 mm

LF TYRE TREAD

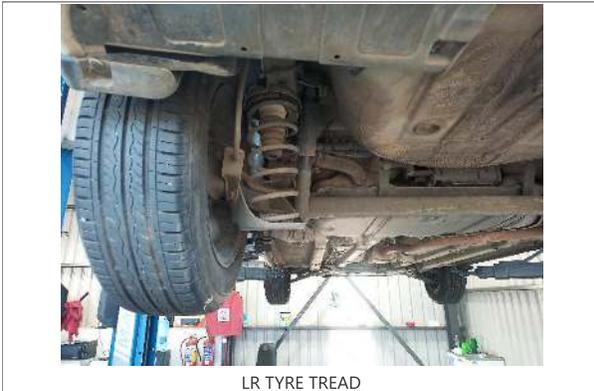
LR TYRE TREAD

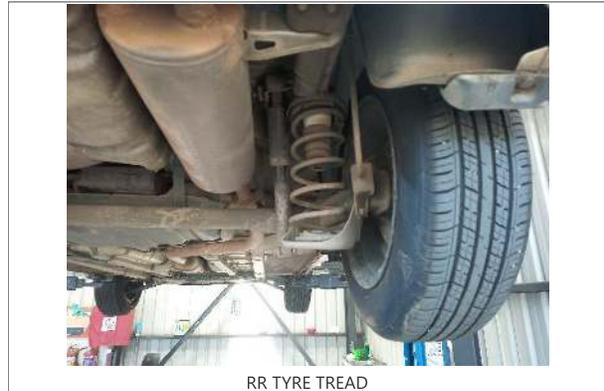
RR TYRE TREAD

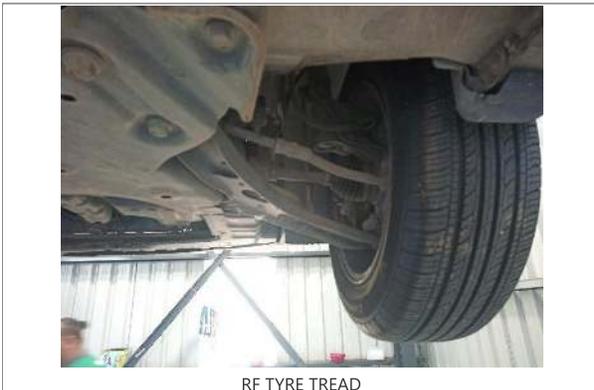
RF TYRE TREAD

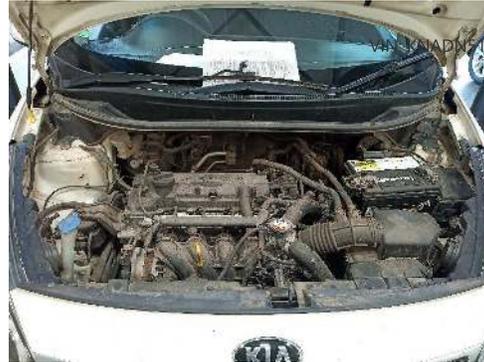
ENGINE 1

No Test Drive
 Battery Flat
 Engine number – not possible to verify engine number (not visible without dismantling)
 Inspection conditions for the vehicle inspection were sufficient

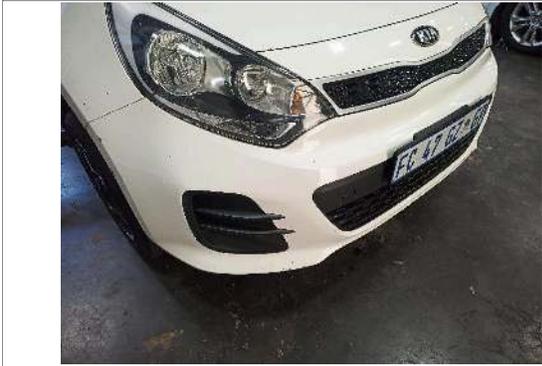
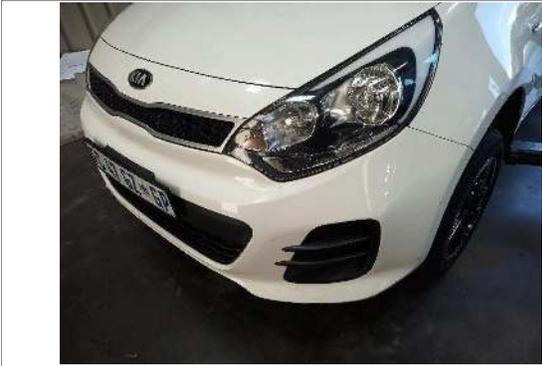
Damage	Repair Way
Windscreen Wiper Damaged	Replace
Side Mirror Right Damaged	Repair
Front Bumper Damaged	Repair
Bonnet Damaged	Repair
Front Fender Left Damaged	Repair
Front Fender Right Damaged	Repair
Rear Fender Left Damaged	Repair
Rear Fender Right Damaged	Repair
Door Front Left Damaged	Repair
Door Front Right Damaged	Repair
Door Rear Left Damaged	Repair
Door Rear Right Damaged	Repair
Boot Lid / Hatch door Damaged	Repair
Rear bumper Damaged	Repair
Roof Damaged	Repair
Windscreen Damaged	Replace
Engine	Battery loose
