## CONDITION REPORT

Report No:  
2017295873  
DATE  
08/09/2026

| Manufacturer | HYUNDAI | Registration Number | DL43KXGP |
| Model | GRAND I10 1.25 FLUID 5-DR AT [2014-2017] | Register Number | |

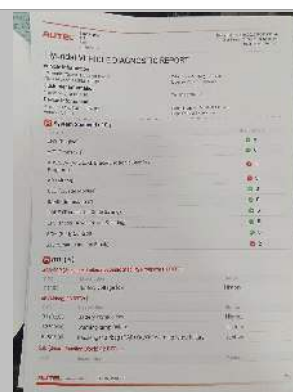
Brake test.

| | Left | Right | | |
|---|---|---|---|---|
| Front | 2.42 | 1.96 | - | |
| Rear | 1.66 | 1.65 | - | |
| Emergency / Parking | 1.23 | 1.27 | - | |

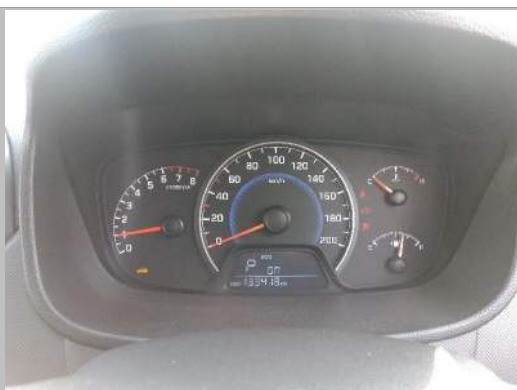
Front Bumper Damaged  
 Bonnet Damaged  
 Front Fender Left Damaged  
 Front Fender Right Damaged  
 Rear Fender Right Damaged  
 Door Front Left Damaged  
 Door Front Right Damaged  
 Door Rear Left Damaged  
 Door Rear Right Damaged  
 Boot Lid / Hatch door Damaged  
 Rear bumper Damaged  
 Windscreen Damaged  
 Tyre Front Right Worn  
 Spare Tyre Defective  
 Airbag warning light illuminated

DASHBOARD (W/ ENGINE RUNNING)

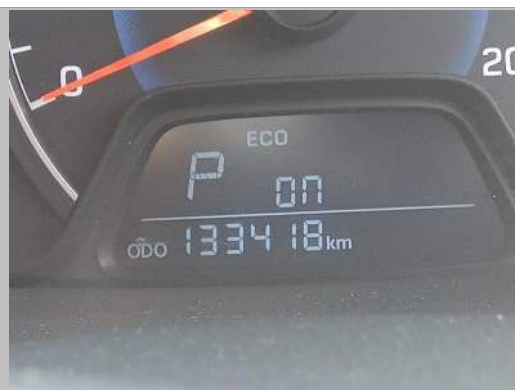
ODOMETER

| Km Reading | 133,418 KM | Fuel | PETROL |

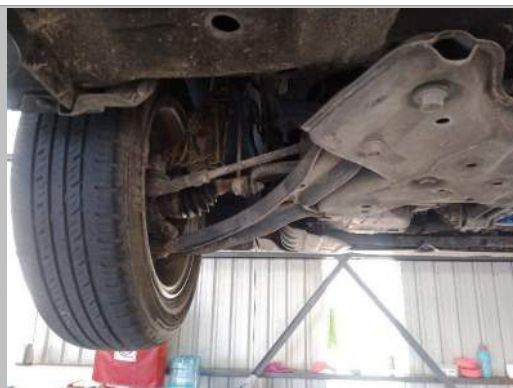
LF TYRE TREAD

| | Size | Load/Speed Index | Manufacture | Model | Type* | Production Date | Tread Depth (mm) |
|---|---|---|---|---|---|---|---|
| Front Left | 165/65R14 | 79H | Westlake | Radial | V | 2123 | 3 mm |

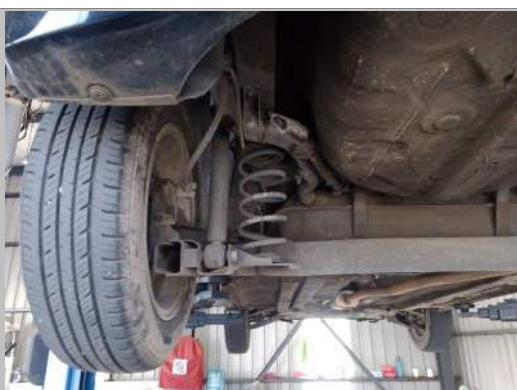
LR TYRE TREAD

| | Size | Load/Speed Index | Manufacture | Model | Type* | Production Date | Tread Depth (mm) |
|---|---|---|---|---|---|---|---|
| Rear Left | 165/65R14 | 79H | Westlake | Radial | V | 2123 | 3 mm |

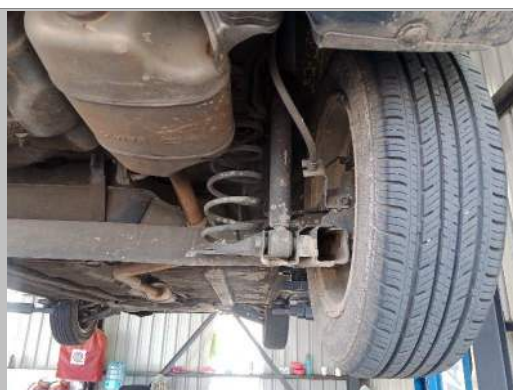
RR TYRE TREAD

| | Size | Load/Speed Index | Manufacture | Model | Type* | Production Date | Tread Depth (mm) |
|---|---|---|---|---|---|---|---|
| Rear Right | 165/65R14 | 79H | Westlake | Radial | V | 2123 | 3 mm |

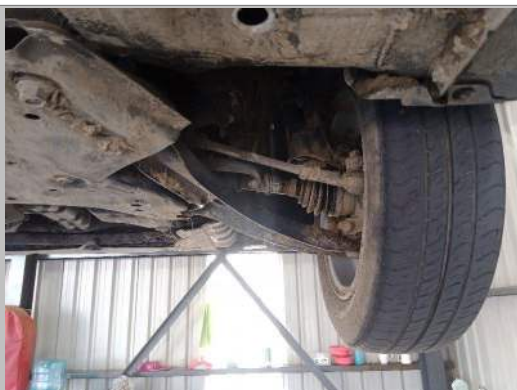
RF TYRE TREAD

| | Size | Load/Speed Index | Manufacture | Model | Type* | Production Date | Tread Depth (mm) |
|---|---|---|---|---|---|---|---|
| Front Right | 165/65R14 | 79H | Nexen | Radial | V | 1614 | 0 mm |

Repair  
 Repair  
 Repair  
 Repair  
 Repair  
 Repair  
 Repair  
 Repair  
 Repair  
 Repair  
 Replace  
 Replace  
 Replace  
 Repair

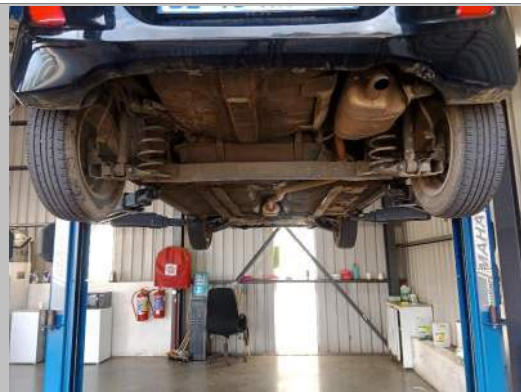
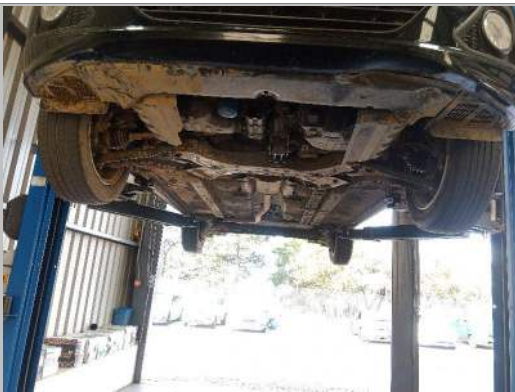
General Comments: ACCORDING TO THE AGE AND MILEAGE OF THE VEHICLE, NORMAL WEAR AND TEAR MARKS ARE VISIBLE ON THE INTERIOR, EXTERIOR, ELECTRICAL AND MECHANICAL PARTS. 6 DTC'S AT TIME OF TESTING SEE DTC REPORT. Body • Exterior: Minor dents and scratches and stone chips to body panels. Signs of repair work done to body panels. Poor alignment to somebody panels. Tyres and Rims: sparewheel deflated. Undercarriage: undercarriage dirty.

Undercarriage front.

Undercarriage rear.

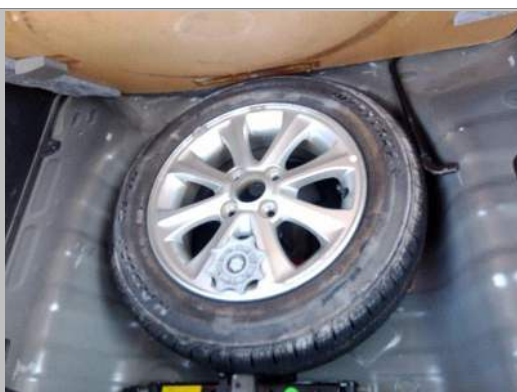
Spare Tyre

| | Size | Load/Speed Index | Manufacture | Model | Type* | Production Date | Tread Depth (mm) |
|---|---|---|---|---|---|---|---|
| Spare | 165/65R14 | 79H | Westlake | Radial | V | 2123 | 2 mm |
