## CONDITION REPORT

2017298226

| Manufacturer | RENAULT | Registration Number | LY92XSGP |
| Model | KWID | Register Number | |

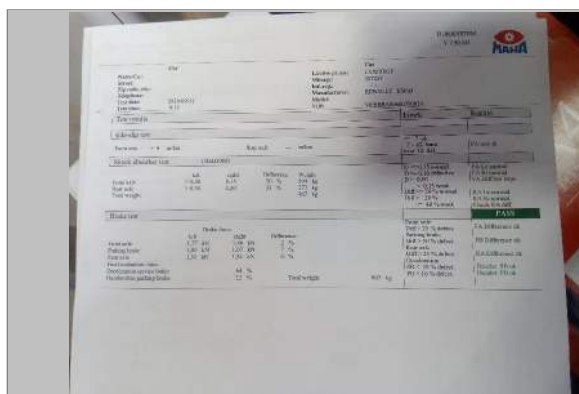
| | Left | Right | | |
| | Braking Force [KN] | Braking Force [KN] | Axle Weight [KG] | Deceleration [m/s <sup>2</sup> ] |
| Front | 1.77 | 1.8 | - | |
| Rear | 1.31 | 1.24 | - | |
| Emergency / Parking | 1 | 1.07 | - | |

Brake test.

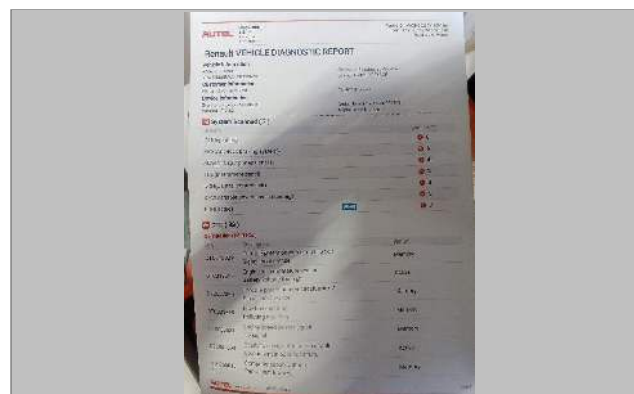
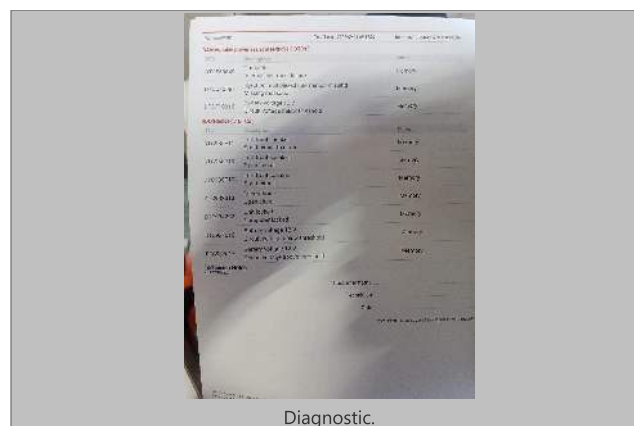
| No | System | Code | Description | Status |
|---|---|---|---|---|
| 1 | INJ | DTC012029 | THROTTLE POTENTIOMETER CIRCUIT TRACK 1 | |

Diagnostic.

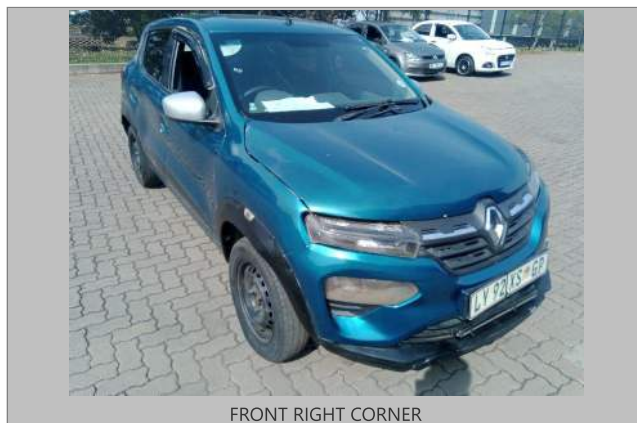
FRONT RIGHT CORNER

Vehicle body in poor condition. Repair work done to vehicle below standard. Signs of impact damage to front of vehicle. hatch door does not open.

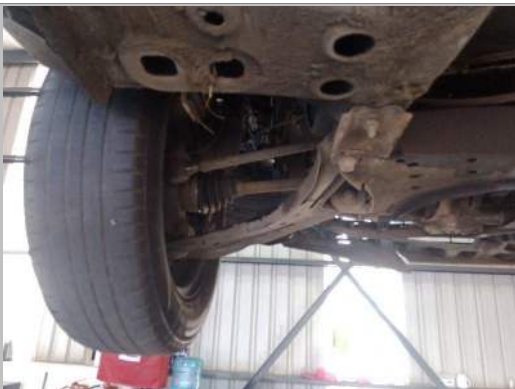
LF TYRE TREAD

| | Size | Load/Speed Index | Manufacture | Model | Type* | Production Date | Tread Depth (mm) |
|---|---|---|---|---|---|---|---|
| Front Left | 175/65R14 | 82H | Timax | Radial | V | 4425 | 0 mm |

| Damage | Repair Way |
|---|---|
| Tyre Front Left Worn | Replace |

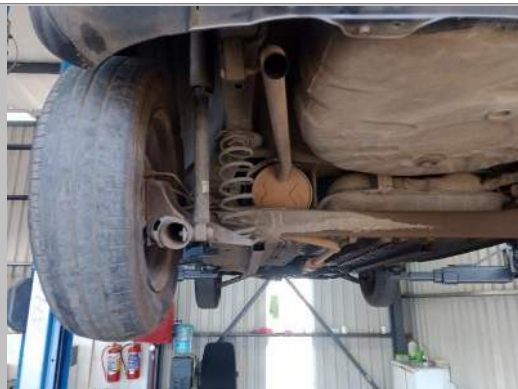
LR TYRE TREAD

| | Size | Load/Speed Index | Manufacture | Model | Type* | Production Date | Tread Depth (mm) |
|---|---|---|---|---|---|---|---|
| Rear Left | 165/70R14 | 81H | Windforce | Radial | V | 3424 | 0 mm |

| Damage | Repair Way |
|---|---|
| Tyre Rear Left Worn | Replace |

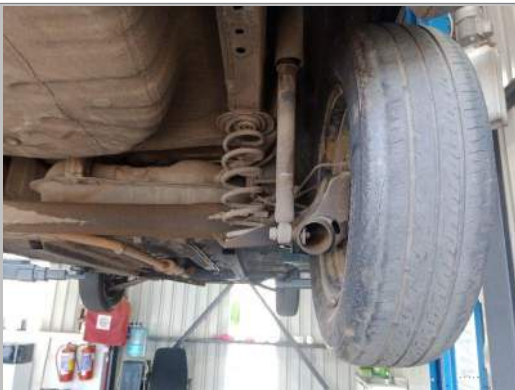
RR TYRE TREAD

| | Size | Load/Speed Index | Manufacture | Model | Type* | Production Date | Tread Depth (mm) |
|---|---|---|---|---|---|---|---|
| Rear Right | 175/65R14 | 82H | Firestone | Radial | V | 1118 | 0 mm |

| Damage | Repair Way |
|---|---|
| Tyre Rear Right Worn | Replace |

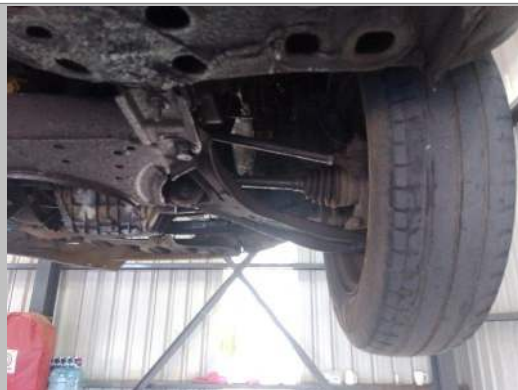
RF TYRE TREAD

| | Size | Load/Speed Index | Manufacture | Model | Type* | Production Date | Tread Depth (mm) |
|---|---|---|---|---|---|---|---|
| Front Right | 165/70R14 | 81T | Apollo | Radial | V | 3220 | 0 mm |

| Damage | Repair Way |
|---|---|
| Tyre Front Right Worn | Replace |

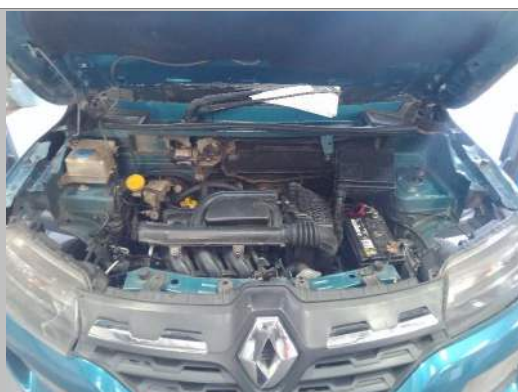
ENGINE 1

General Comments: ACCORDING TO THE AGE AND MILEAGE OF THE VEHICLE, NORMAL WEAR AND TEAR MARKS ARE VISIBLE ON THE INTERIOR, EXTERIOR, ELECTRICAL AND MECHANICAL PARTS. 33 DTC'S AT TIME OF TESTING SEE DTC REPORT. Engine Compartment: Battery loose. aircon fan belt missing.
