## CONDITION REPORT

Report No:  
2017288678  
DATE  
24/08/2026

| Manufacturer | HYUNDAI | Registration Number | KS65KFGP |
| Model | CRETA 1.5 PREMIUM [2022-2024] | Register Number | |

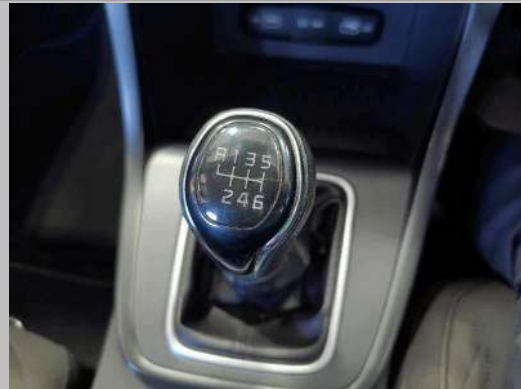
Manual transmission.

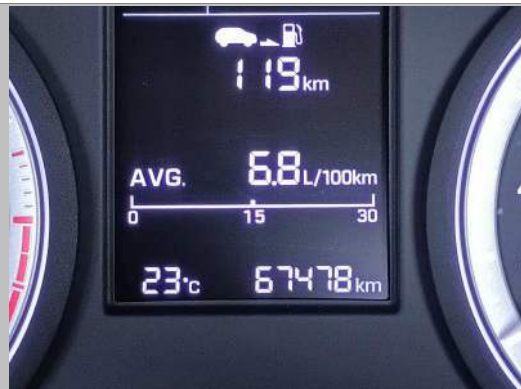
ODOMETER

| Km Reading | 67,478 KM | Fuel | PETROL |

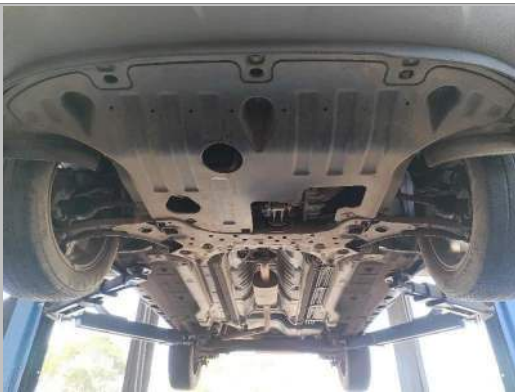
CHASSIS

Replace  
Repair  
Repair  
Repair  
Repair  
Bottom of engine is fully covered

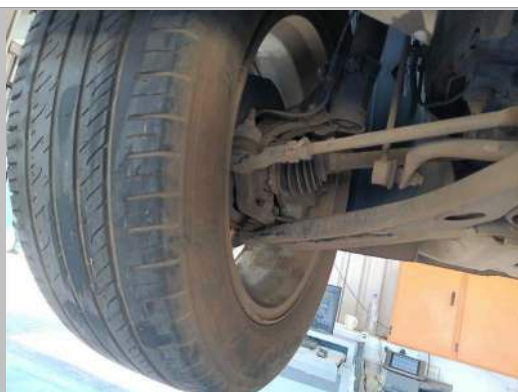
LF TYRE TREAD

| | Size | Load/Speed Index | Manufacture | Model | Type* | Production Date | Tread Depth (mm) |
|---|---|---|---|---|---|---|---|
| Front Left | 215/60R17 | 96H | Kumho | Solus | V | 1122 | 3 mm |

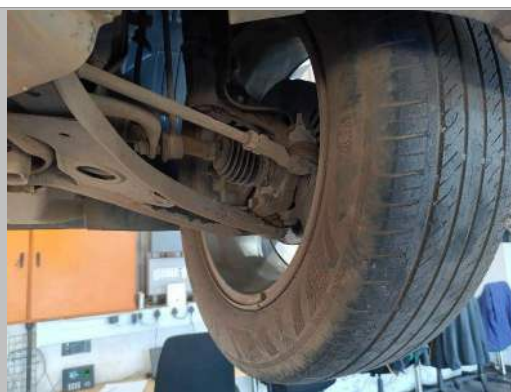
RF TYRE TREAD

| | Size | Load/Speed Index | Manufacture | Model | Type* | Production Date | Tread Depth (mm) |
|---|---|---|---|---|---|---|---|
| Front Right | 215/60R17 | 96H | Kumho | Solus | V | 0922 | 3 mm |

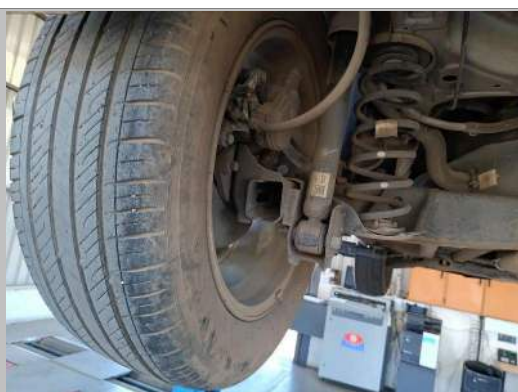
LR TYRE TREAD

| | Size | Load/Speed Index | Manufacture | Model | Type* | Production Date | Tread Depth (mm) |
|---|---|---|---|---|---|---|---|
| Rear Left | 215/60R17 | 96H | Kumho | Solus | V | 0922 | 5 mm |

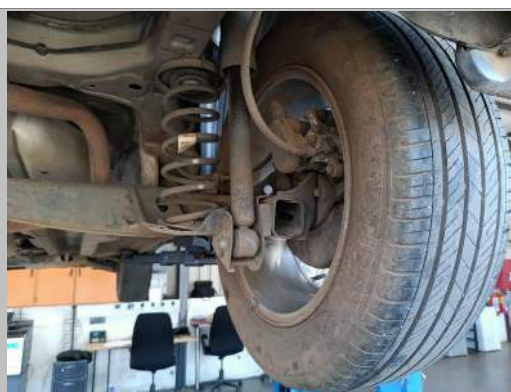
RR TYRE TREAD

| | Size | Load/Speed Index | Manufacture | Model | Type* | Production Date | Tread Depth (mm) |
|---|---|---|---|---|---|---|---|
| Rear Right | 215/60R17 | 96H | Kumho | Solus | V | 0922 | 5 mm |

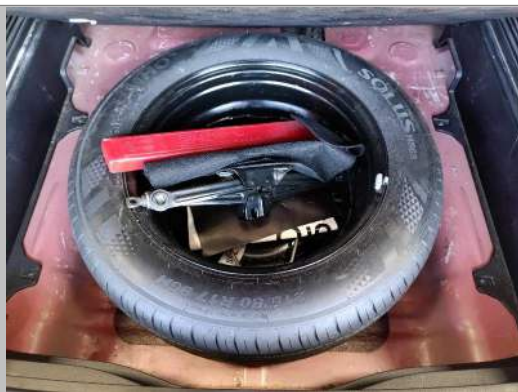
### Sparewheel

| | Size | Load/Speed Index | Manufacture | Model | Type* | Production Date | Tread Depth (mm) |
|---|---|---|---|---|---|---|---|
| Spare | 215/60R17 | 96H | Kumho | Solus | V | 0000 | 6 mm |

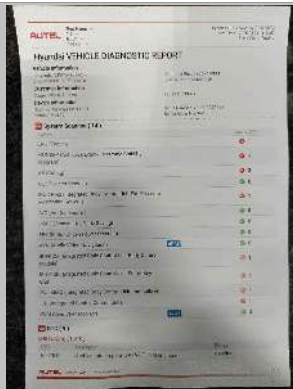
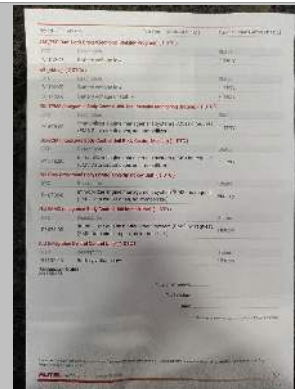
Diagnostic Report page 1

During the diagnostic the following error messages were detected: (See also attached Diagnostic Report. For more information regarding the Fault Codes (DTC) and the recommended rectifications please contact the workshops of the vehicle manufacture).

| No | System | Code | Description | Status |
|---|---|---|---|---|
| 1 | ENGINE | P0070:00 | AMBIENT AIR TEMPERATURE AAT SENSOR CIRCUIT | |

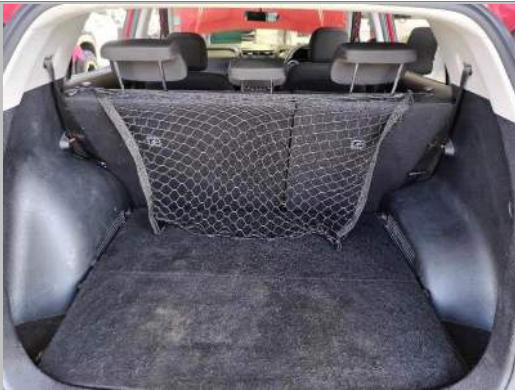
Parcel Tray Missing  
Front Bumper Paintwork • Scratched  
Front Fender Left Residual Traces of Repair  
Door Front Left Paintwork • Scratched  
Rear bumper Paintwork • Scratched  
Engine

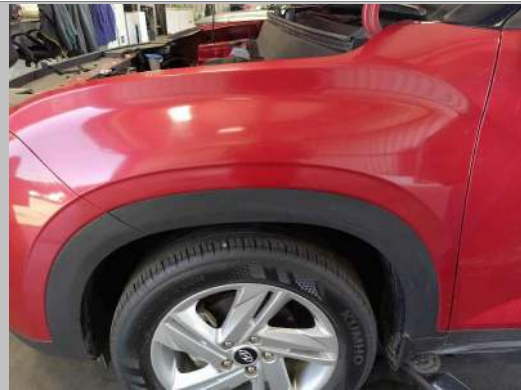
Front Fender Left

General Comments: ACCORDING TO THE AGE AND MILEAGE OF THE VEHICLE, NORMAL WEAR AND TEAR MARKS ARE VISIBLE ON THE INTERIOR, EXTERIOR, ELECTRICAL AND MECHANICAL PARTS. BODY EXTERIOR - SIGNS OF SPRAY WORK DONE ON BODY PANELS. BODY EXTERIOR - RESIDUAL TRACES OF POOR REPAIR ON BODY PANELS
