CONDITION REPORT

Report No: 2016219218

DATE  
05/01/2024

Vehicle Type	PASSENGER VEHICLE	Registered Owner	MFC
Manufacturer	KIA	Registration Number	KB76WRGP
Model	SONET	Register Number	
VIN	MZBFC814LMN083421	Date Of First Licensing	
Engine Number		Last COR	
Doors	5	License Expiry Date	31/07/2024
Color	SILVER	Power / Displacement	
Year Model		Paint Finish	TWO COAT METALLIC
Km Reading	63,196 KM	Fuel	PETROL
Cab / Body Type	HATCHBACK	Transmission	MANUAL

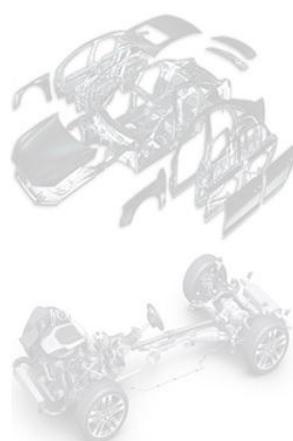
Damage	Repair Way
Front Bumper Damaged	Repair
Door Front Left Damaged	Repair
Door Front Right Damaged	Repair
Door Rear Left Damaged	Repair
Door Rear Right Damaged	Repair
Rear bumper Damaged	Repair
Service Brake Performance Front Axle Insufficient	Repair

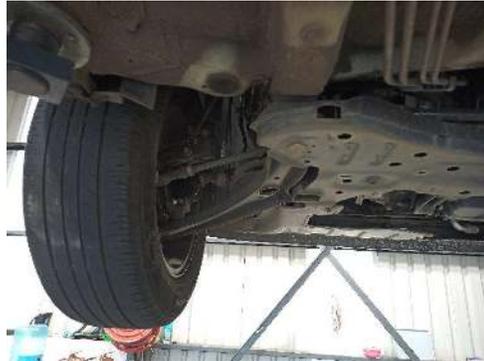
LF TYRE TREAD

Size	Load/Speed Index	Manufacture	Model	Type*	Production Date	Tread Depth (mm)
Front Left	215/60R16	95H	MRF	Radial	V	1721	2 mm
Front Right	215/60R16	95H	MRF	Radial	V	1621	2 mm
Rear Left	215/60R16	95H	MRF	Radial	V	1621	2 mm
Rear Right	215/60R16	95H	MRF	Radial	V	1621	2 mm
