MFC Auction House
M57 Pretoria Rd, Glenmarais, KEMPTON PARK
Gauteng

Assignment

VEHICLE INSPECTION

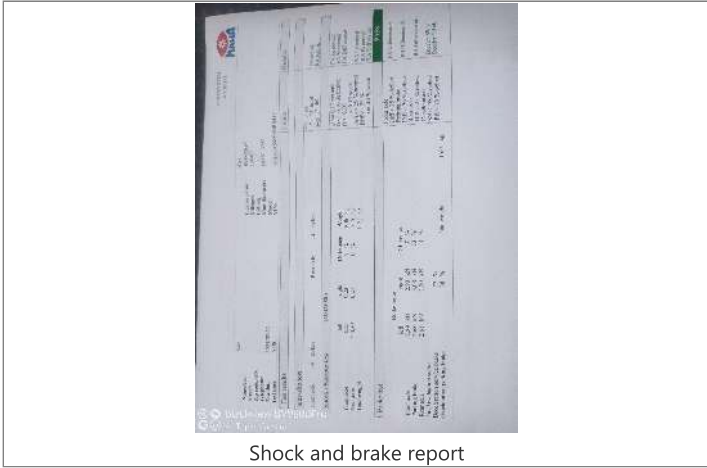
Left	Right	Axle Weight [KG]	Deceleration [m/s ²]
	Braking Force [KN]	Braking Force [KN]		
Front	2.8	2.9	-	
Rear	2.6	2.7	-	
Emergency / Parking	2.6	3	-

Shock and brake report

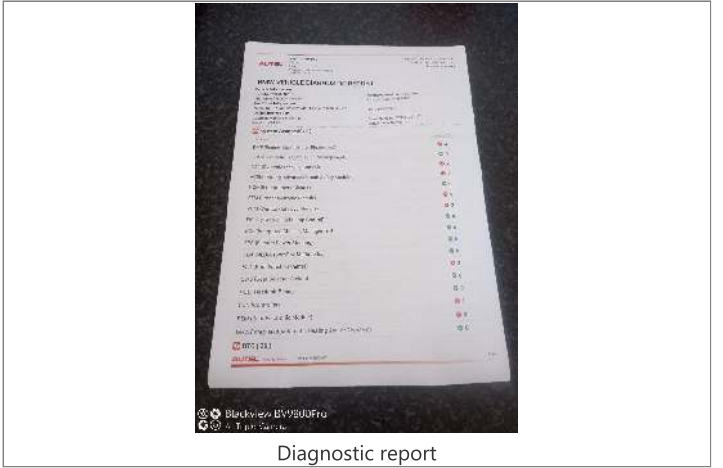
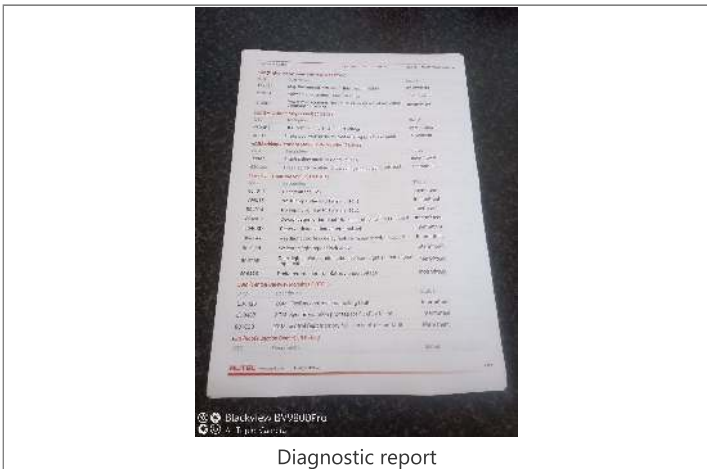
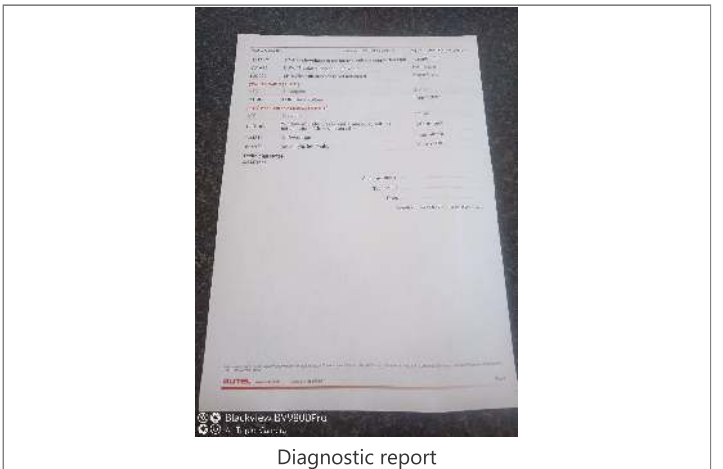
During the diagnostic no active error messages were detected. (See also attached Diagnostic Report. For more information regarding the Fault Codes (DTC) and the recommended rectifications please contact the workshops of the vehicle manufacture).

Diagnostic report

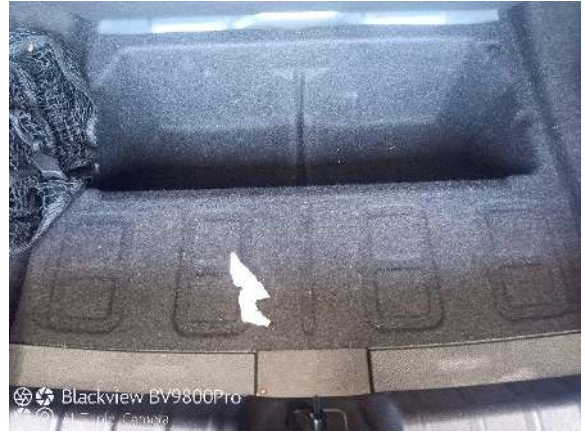
No spare wheel

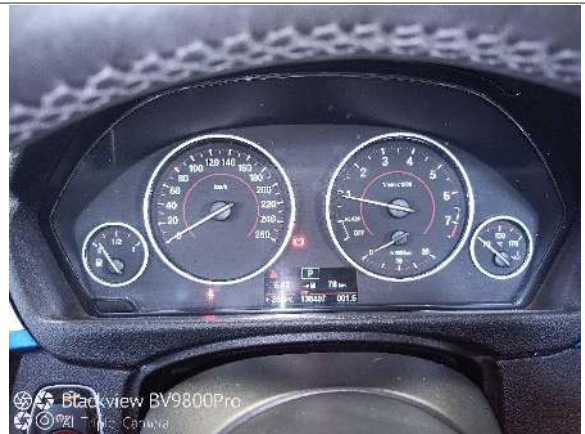
DASHBOARD (W/ ENGINE RUNNING)

Damage	Repair Way
Front Bumper Paintwork • Scratched	Repair
Rear Fender Right Dented	Repair
Rear bumper Paintwork • Scratched	Repair
Windscreen Cracked	Replace
Shock Absorber Front Left Leak	Replace
Shock Absorber Front Right Leak	Replace
Tyre Rear Left Smooth	Replace
Windscreen washers not working	Repair
Park brake warning light stays illuminayed	Repair

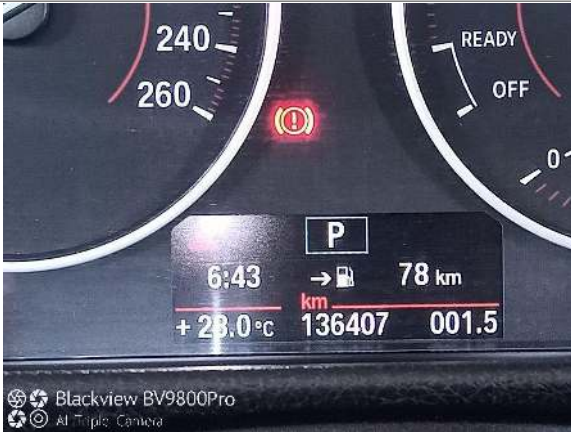
ODOMETER

Vehicle Type	PASSENGER VEHICLE	Registered Owner	MFC AUCTION HOUSE
Manufacturer	BMW	Registration Number	JN48FSGP
Model	328I	Register Number	
VIN	WBA3A56000NR04154	Date Of First Licensing	
Engine Number		Last COR	
Doors	4	License Expiry Date	31/10/2023
Color	BLUE	Power / Displacement	
Year Model		Paint Finish	M - METALLIC
Km Reading	136,407 KM	Fuel	PETROL
Cab / Body Type	SEDAN	Transmission	AUTOMATIC

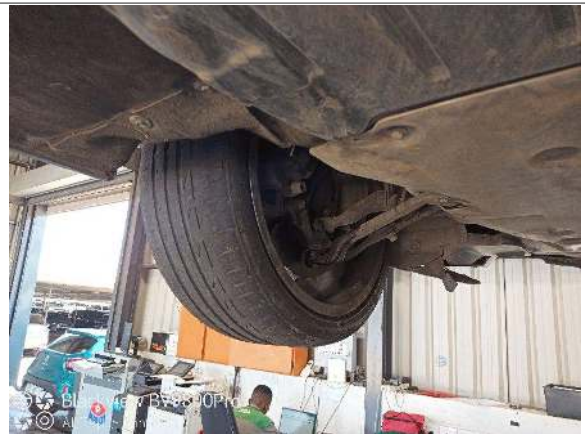
LF TYRE TREAD

Size	Load/Speed Index	Manufacture	Model	Type*	Production Date	Tread Depth (mm)
Front Left	225/40R19	89Y	Bridgestone	Potenza	V	2819	1 mm
Front Right	225/40R19	89Y	Bridgestone	Potenza	V	1322	4 mm
Rear Left	255/35R19	92Y	Goodyear	Eagle	V	2019	0 mm
Rear Right	255/35R19	92Y	Bridgestone	Potenza	V	1720	4 mm

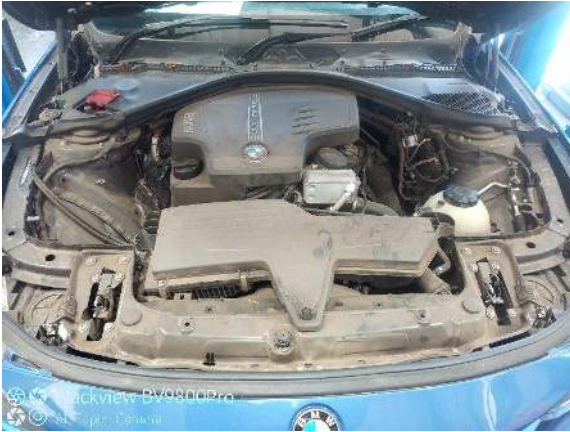
ENGINE 1

No Test Drive
 Battery Flat
 Engine number – not possible to verify engine number (not visible without dismantling)
 Inspection conditions for the vehicle inspection were sufficient
