CONDITION REPORT

Report No: 2016660635

Vehicle Type	PASSENGER VEHICLE	Registered Owner	
Manufacturer	BMW	Registration Number	JS09VKGP
Model	320I STEPTRONIC [2015-2019]	Register Number	
VIN	WBA8A16070NT98238	Date Of First Licensing	
Engine Number		Last COR	
Doors	4	License Expiry Date	30/09/2024
Color	BLUE	Power / Displacement	
Year Model	2016	Paint Finish	TWO COAT UNI
Km Reading	304,623 KM	Fuel	PETROL
Cab / Body Type	SEDAN	Transmission	AUTOMATIC

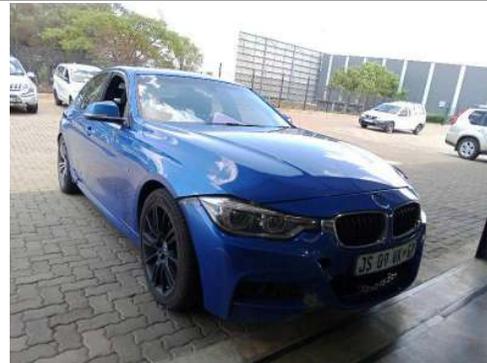
FRONT RIGHT CORNER

Control Arm Bush(es) Front Axle Right Cracked	Replace
Tyre Front Left Damaged	Replace
Tyre Rear Left Defective	Replace
Tyre Rear Right Damaged	Replace
Rim Front Right Scratched	Repair
Rim Rear Left Scratched	Repair
Rim Rear Right Scratched	Repair
Bolt(s) / Nut(s) Front Wheel Right Missing	Replace
Bolt(s) / Nut(s) Rear Wheel Left Missing	Replace
Bolt(s) / Nut(s) Rear Wheel Right Missing	Replace
Chassis Dented	Repair
Sub Frame Dented	Repair
Engine to silencer pipe Defective	Repair
Belly plates Damaged	Replace
Fuel Lines Defective	Repair
Radiator Cradle Damaged	Repair
Jack Missing	Replace
Triangle Damaged	Replace
Front right shock absorber weak	Replace
Undercarriage	Engine splash plate missing.
Brakes	Front left brake piping bracket loose.
Undercarriage	Front left Headlight leveling sensor missing.
Body and Exterior	Dents and scratches on some body panels
Body and Exterior	Signs of impact damage to front of vehicle.

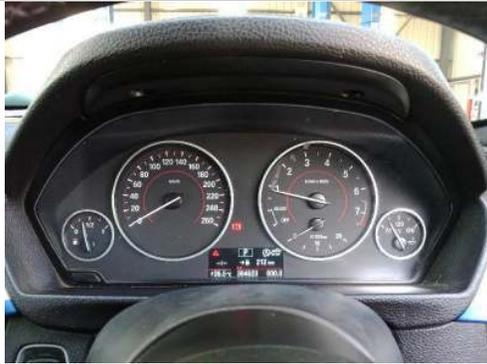
DASHBOARD (W/ ENGINE RUNNING)

Interior	Vehicle interior dirty and some panels scratched
Body and Exterior	Front emblem missing.
Warning light illuminated on dashboard	Repair
Axle and suspension	Front and rear suspension noisy
Tyres and rims	Spare wheel missing.
Tyres and rims	Front and rear tyre sizes different.

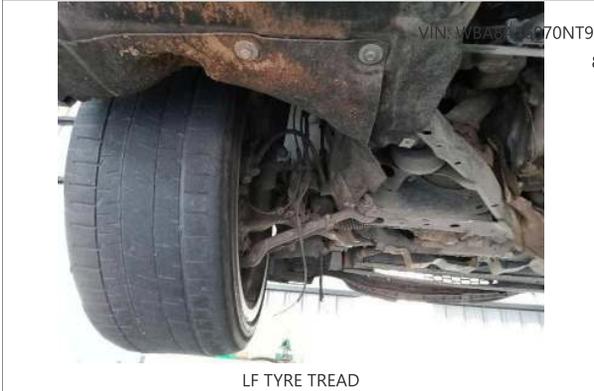
LF TYRE TREAD

Size	Load/Speed Index	Manufacture	Model	Type*	Production Date	Tread Depth (mm)
Front Left	245/35Z R19	93Y	Pirelli	Pzero	V	0721	0 mm
Front Right	255/40Z R18	99Y	Nexen	Nfera	V	3222	2 mm
Rear Left	255/40Z R19	96Y	Pirelli	Pzero	V	1516	0 mm
Rear Right	245/45 R19	98Y	Goodyear	Excellence	V	1919	2 mm

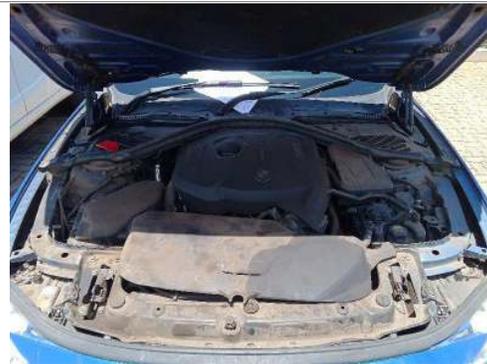
ENGINE 1

Damage	Repair Way
Engine Oil Leak	Repair
Engine Wiring Defective	Repair
Hooter Defective	Replace
Center Console / Cubbyhole + Lid Damaged	Repair
Windscreen Wiper Damaged	Replace
Tail Light Left Damaged	Replace
Fog Light Front Left Missing	Replace
Fog Light Front Right Missing	Replace
Headlight Left Damaged	Replace
Headlight Right Damaged	Replace
Seat Front Left Damaged	Repair
Seat Rear Damaged	Repair
Hood Lining Dirty	Repair
Door Panel Front Right Defective	Repair
Door Handle Front Left Defective	Repair
Door Handle Front Right Defective	Repair
Door Handle Rear Right Defective	Repair
Side Mirror Left Paintwork • Scratched	Repair
Side Mirror Right Damaged	Replace
Front Bumper Damaged	Repair

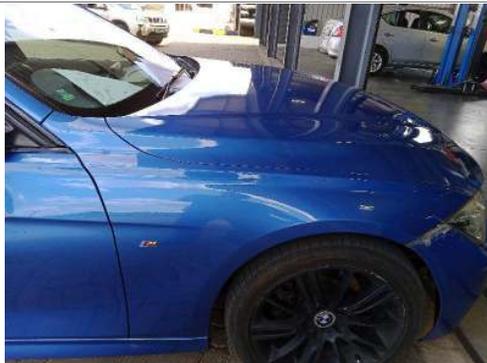
Damage	Repair Way
Bonnet Damaged	Repair
Bonnet slam plate (Shock tower/ Inner tray) Defective	Repair
A • Pillar Left Damaged	Repair
Front Fender Left Damaged	Repair
Front Fender Right Damaged	Repair
Rear Fender Left Damaged	Repair
Rear Fender Right Damaged	Repair
Front Fender Left / Inner Tray Damaged	Replace
Front Fender Right / Inner Tray Damaged	Replace
Rear Fender Left / Inner Tray Damaged	Repair
Door Front Left Damaged	Repair
Door Front Right Damaged	Repair
Door Rear Left Damaged	Repair
Door Rear Right Damaged	Repair
Boot Lid / Hatch door Paintwork • Scratched	Repair
Rear bumper Damaged	Repair
Rocker Panel Left Damaged	Repair
Rocker Panel Right Paintwork • Scratched	Repair
Windscreen Damaged	Replace
Brake disc 2. Axle left Broken	Replace
Brake disc 2. Axle right Defective	Replace
Speed Sensor Damaged	Replace
Stabilizer Mounting Front Left Damaged	Replace
Rear Axle Defective	Repair
Control Arm Bush(es) Front Axle Left Cracked	Replace
