CONDITION REPORT

Report No: 2016272891

DATE
19/02/2024

Vehicle Type	PASSENGER VEHICLE	Registered Owner	MFC AUCTION HOUSE
Manufacturer	FORD	Registration Number	JS88RXGP
Model	ECOSPORT	Register Number	
VIN	WF01XXERK1JU81845	Date Of First Licensing	
Engine Number		Last COR	
Doors	5	License Expiry Date	30/11/2021
Color	WHITE	Power / Displacement	
Year Model		Paint Finish	TWO COAT UNI
Km Reading	96,445 KM	Fuel	PETROL
Cab / Body Type	STATION WAGON	Transmission	MANUAL

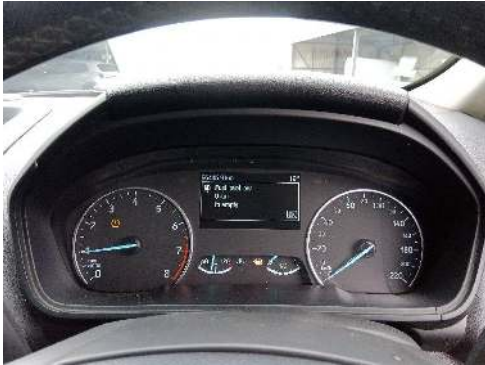
DASHBOARD (W/ ENGINE RUNNING)

No	System	Code	Description	Status
1	ABS(ANTI-LOCK BRAKE SYSTEM)	U0420:86-68	INVALID DATA RECEIVED FROM POWER STEERING CONTROL

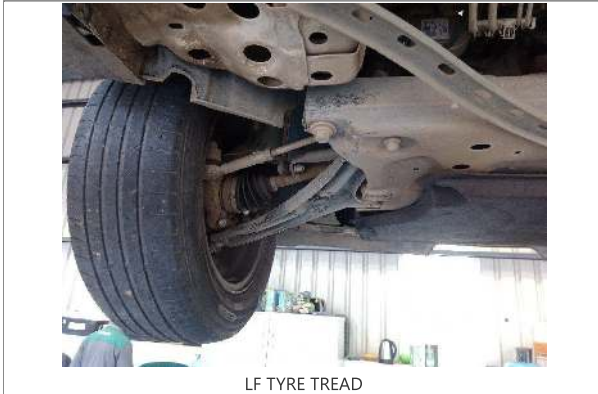
LF TYRE TREAD

Size	Load/Speed Index	Manufacture	Model	Type*	Production Date	Tread Depth (mm)
Front Left	205/60 R16	92H	Dunlop	Sp-Sport	V	0420	2 mm
Front Right	205/60 R16	92H	Dunlop	Sp-Sport	V	0420	2 mm
Rear Left	205/60 R16	92V	Kumho	Solus	V	1717	6 mm
Rear Right	205/55 R16	91V	Continental	Contipremuim	V	3019	6 mm

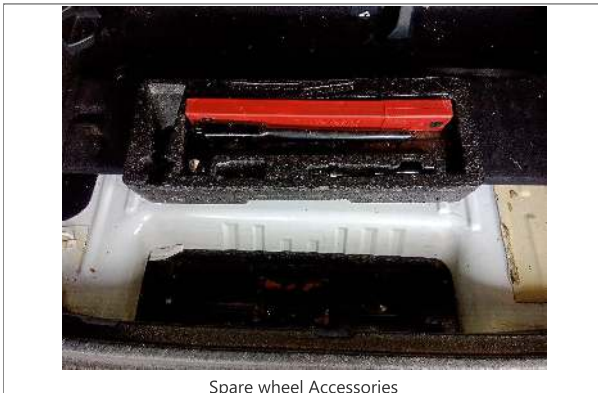
Interior	Vehicle interior dirty.
Tyres and Rims	Alloy rims scratched
Tyres and Rims	Spare wheel covered and cover scratched.
Body and Exterior	Residual traces of repair on some body panels
Body and Exterior	Some body panels misaligned
Undercarriage	Bottom of engine and gearbox fully covered

Spare wheel Accessories

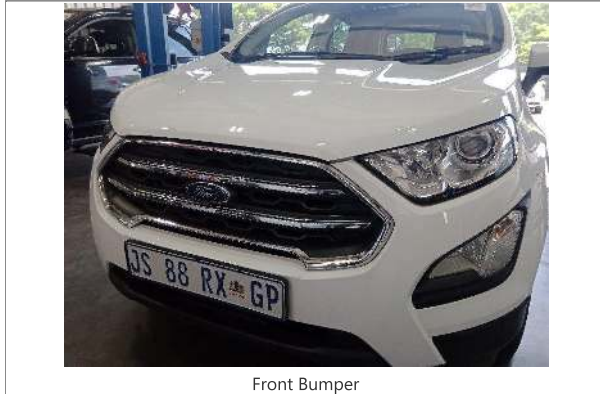
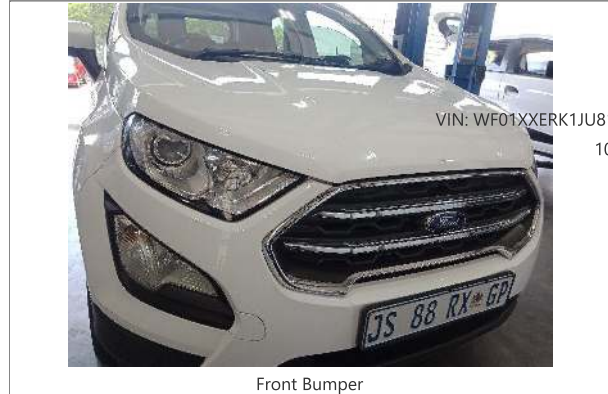
Damage	Repair Way
Engine Oil Leak	Repair
Seat Front Left Dirty	Repair
Seat Front Right Defective	Repair
Seat Rear Dirty	Repair
Hood Lining Dirty	Repair
Front Bumper Paintwork • Scratched	Repair
Bonnet Paintwork • Scratched	Repair
Front Fender Left Paintwork • Scratched	Repair
Front Fender Right Paintwork • Scratched	Repair
Rear Fender Right Dented	Repair
Door Front Left Paintwork • Chipmarks	Repair
Door Front Right Residual Traces of Repair	Repair
Door Rear Left Paintwork • Scratched	Repair
Door Rear Right Paintwork • Scratched	Repair
Boot Lid / Hatch door Dented	Repair
Rear bumper Paintwork • Scratched	Repair
Sill Panel Left Defective	Repair
Sill Panel Right Paintwork • Scratched	Repair
Engine Noise Excessive	Repair
Body and Exterior	Vehicle antenna missing
Body and Exterior	Dents and scratches on some body panels
Body and Exterior	Spray work on some body panels
Body and Exterior	Stone chips on some body panels

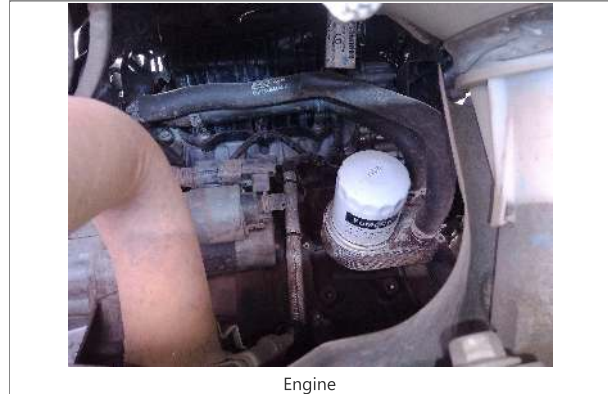
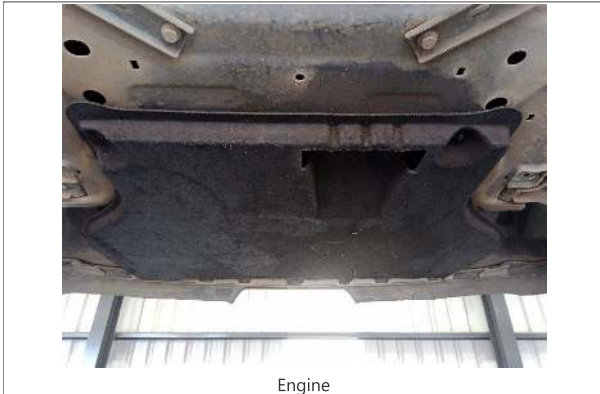
Damage	Repair Way
Undercarriage	Signs of oil leak on engine splash plate
Tyres and Rims	Rear left and right tyre sizes different.
Tyre pressure warning light illuminated on dashboa	Repair
Interior	Some interior panels scratched
Axle and Suspension	Abnormal noise coming from front and rear suspensi
Engine	Engine bay dirty. Brake fluid level ok.
