CONDITION REPORT

Report No:
2017296789
DATE
10/09/2026

MFC Auction House
M57 Pretoria Rd, Glenmarais, KEMPTON PARK
Gauteng

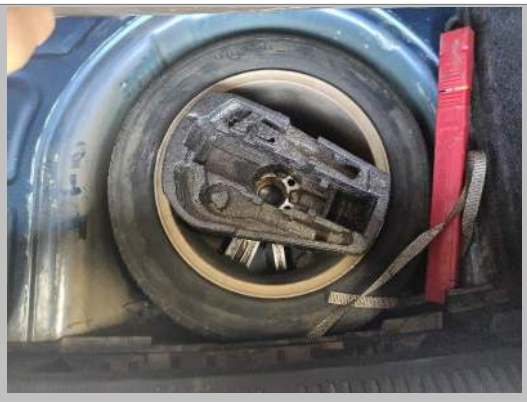
Sparewheel

Size	Load/Speed Index	Manufacture	Model	Type*	Production Date	Tread Depth (mm)
Front Left	185/60R14	82H	Goodyear	Efficient	V	1423	5 mm
Front Right	185/60R15	84H	Hilo	Genesys	V	4621	3 mm
Rear Left	185/60R15	84H	Continental	Contact	V		4 mm
Rear Right	185/60R15	84H	Continental	Contact	V	1825	4 mm
Spare	185/60R15	84H	Continental	Contact	V	0000	3 mm

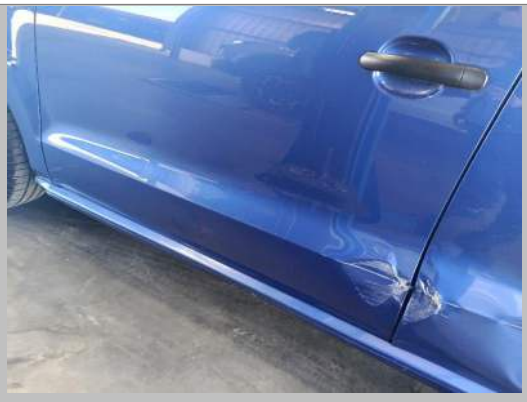
Damage	Repair Way
Engine Wiring Damaged	Repair
Caps Missing	Replace
Radiator Damaged	Replace
Seat Front Right Torn / Cut	Repair
Side Mirror Right Cracked	Replace
Front Bumper Damaged	Repair
Front Fender Right Paintwork • Scratched	Repair
Rear Fender Left Paintwork • Scratched	Repair
Door Front Left Damaged	Repair
Door Front Right Paintwork • Scratched	Repair
Door Rear Left Damaged	Repair
Door Rear Right Dented	Repair
Rear bumper Damaged	Repair
Sill Panel Left Damaged	Repair
Roof Dented	Repair
Bolt(s) / Nut(s) Rear Wheel Left Missing	Replace
Radiator Cross Member Missing	Repair
Engine Performance Idling / Hunting	Repair
Body exterior	Signs of spray work done on body panels
Body exterior	Residual traces of repair work done on body panels
Body exterior	Minor dents scratches stone chips on body panels
No oil cap	Replace
Radiator is loose	Repair
Front tyre size differs	Replace
