MFC Auction House  
M57 Pretoria Rd, Glenmarais, KEMPTON PARK  
Gauteng

DEKRA MFC  
M57 Pretoria Rd - 1619  
KEMPTON PARK - GT  
08610 33572

## CONDITION REPORT

Report No: 2016207780

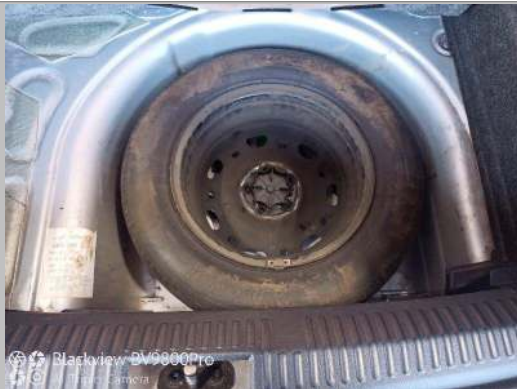
Spare wheel

| | Size | Load/Speed Index | Manufacture | Model | Type* | Production Date | Tread Depth (mm) |
|---|---|---|---|---|---|---|---|
| Spare | 185/65R14 | 86H | Onyx | Ny-801 | V | 0120 | 1 mm |

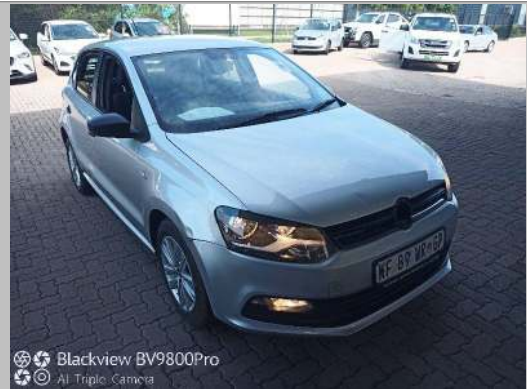
FRONT RIGHT CORNER

| Damage | Repair Way |
|---|---|
| Headlight Right Damaged | Replace |
| Front Fender Right Dented | Repair |

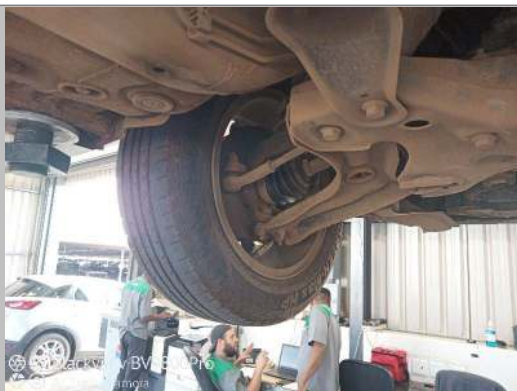
LF TYRE TREAD

| | Size | Load/Speed Index | Manufacture | Model | Type* | Production Date | Tread Depth (mm) |
|---|---|---|---|---|---|---|---|
| Front Left | 185/65R15 | 88H | Ling long | Green-max | V | 2121 | 3 mm |

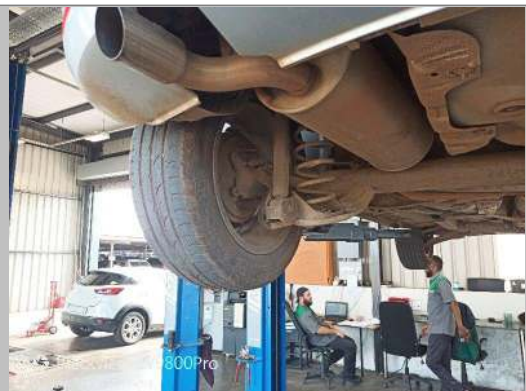
LR TYRE TREAD

| | Size | Load/Speed Index | Manufacture | Model | Type* | Production Date | Tread Depth (mm) |
|---|---|---|---|---|---|---|---|
| Rear Left | 185/60R15 | 84H | Continental | Contact | V | 0515 | 2 mm |

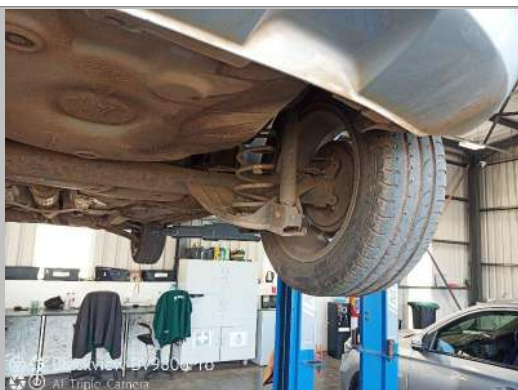
RR TYRE TREAD

| | Size | Load/Speed Index | Manufacture | Model | Type* | Production Date | Tread Depth (mm) |
|---|---|---|---|---|---|---|---|
| Rear Right | 195/55R15 | 85V | Continental | Contact | V | 1308 | 3 mm |

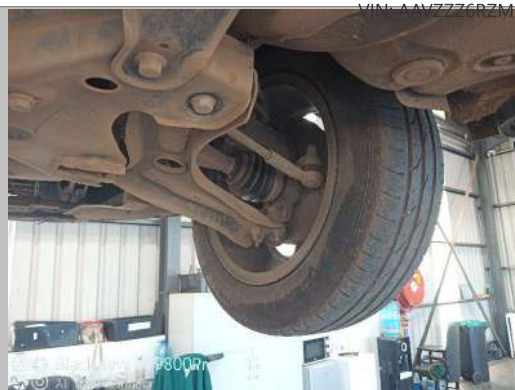
RF TYRE TREAD

| Damage | Repair Way |
|---|---|
| Tyre Front Right Torn / Cut | |

| | Size | Load/Speed Index | Manufacture | Model | Type* | Production Date | Tread Depth (mm) |
|---|---|---|---|---|---|---|---|
| Front Right | 185/60R15 | 84H | Continental | Contact | V | 1921 | 3 mm |

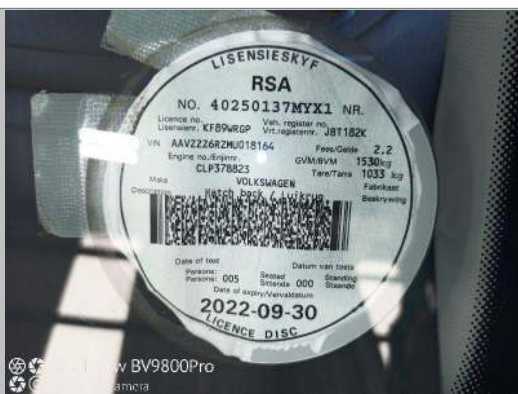
LICENSE DISC

| Doors | 5 | License Expiry Date | 30/09/2022 |
