## CONDITION REPORT

Report No:  
2017138036  
DATE  
27/01/2026

| Manufacturer | VOLKSWAGEN | Registration Number | LG99CJGP |
| Model | POLO VIVO 1.4 55KW TRENDLINE 5-DR<br>[2022-2024] | Register Number | |

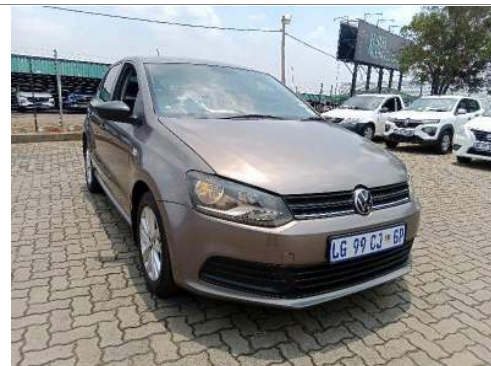
FRONT RIGHT CORNER

| Damage | Repair Way |
|---|---|
| Headlight Right Damaged | Replace |
| Front Fender Right Damaged | Repair |

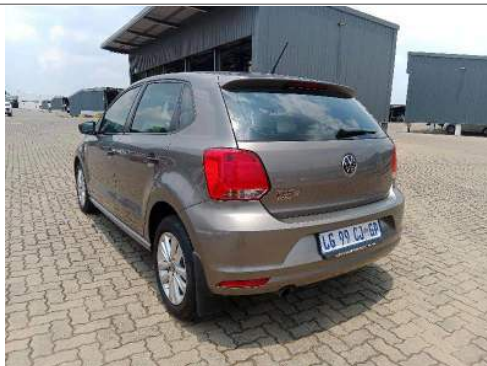
REAR LEFT CORNER

| Damage | Repair Way |
|---|---|
| Tail Light Left Cracked | Replace |
| Rear Fender Left Dented | Repair |

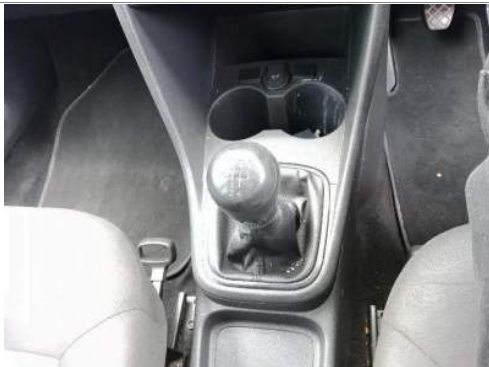
Manual Transmission

| Damage | Repair Way |
|---|---|
| Gear Selections Malfunction | Repair |
| Road test | Gearbox faulty |

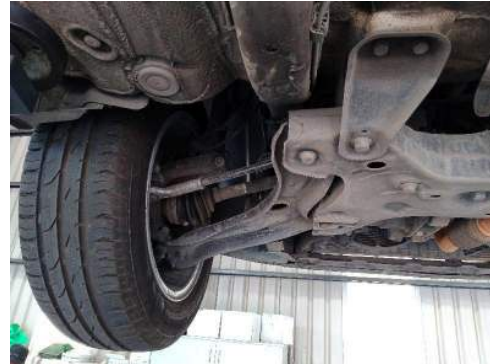
LF TYRE TREAD

| Damage | Repair Way |
|---|---|
| Tyre Front Left Damaged | Replace |

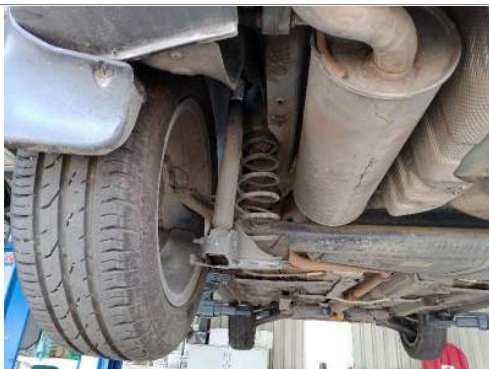
LR TYRE TREAD

| Damage | Repair Way |
|---|---|
| Tyre Rear Left Damaged | Replace |

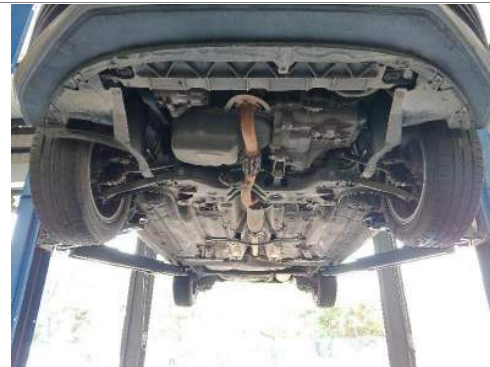
Front chassis

| Damage | Repair Way |
|---|---|
| Chassis Dented | Repair |
| Radiator Cradle Damaged | Repair |
