CONDITION REPORT

Report No: 2016204900

MFC Auction House
M57 Pretoria Rd, Glenmarais, KEMPTON PARK
Gauteng

Vehicle Type	PASSENGER VEHICLE	Registered Owner	MFC
Manufacturer	VOLKSWAGEN	Registration Number	HM30RFGP
Model	POLO VIVO	Register Number	
VIN	AAVZZZ6SZEU022520	Date Of First Licensing	
Engine Number		Last COR	
Doors	4	License Expiry Date	18/12/2023
Color	SILVER	Power / Displacement	
Year Model		Paint Finish	TWO COAT UNI
Km Reading	292,163 KM	Fuel	PETROL
Cab / Body Type	SEDAN	Transmission	MANUAL

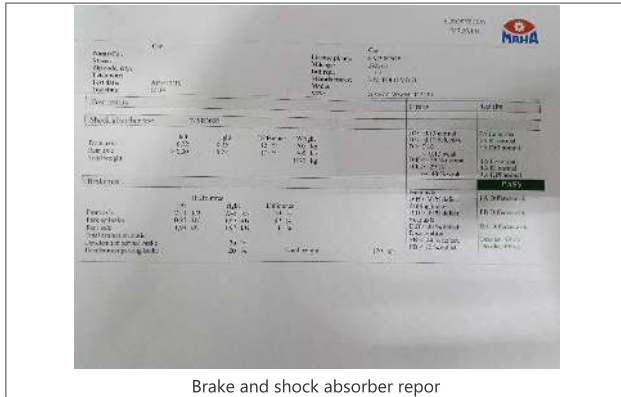
Brake and shock absorber repor

Left	Right		
	Braking Force [KN]	Braking Force [KN]	Axle Weight [KG]	Deceleration [m/s ²]
Front	2.71	2.45	-	
Rear	1.99	1.97	-	
Emergency / Parking	0.87	1.42	-

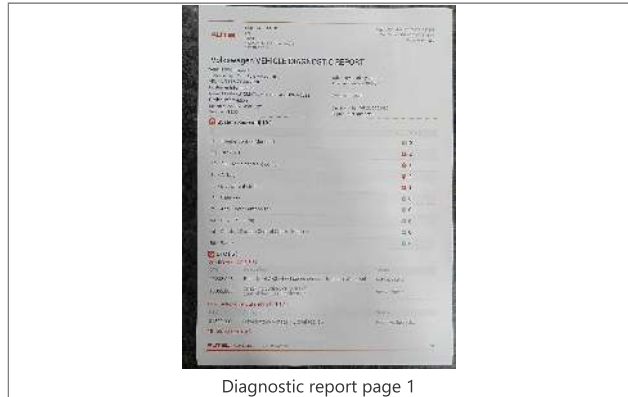
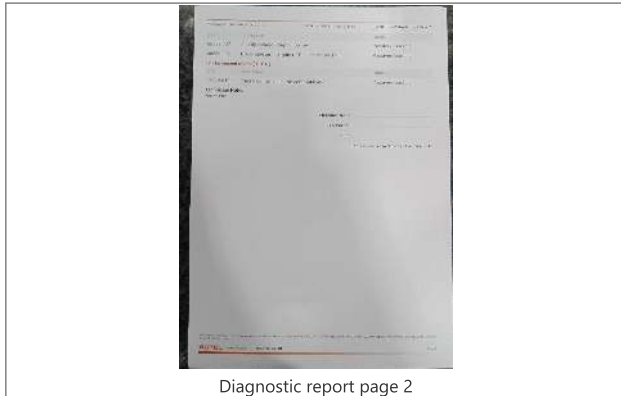
No	System	Code	Description	Status
1	03-BRAKES 1	00285:008	RIGHT FRONT ABS WHEEL SPEED SENSOR-IMPLAUSIBLE SIG

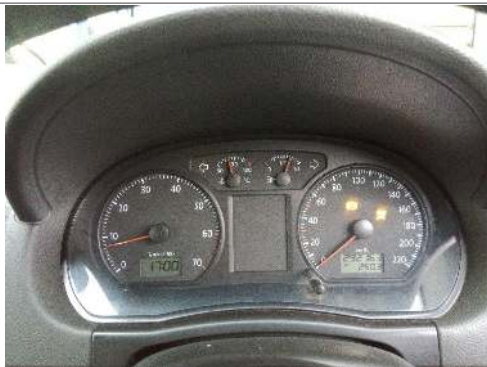
DASHBOARD (W/ ENGINE RUNNING)

Damage	Repair Way
Inner Boot Floor Pan and Spare Wheel Well Dented	Repair
Sill Panel Left Dented	Repair
Rocker Panel Left Dented	Repair
Rocker Panel Right Dented	Repair
Windscreen Cracked	Replace
Steering Rack Boot Left Damaged	Replace
Shock Absorber Front Right Damaged	Replace
Control Arm(s) Front Axle Right Damaged	Replace
Control Arm Bush(es) Front Axle Left Damaged	
Control Arm Bush(es) Front Axle Right Cracked	Replace
Tyre Rear Left Worn	Replace
Tyre Rear Right Damaged	Replace
Chassis Dented	Repair
Sub Frame Scratched	Repair
Engine to silencer pipe Defective	Repair
Belly plates Damaged	Replace
Gearbox Oil Sweat	Repair
CV Joint(s) Front Left (inner/outer) Defective	Repair
CV Joint(s) Front Right (inner/outer) Defective	Repair
CV Joint(s) Boot(s) Front Left (inner/outer) Damaged	Replace
Warning lights illuminated on dashboard	Repair

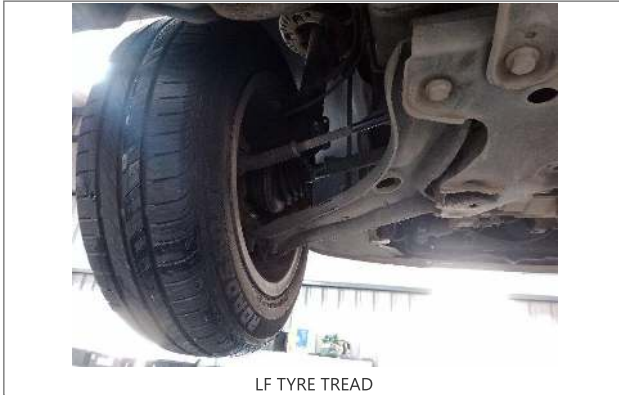
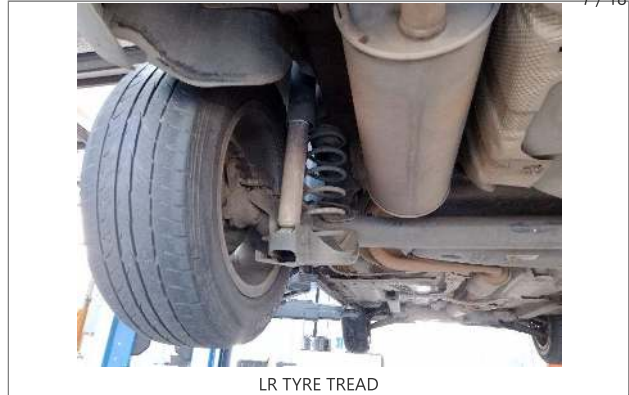
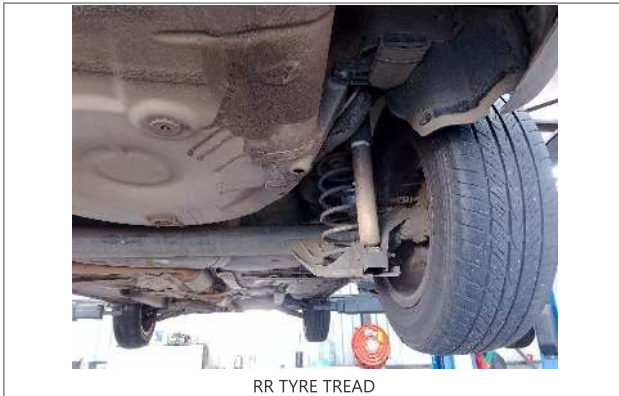
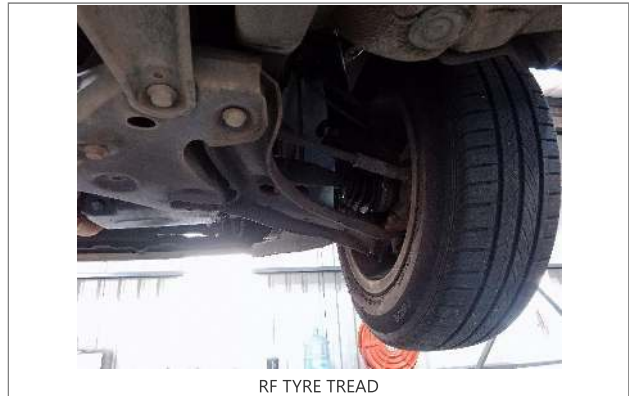
Size	Load/Speed Index	Manufacture	Model	Type*	Production Date	Tread Depth (mm)
Front Left	175/65 R14	82T	Eurovis	Roadstone	V	0322	4 mm
Front Right	175/65 R14	82T	Eurovis	Roadstone	V	0222	4 mm
Rear Left	185/60 R14	82H	Sumitomo	HTR	V	4620	0 mm
Rear Right	185/60 R14	82H	Sumitomo	HTR	V	4620	2 mm
Spare	175/65 R14	86T	RoadX	Rxmotion	V	3819	4 mm

Tyres and Rims: Alloy rims scratched Loose second tyre inside boot of vehicle. Front and rear tyre sizes different. Front left and rear right wheel caps missing.

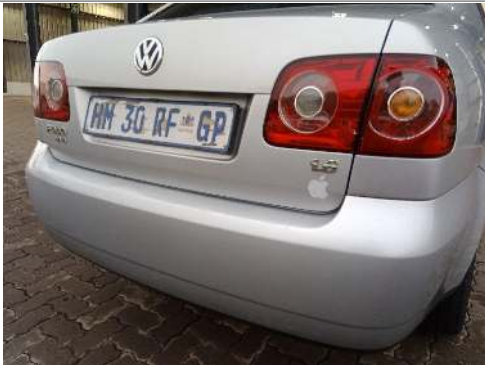
Rear bumper Damaged	Repair

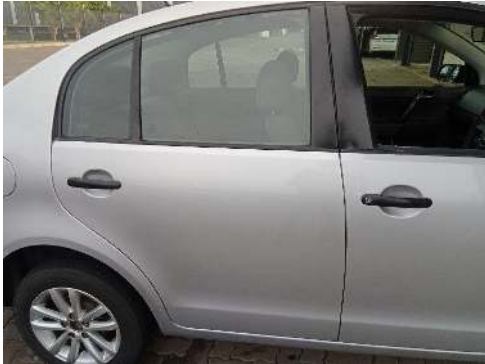
Damage	Repair Way
Engine Oil Leak	Repair
Engine Wiring Defective	Repair
Hoses Damaged	Replace
Radiator Defective	Replace
Central Air Vent Damaged	Replace
Center Console / Cubbyhole + Lid Defective	Repair
Interior Lights Malfunction	Repair
Headlight Left Defective	Replace
Headlight Right Defective	Replace
Seat Front Left Dirty	Repair
Seat Front Right Damaged	Repair
Seat Rear Defective	Repair
Seat Belt Rear Middle Defective	Repair
Hood Lining Dirty	Repair
Boot Carpet Defective	Repair
Mirror Adjusters Defective	Replace
Steering Wheel Trim Defective	Repair
Front Bumper Paintwork • Scratched	Repair
Bonnet Paintwork • Chipmarks	Repair
C • Pillar Left Dented	Repair
Front Fender Left Dented	Repair
Front Fender Right Dented	Repair
Rear Fender Left Paintwork • Scratched	Repair
Rear Fender Right Dented	Repair
Door Front Left Dented	Repair
Door Front Right Dented	Repair
Door Rear Left Dented	Repair
Door Rear Right Paintwork • Scratched	Repair
