MFC Auction House
M57 Pretoria Rd, Glenmarais, KEMPTON PARK
Gauteng

Vehicle Type	PASSENGER VEHICLE	Registered Owner	MFC AUCTION HOUSE
Manufacturer	VOLKSWAGEN	Registration Number	JKK574MP
Model	POLO VIVO	Register Number	
VIN	AAVZZZ6SZGU014818	Date Of First Licensing	
Engine Number		Last COR	
Doors	5	License Expiry Date	30/11/2020
Color	WHITE	Power / Displacement	
Year Model		Paint Finish	TWO COAT UNI
Km Reading	524,347 KM	Fuel	PETROL
Cab / Body Type	HATCHBACK	Transmission	MANUAL

CONDITION REPORT

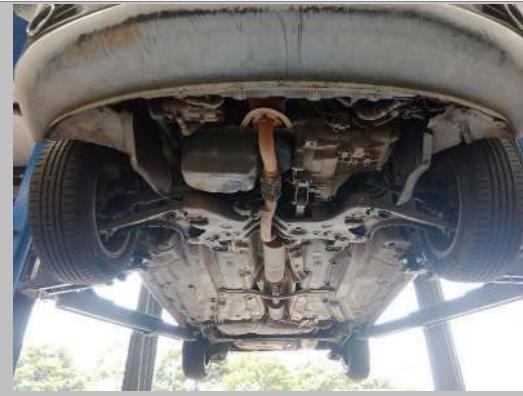
Front chassis

Boot Lid / Hatch door Paintwork • Scratched	Repair
Boot Lid / Hatch Door Shock Left Damaged	Replace
Boot Lid / Hatch Door Shock Right Damaged	Replace
Rear bumper Damaged	Repair
Sill Panel Left Paintwork • Scratched	Repair
Sill Panel Right Paintwork • Scratched	Repair
Rocker Panel Left Damaged	Repair
Rocker Panel Right Damaged	Repair
Roof Residual Traces of Repair	Repair
Windscreen Chipped	Repair
Back Window Scratched	Repair
Steering Rack Boot Left Defective	Replace
Shock Absorber Rear Right Leak	Replace
Shock Absorber Mounting Front Left Defective	Replace
Shock Absorber Mounting Front Right Defective	Replace
Rear Axle Defective	Replace
Control Arm Bush(es) Front Axle Left Cracked	Repair
Tyre Rear Right Damaged	Replace
Rim Front Left Scratched	Repair
Rim Front Right Scratched	Repair
Rim Rear Left Scratched	Repair
Rim Rear Right Scratched	Repair
Chassis Damaged	Repair
Sub Frame Dented	Replace
Engine to silencer pipe Defective	Repair

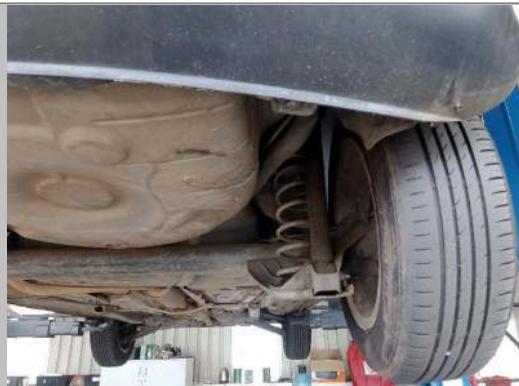
RR TYRE TREAD

Size	Load/Speed Index	Manufacture	Model	Type*	Production Date	Tread Depth (mm)
Front Left	185/60 R14	82H	Nexen	Nblue	V	0923	4 mm
Front Right	185/60 R14	82H	Nexen	Nblue	V	0923	4 mm
Rear Left	185/60 R14	82H	Nexen	Nblue	V	0923	3 mm
Rear Right	185/60 R14	82H	Nexen	Nblue	V	0923	0 mm

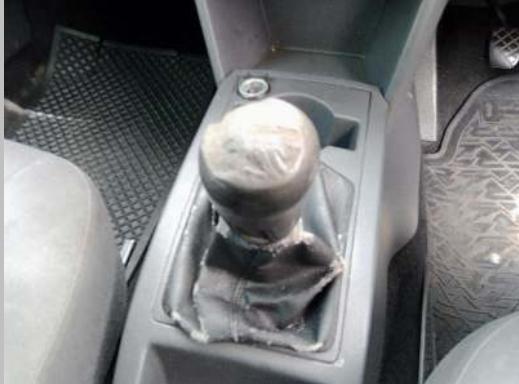
Damage	Repair Way
Window Winder rear left Defective	Replace
Gear Lever Dust Boot Damaged	Repair
Steering Wheel Trim Defective	Repair
Side Mirror Right Residual Traces of Repair	Repair
Front Bumper Damaged	Repair
Bonnet Residual Traces of Repair	Repair
A • Pillar Left Residual Traces of Repair	Repair
A • Pillar Right Dented	Repair
B • Pillar Left Dented	Repair
B • Pillar Right Residual Traces of Repair	Repair
C • Pillar Left Residual Traces of Repair	Repair
Front Fender Left Residual Traces of Repair	Repair
Front Fender Right Damaged	Repair
Rear Fender Left Residual Traces of Repair	Repair
Rear Fender Right Residual Traces of Repair	Repair
Front Fender Left / Inner Tray Defective	Repair
Front Fender Right / Inner Tray Damaged	Repair
Rear Fender Right / Inner Tray Dented	Repair
Door Front Left Residual Traces of Repair	Repair
Door Front Right Damaged	Repair
Door Rear Left Residual Traces of Repair	Repair
Door Rear Right Dented	Repair

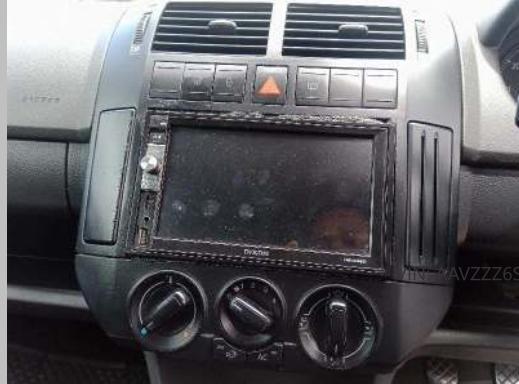
Damage	Repair Way
Engine Oil Leak	Repair
Engine Wiring Defective	Repair
Hoses Defective	Repair
Fan Belt Torn / Cut	Replace
Battery box Corrosion	Repair
Air cleaner Defective	Repair
Center Console / Cubbyhole + Lid Defective	Repair
Electrical Window Winder front right Defective	Replace
Windscreen Wiper Missing	Replace
Windscreen Washer Damaged	Replace
Air Conditioner Insufficient	Replace
Park Light Front Left Defective	Replace
Park Light Front Right Defective	Replace
Dim Light Right Damaged	Replace
Bright Light Right Damaged	Replace
Fog Light Front Left Missing	Replace
Fog Light Front Right Defective	Repair
Number Plate Light Left Defective	Replace
Number Plate Light Right Defective	Replace
Headlight Left Defective	Repair
Headlight Right Scratched	Repair
Seat Front Left Dirty	Repair
Seat Front Right Damaged	Repair
Seat Rear Damaged	Repair
Seat Belt Rear Middle Defective	Repair
Hood Lining Dirty	Repair
Door Hinges Front Right Defective	Repair

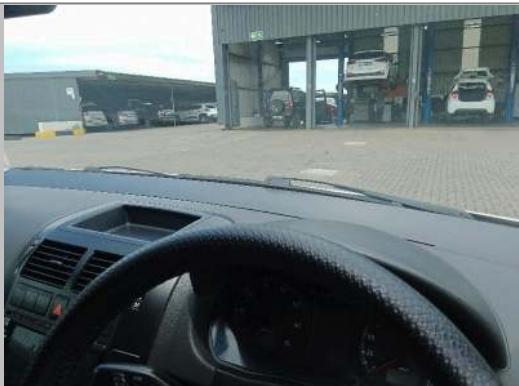
Parcel Tray Damaged	Replace
Dash Padding Defective	Repair

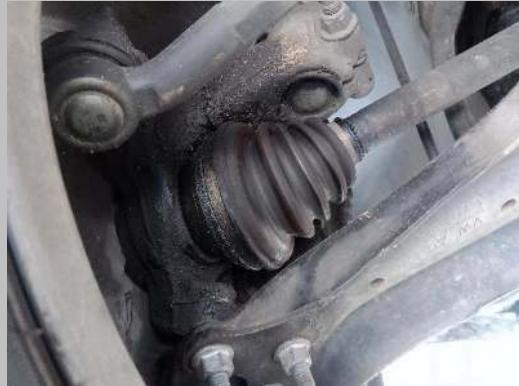
Belly plates Damaged	Replace
CV Joint(s) Front Left (inner/outer) Defective	Replace
CV Joint(s) Front Right (inner/outer) Defective	Replace
CV Joint(s) Boot(s) Front Left (inner/outer) Defective	Replace
Gear Selections Malfunction	Repair
Clutch Operation Insufficient	Replace
Rear right shock absorber weak	Replace
Body and Exterior	Dents and scratches on some body panels
Body and Exterior	Some body panels misaligned
Body and Exterior	Poor residual traces of repair on some body panels
Body and Exterior	Some body panels misaligned
Warning lights illuminated on dashboard	Repair
Interior	Aftermarket sound fitted to vehicle
Tyres and Rims	Spare wheel could not be checked
Engine	Engine bay dirty and battery loose
Engine	Computer box strapped with cable ties
Undercarriage	Vehicle undercarriage dirty.
Interior	Bonnet release handle loose
Interior	Vehicle interior dirty and some panels scratched
